EMD JACKET WATER PUMP WITH INCORRECT IMPELLER ORIENTATION

Report No. 10CFR21-0100

**10CFR21 REPORTING OF DEFECTS
AND NON-COMPLIANCE**

COMPONENT: EMD water pumps

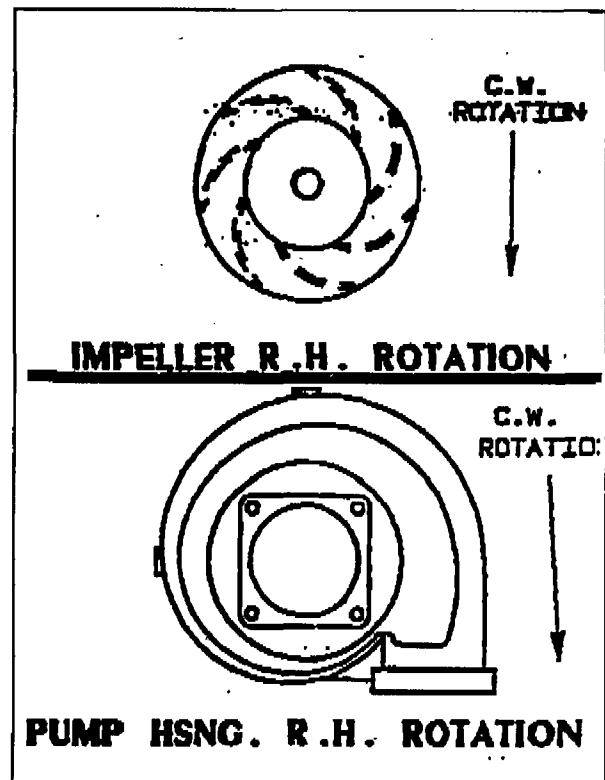
Subsequently, the water pump was returned to ESI for further inspection. It was apparent from a visual inspection that the incorrect impeller was installed for this pump. P/N 8324589 corresponds to a right hand rotation, left bank water pump for use on a 12-cylinder EMD 645E4 or E4B engine. As shown in Photos 1 and 2 below, the housing corresponds to a right hand rotation pump, but the impeller is for left hand rotation. Figure 3 shows the correct impeller for a right hand rotation pump.

Figure 3: Correct Housing and Fin Orientation for RH Rotation

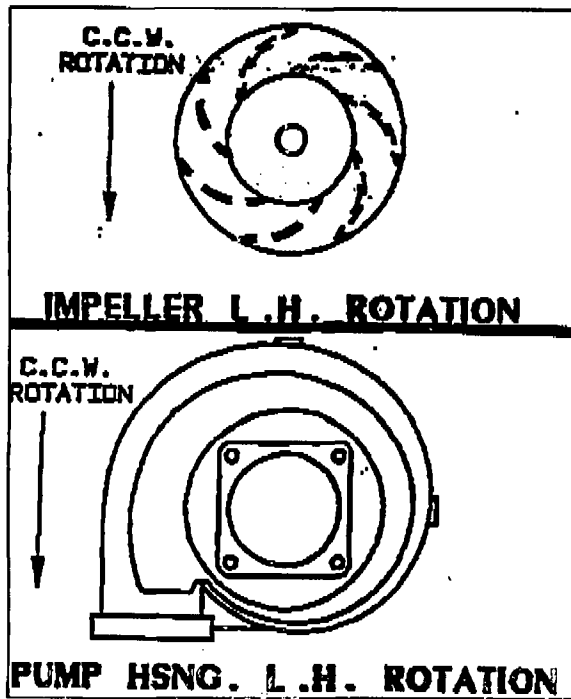
Figure 4: Correct Housing and Fin Orientation for LH Rotation

ESI recommends that as a precaution, all customers with an EMD water pump in stock which was supplied by ESI prior to April 2000 should perform a visual inspection to ensure the correct impeller is installed. A pump which has been installed on the diesel engine is considered acceptable based on successful operation of the diesel engine. The impeller inspection is easily performed, without disassembly, by looking into the inlet port of the pump to confirm the orientation of the impeller matches the pump housing. A listing of the various part numbers supplied prior to April 2000 is included in Table 1. Figures 4 and 5 contain visual guidance to ensure the impeller corresponds to the installed pump housing.

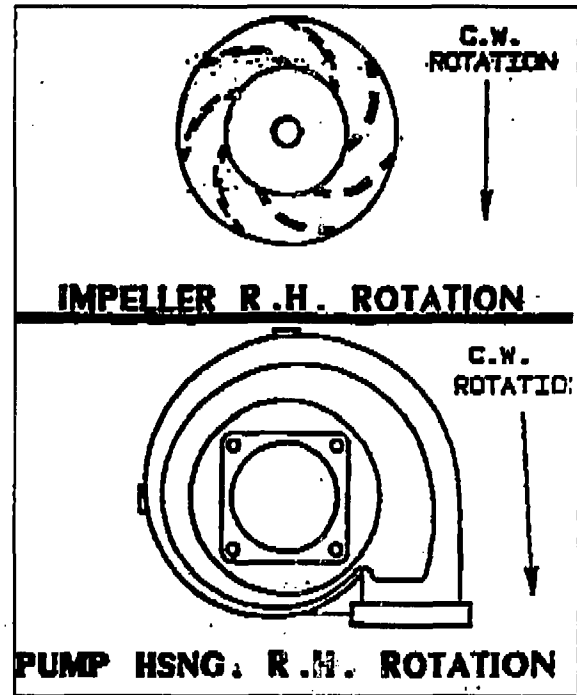
Figure 5: Correct Housing and Fin Orientation for RH Rotation
