TE Connectivity
Energy Division
8000 Purfoy Road
Fuquay-Varina, North Carolina 27526-9349

NOTICE OF DEVIATION PURSUANT TO 10 CFR 21

Subject: NPKC-7-21A(N) Splice kit with possible compromised jacket seal

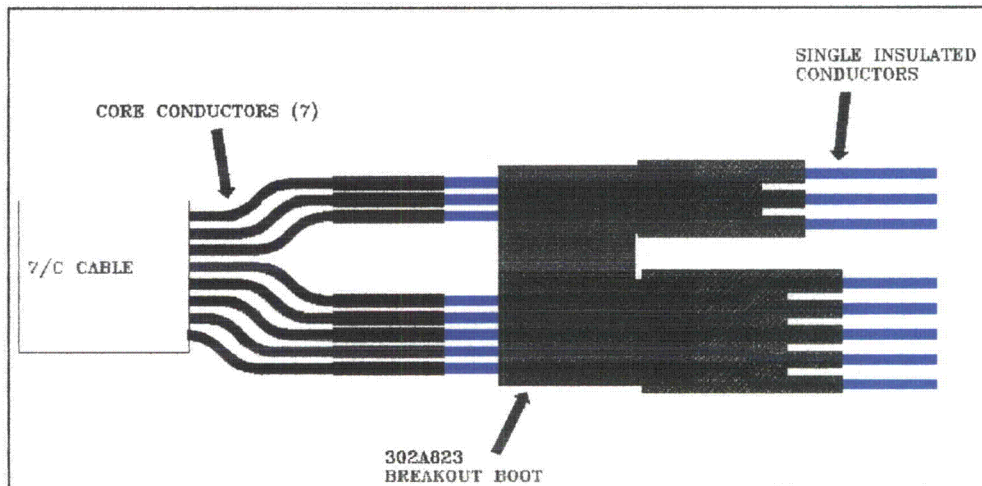
TE Connectivity Energy division has determined that when the Raychem brand splice kit NPKC-7-21A(N) was created, an incorrect breakout boot was selected as part of the kit. As a result, the jacket sealing properties of the splice kit may be compromised when the kit is installed on single insulated conductors that have an outside diameter less than 0.18 inches.

2. USING THIS ILLUSTRATION:

Determine if any splices were installed on single insulated conductors that have an outside diameter less than 0.18 inches.

2.1. If NOT, then the installed splices are still insulated, sealed and protected and therefore no corrective action or replacement is required.

2.2. If YES, Determine whether or not the cable jacket or the cable jacket seal is required for Environmental Qualification.

2.2.1. If YES, the splices should be removed and replaced. Notify TE Connectivity for replacement. (Telephone 800-327-6996)

2.2.2 If NOT, then verify the diameter of the seven core conductors to be greater than 0.11 inch. If they are equal to or greater than 0.11 inches, then the seven individual conductor splices are still insulated, sealed and protected and therefore not part of this notification. If they are less than 0.11 inches, the splices should be removed and replaced. Notify TE Connectivity for replacement. (Telephone 800-327-6996)
