Part 21 (PAR) Event# 46821

#### PRESSURE SWITCH WITH POSSIBLE SUB-STANDARD ELECTRICAL LEAD TERMINATIONS

#### INFORMATION NOTICE

Subject: Evaluation of Deviation for Defect Report: Wire Conductor Crimping

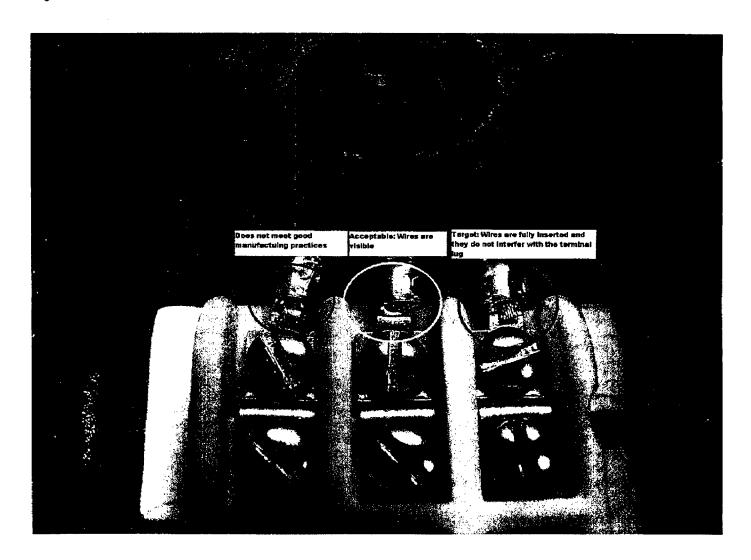
This is an information notice regarding SOR pressure switches that have the electrical terminal block option. A condition of general good manufacturing practice has been brought to our attention in regards to the crimping of wire lugs onto lead wires in the SOR terminal block assembly. SOR allowed a switch to be shipped in which one of the three lead wires in this switch did not meet these criteria, see attached picture.

Good manufacturing practice for creating a connection between a stripped, stranded wire and a crimped terminal suggests that the stranded wire be visible inside the lug after crimping. The wire may be flush with the end of the terminal or protruding out no more than 1/16". In one instance, one of the three wires on a terminal block did not have bare wires that were flush with the terminal end. We believe this was a random occurrence, however, we decided to bring this to your attention. In addition, all switches at SOR must pass a number of tests before they are released for shipment. All of these tests are documented by Production personnel and witnessed by Quality Control personnel. All pressure switches that are in your possession now have passed these tests. There have been no known field problems associated with this issue.

At our customer's option, the subject products may be visually inspected and any wire connections that do not meet the noted criteria may be returned to SOR for rework. To return a switch, contact SOR for a Returned Material Authorization (RMA) number. SOR will pay freight and replace the terminal free of charge. If you decide to inspect the switches, SOR will send replacement cover gaskets. Please notify us if you wish to have gaskets shipped to you.

We have instituted improved procedures and training for Fabrication, Assembly and Inspection personnel to prevent future incidences.
