Subject: 10CFR21 Reporting of Defects and Non-Compliance -  
Engine Systems, Inc. Report No. 10CFR21-0101, Rev. 0

Magnetrol Level Switch, ESI P/N 8277780-ESI  
Magnetrol Type A10

**Report No. 10CFR21-0101**

**10CFR21 REPORTING OF DEFECTS  
AND NON-COMPLIANCE**

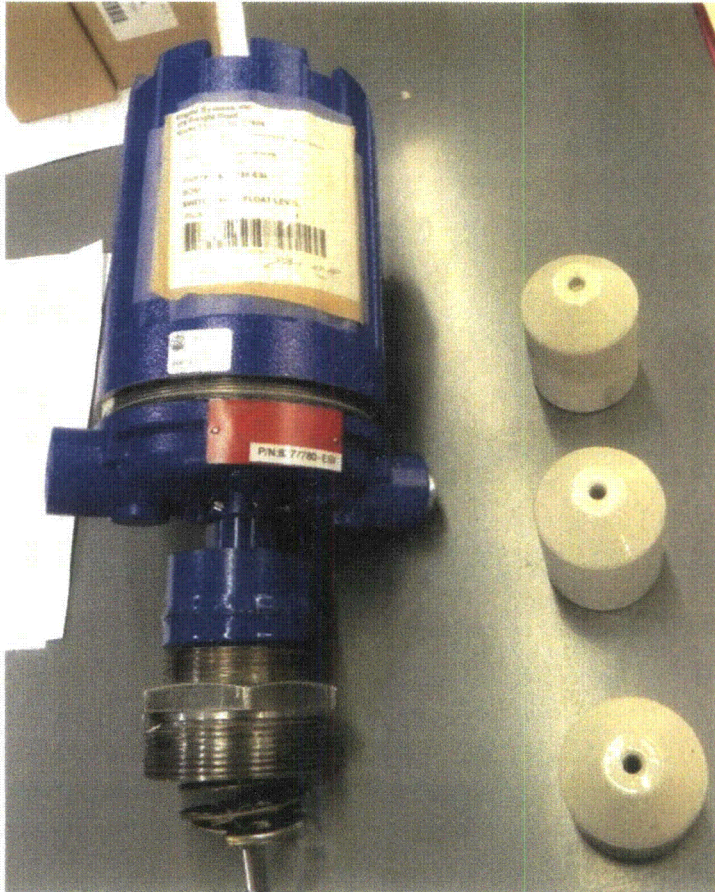
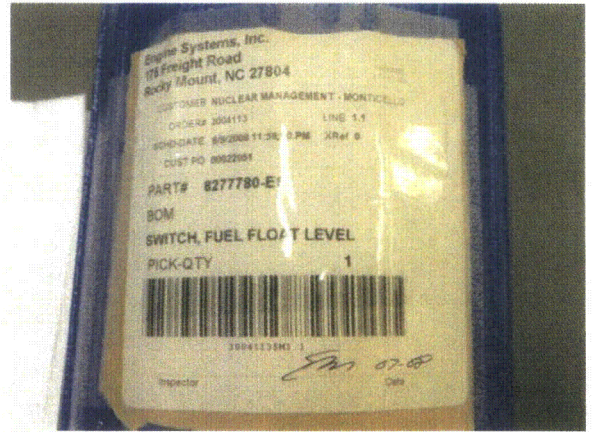
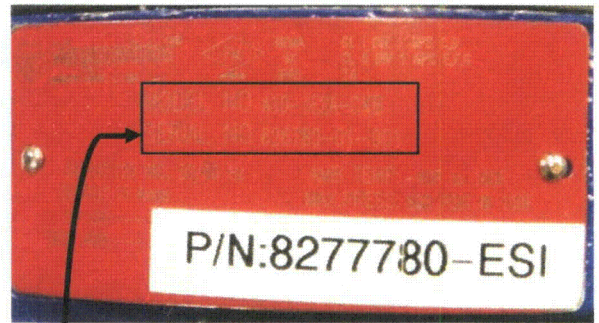
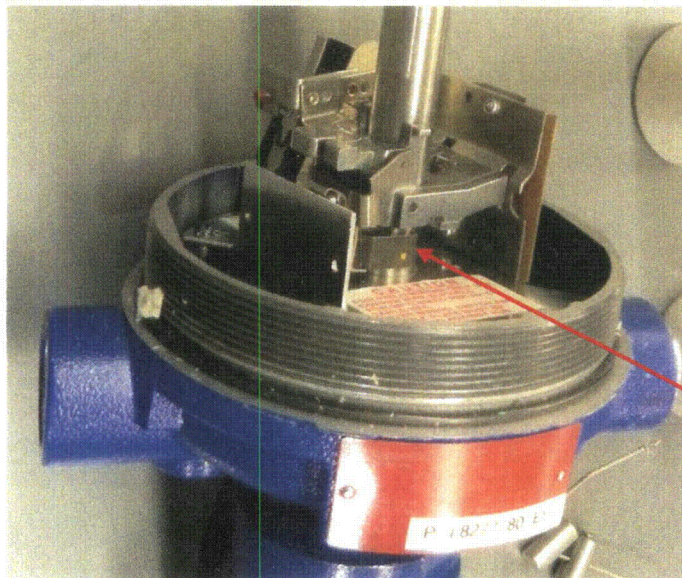
Photos of Level Switch Returned by Monticello Nuclear Plant

Upon receipt at ESI, the switch was inspected and tested. As-found visual inspection did not identify any obvious signs of damage or indicate a cause of failure. Overall condition appeared satisfactory. See photos below for a visual representation of the level switch:

Model No.: A10-1E2A-CKB  
Serial No.: 626780-01-001

Switch mechanism  
Housing (cover) removed

Magnet

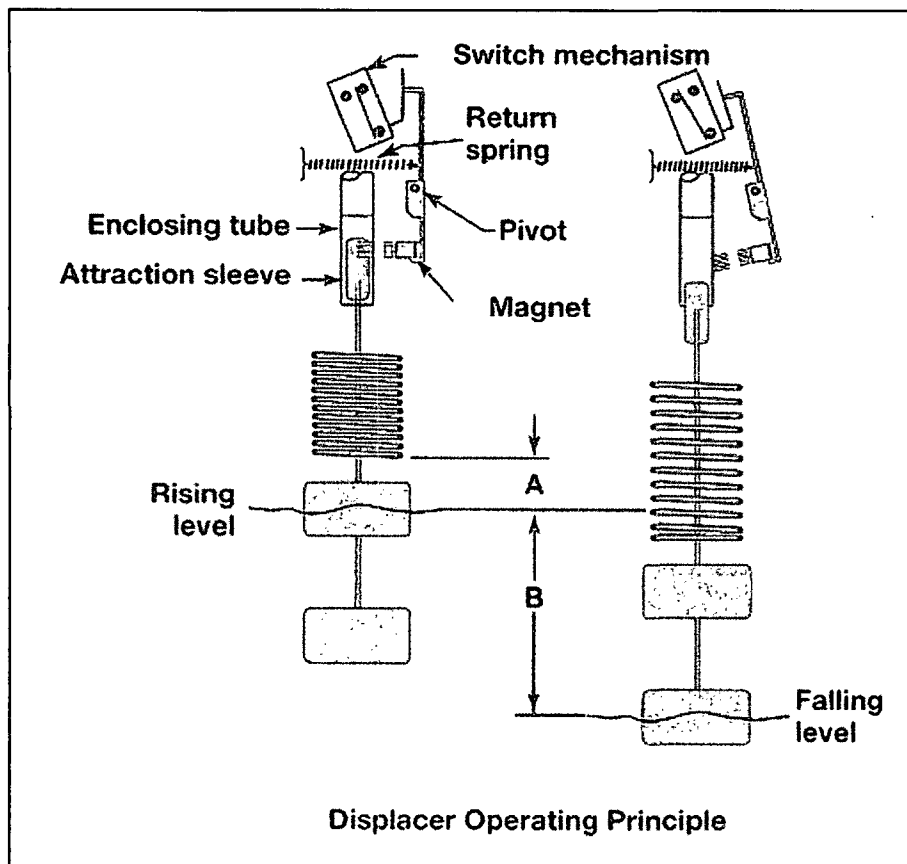
ESI then attempted to functionally test the level switch by manually actuating the float cable by hand and noting proper movement of the switch mechanism. It was found that the switch mechanism would not pull-in as the cable and spring were raised. Operation of the switch is such that as the cable assembly rises (with rising fluid level), an attraction sleeve rises and moves into the path of a magnet on the switch mechanism. The pull of the magnet to the attraction sleeve causes the switch mechanism to change state. Conversely, as the cable assembly falls (with falling fluid level), the attraction sleeve falls and the magnet retracts causing the switch mechanism to change state.

After noting this weak magnetic pull, ESI selected two similar Magnetrol level switches which had been used previously as seismic test specimens; one from 2006 and one from 2001. While they are different part number level switches, they both utilize the same magnet within the switch mechanism. Both of the units were found to still operate satisfactorily. The magnet in the customer's unit was then replaced with a magnet from each of the seismic specimens. In both instances, the customer's unit was operational (switch changed state). The magnet from the customer's unit was then placed into each of the seismic specimens. In both instances, the unit would not operate (switch would not change state). This series of testing provided further evidence that the magnet in the customer's unit was weak and was the cause of failure.
