Part 21 (PAR)

Event # 46923

#### POTENTIAL DEFECT IN CERTAIN VELAN SUPPLIED GLOBE VALVES

**Subject:** Globe Valve Notification, sizes 0.5, 0.75 and 1 NPS, Class 800, Carbon Steel

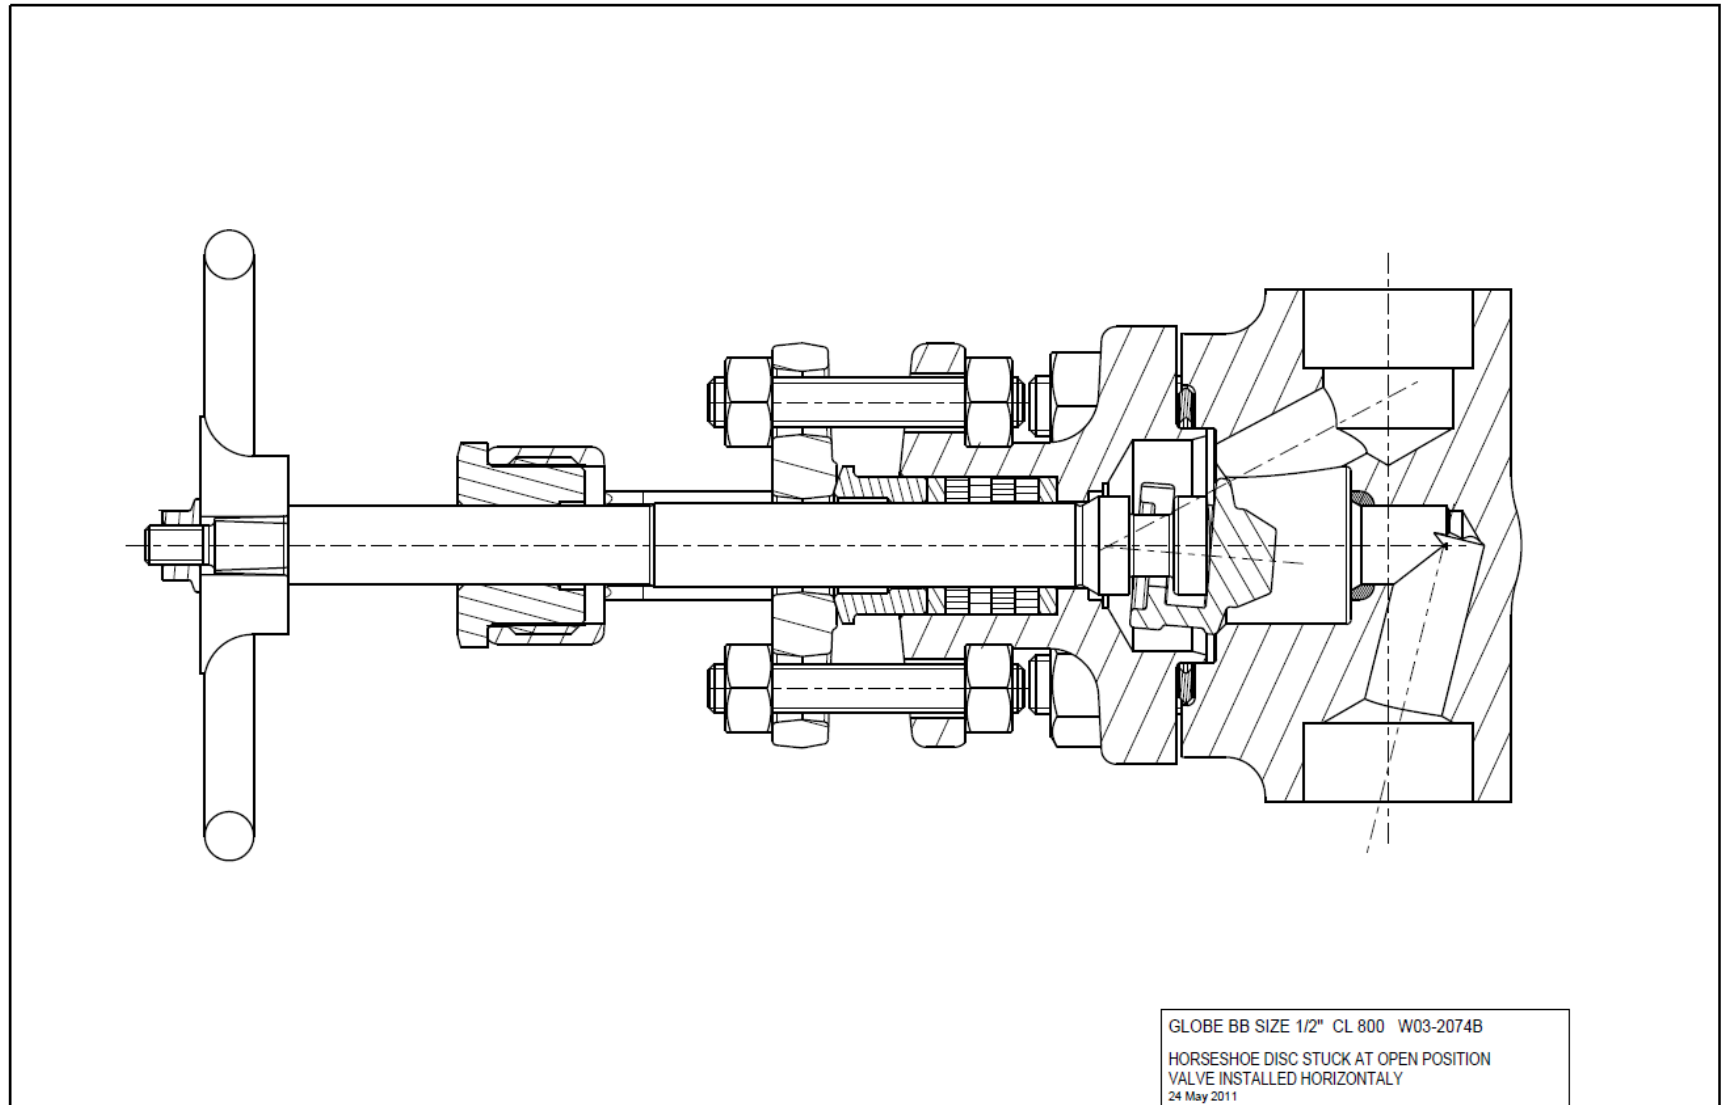
The valve was installed with the stem in a horizontal orientation; during the installation and commissioning procedure the valve was fully open (on the back seat position). The disc travelled into the bonnet cavity and became jammed between body and bonnet; the sketch in Exhibit # 1 shows the failure mode.

The analysis revealed that the failure was caused by the wrong bonnet being installed on the valve which ultimately allowed the disc to travel too far into the bonnet cavity and consequently the disc dropped into the body-bonnet gap. This prevented the valve from being closed during manual operation. The event is covered by Millstone 2 OE 33277.

We requested that each affected utility reviews the individual applications for the specific valves identified in this notification; in the event of any application where the valves inability to close will impact significantly the safe operation of the plant Velan will work with the Utility towards reaching a suitable solution.

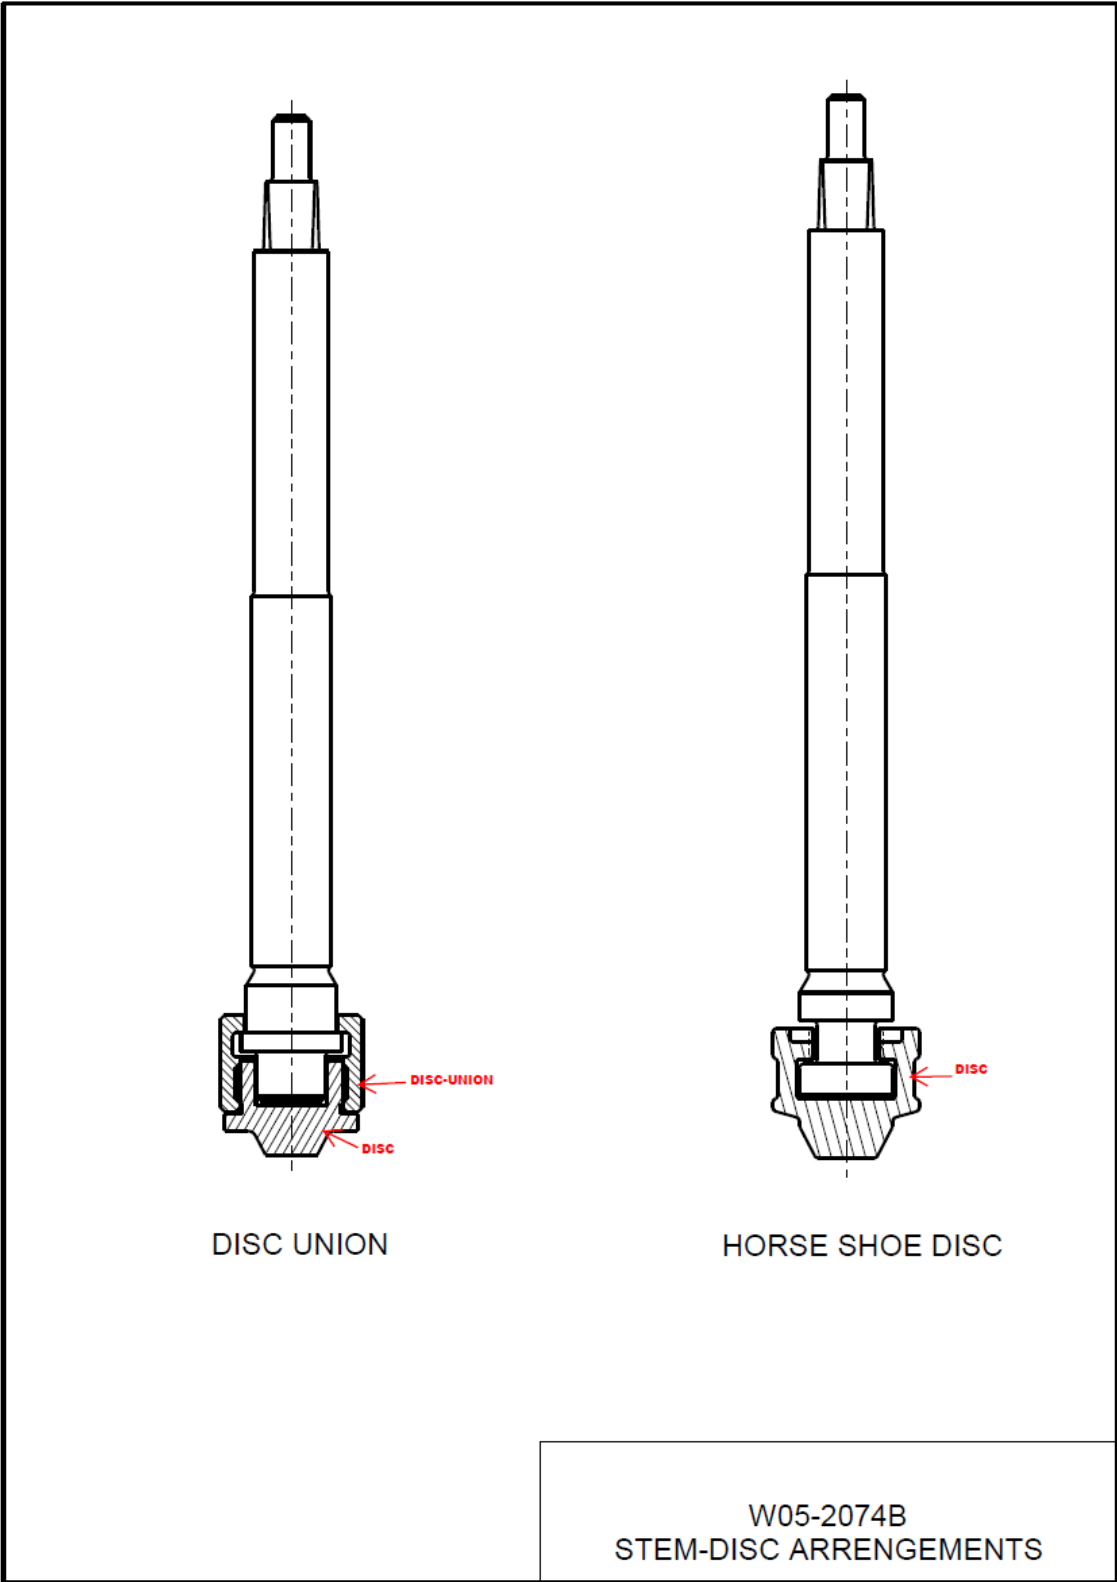
Prior to 1984 Velan employed a disc-union to connect the disc with the valve stem. In 1984 a new design was introduced, using a horseshoe disc thereby eliminating the need for a disc-union and the welding required to assemble the disc to the disc-union. The old design, using bonnet part number 3523-010 was reserved afterwards for military applications.

The new design, intended for all commercial and nuclear applications, also used a new bonnet (part 3524-037), with a lower backseat necessary to accommodate the shorter lift as a result of the disc-union being eliminated. Exhibit # 2 displays two stems, showing the aforementioned methods used to connect the disc to the stem.

Due to the bonnet part 3523-010 being nearly identical with the new bonnet, 3524-037, it was incorrectly deemed interchangeable for the latter and used in a small number of instances identified in the above table.

In 2003 an Engineering review identified the potential for this type of failure on valves installed with the stem in a horizontal orientation. Consequently, the existing stock of bonnets suitable for valves using the disc-union connection was scrapped immediately. Because the operational feed-back did not indicate any field problems at the time, the analysis failed to recognize the potential impact on valves assembled with old bonnets used in safety-related applications.

Corrective actions to eliminate the recurrence of such events are under review.
