PART 21 REPORT - FOREIGN MATERIAL FOUND IN EMERGENCY DIESEL GENERATOR HIGH PRESSURE FUEL HOSE

Report No. 10CFR21-0104

**10CFR21 REPORTING OF DEFECTS
AND NON-COMPLIANCE**

COMPONENT: NPPD fuel hose 2-01H-050-003

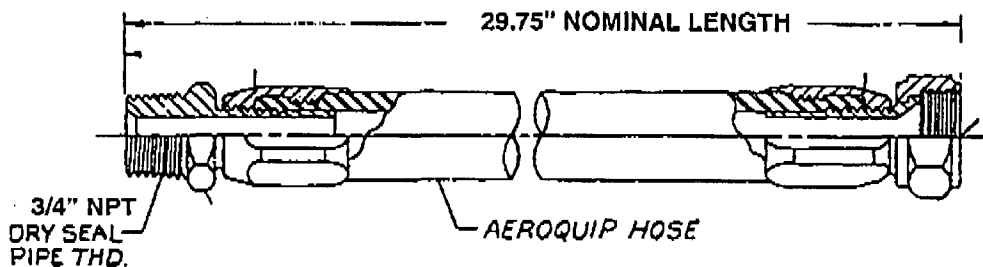
FIGURE 1
FUEL HOSE #2-01H-050-003

The foreign material found during inspection of the returned hose assembly was determined to be very small pieces of the elastomer tube internal to the hose. It appears these pieces were introduced during assembly of the end fittings onto the hose during fabrication of the hose assembly.

Hoses remaining in customer inventory should be inspected to verify they are free of foreign material prior to installation. Any hoses previously installed on the EDG are not suspect as operability has been confirmed via functional testing.

To prevent recurrence of this issue, the dedication report for the hose assembly has been revised to include a requirement to solvent flush each hose prior to shipment. Filtered solvent will be pumped through the hose for a minimum of 5 minutes. After flushing, nitrogen will be blown through the hose to remove excess flushing fluid and a detailed visual inspection will be performed to ensure there are no visible contaminants immediately prior to installation of the hose end caps. This flushing requirement was already included in the dedication reports for other critical application hose assemblies so this notification is being limited to this part number only.

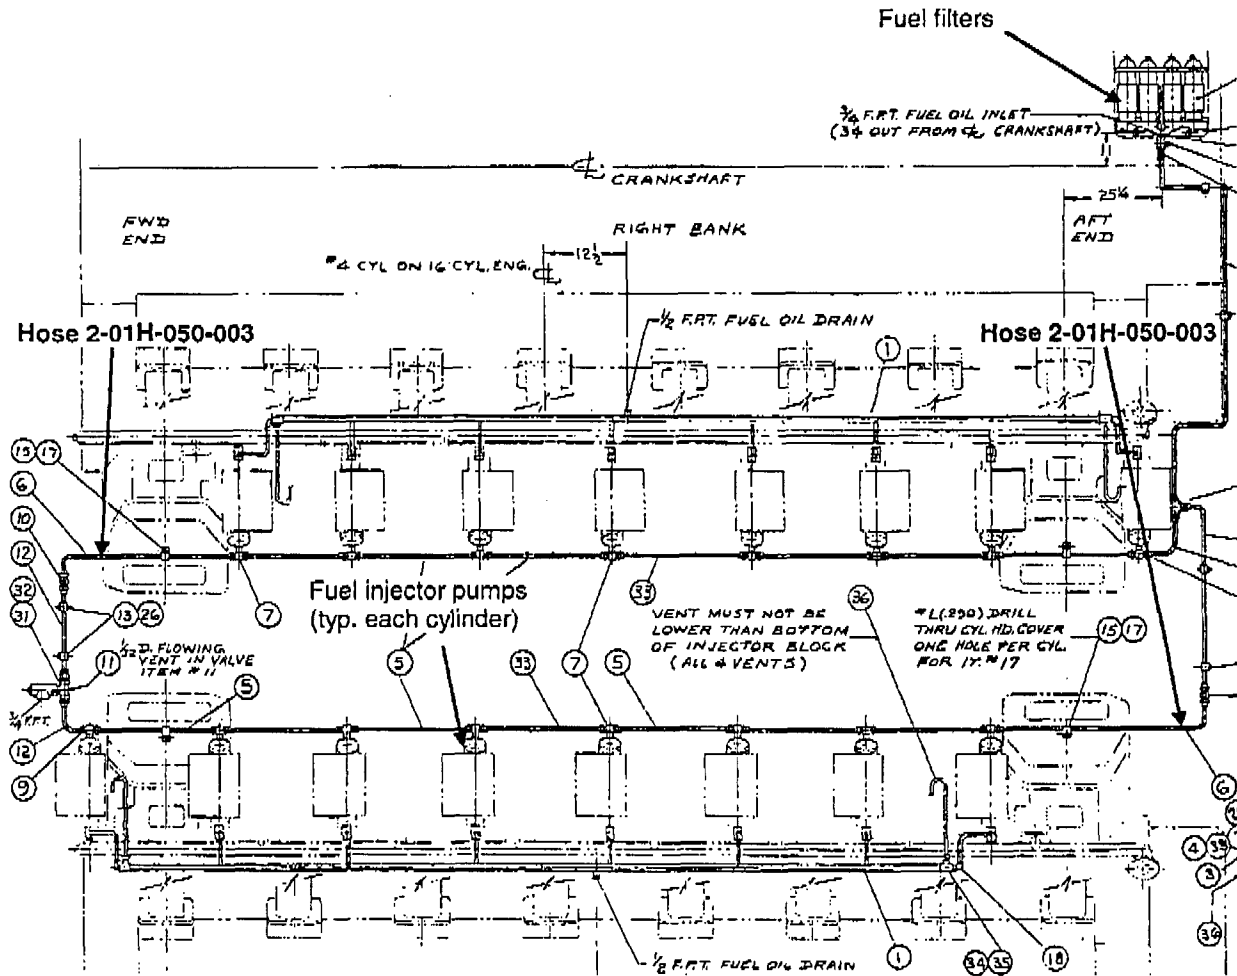
FIGURE 2
LOCATIONS OF FUEL HOSE #2-01H-050-003

The hose, P/N 2-01H-050-003, is located after the engine fuel filter and before the fuel injection pumps. Foreign material within this hose could migrate to the fuel injection pumps. The entrance of foreign material could impact operability of one or more fuel injection pumps and therefore affect fuel delivery to one or more engine cylinders. This could impact the load carrying capability of the diesel engine or possibly complete engine shutdown. Either scenario has the potential to prevent the emergency diesel generator from performing its safety related function.
