Event # 47842

PART 21 REPORT - SWAGELOK U SERIES BELLOWS VALVES LOOSENING OF STEM TIPS

**Subject: Potential 10CFR21 notification**

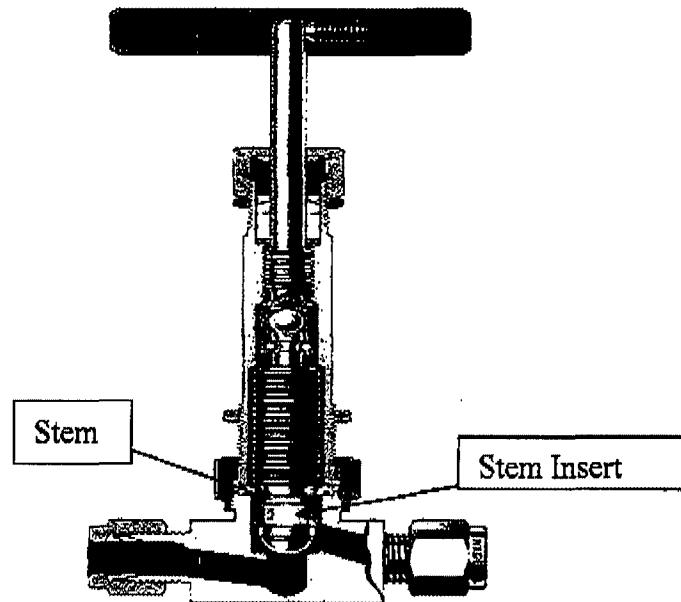
Our evaluation confirmed loosening of the stem tips and determined the root cause to be higher than normal torque being applied to the valve handle during closure. *(Please note that we did not specify a minimum or maximum torque for our operating instructions.)* This caused the stem and the stem insert interface to loosen, but not fully disengage. Our tests show that closure to catalog specification of  $4.0 \times 10^{-9}$  atm. cc/sec of helium can still be achieved with this condition.

The picture above shows a cutaway version of a valve in question.

Although the stem tip may loosen when higher than normal torque is applied to close the valve, the tip will not become completely disengaged from the stem insert. The document below shows the stack up of tolerances on the 8U valve, with a loose stem tip. Even with the tip loosened until it contacts the valve body, at least one thread of engagement still remains between the tip and stem insert. This means the stem tip will remain captured within the valve body and will not enter the process stream. Similar conditions apply to the 4U and 6U Series valves.

Revised drawings will be created for the affected utilities, showing both the recommended and maximum allowable closure torques, for the affected valve series.
