Subject: 10CFR21 Reporting of Defects and Non-Compliance -
Engine Systems, Inc. Report No. 10CFR21-0106, Rev. 0

EMD (Detroit Switch) Temperature Switch – Potential Missing Set Screw

Report No. 10CFR21-0106

SYSTEM: Emergency Diesel Generator

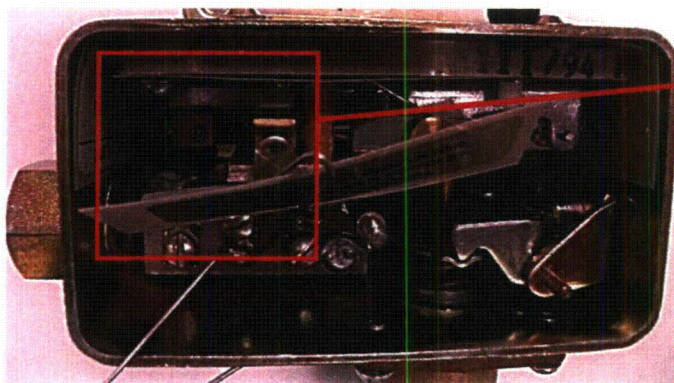
The set screw found in the temperature test fixture oil bath is 1/8" long with #6-32 threads. This is the same length, thread size and style as the set screw used in EMD/Detroit temperature switches to lock the differential adjustment screw.

TYPICAL EMD/DETROIT TEMP SWITCH
(shown with cover removed)

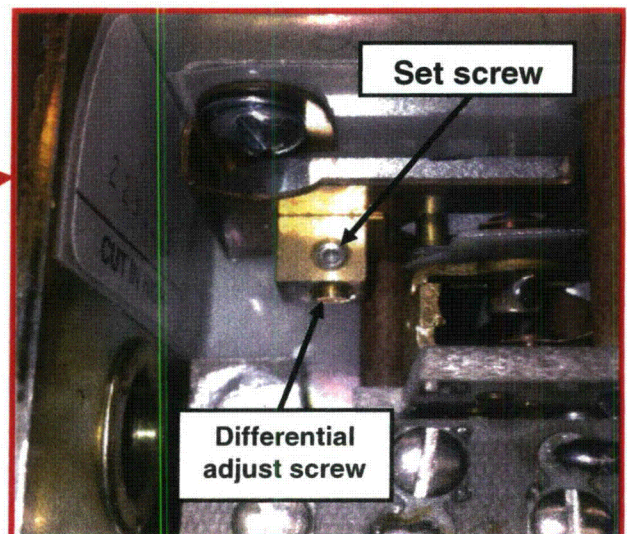
SET SCREW LOCATION

The evaluation was concluded on 10/3/2012 and it was determined that this issue is a reportable defect as defined by 10CFR21. If a switch applied in the immersion heater control application experiences significant setpoint drift, it is possible that the standby temperatures of the lube oil and coolant systems may be degraded enough to affect the start time of the diesel generator.

All affected users should inspect the suspect switches (see Table 1) for presence of the set screw at their earliest convenience. If the set screw is missing, the temperature switch should be returned to ESI for rework.

1. Loosen the screw located in the center of the temperature switch cover.
2. Remove the cover, the mounting screw and cover gasket will remain attached to the cover.
3. Look behind the insulator to access the differential adjust screw.
4. Verify that set screw is installed.
 - a. If installed, re-install the cover; temperature switch is acceptable.
 - b. If not installed, return the temperature switch to ESI for rework.
