Event # 48493

PART 21 - AN OPERATING MECHANISM FRONT COVER FAILED DURING LICENSEE RECEIPT INSPECTION

Subject: 10CFR Part 21 Notification of Deviation re. K-Line Circuit Breaker Operating Mechanism Covers

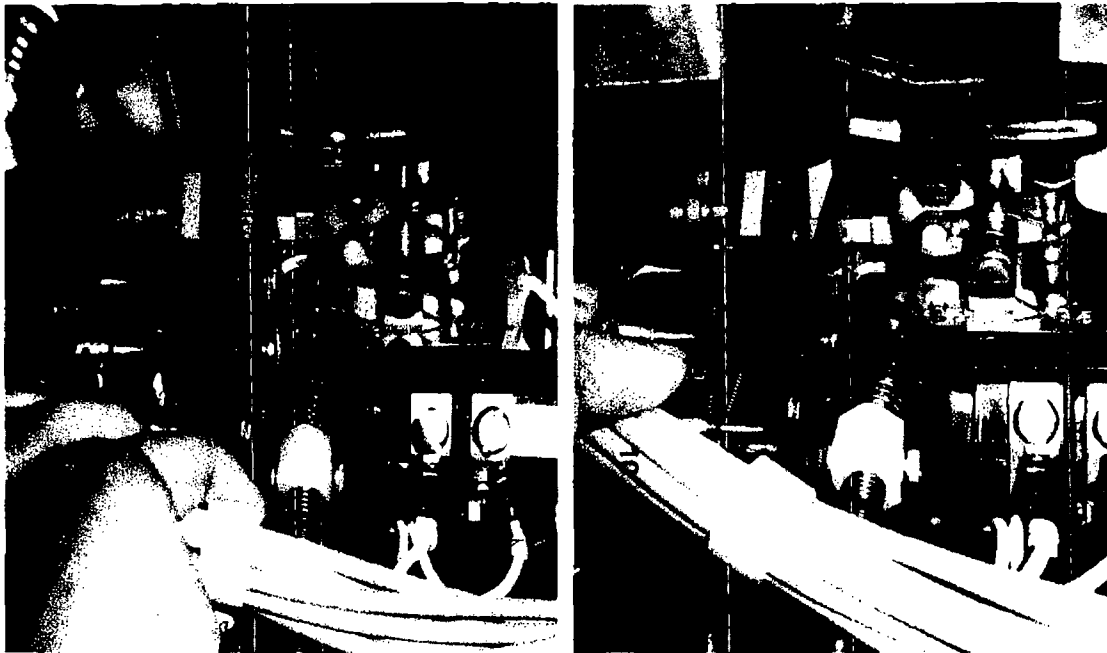
4. Nature of the deviation: One of thirty breakers provided to Seabrook failed to close during receiving inspection. This issue was communicated to ABB 9/14/2012. The subject operating mechanism cover was returned to ABB for inspection and root cause analysis on 9/18/2012. The root cause for the cover hole locations being out of position is corrective maintenance required of the six-part progressive die tooling used in the manufacturing process. Extent of condition performed by ABB indicated all P/N 707939A00 and 707939B00 in inventory had control device mounting hole locations out of position.

Misaligned plunger to secondary close latch.

Correctly aligned plunger to close latch.

5. Corrective actions include:

- a. Removed all P/N 707939A00 and 707939B00 covers from inventory. (Action complete)
- b. Notified Accutrex Products, Inc. of the issue and completed process audit of tooling and manufacture of P/N 707939A00 and 707939B00 covers. This review was supported by ABB Supply Chain Manager, QA Engineer and Fabrication Manager. (Action complete)
- c. ABB approved corrective maintenance repairs to five of six pieces of tooling used to manufacture P/N 707939A00 and 707939B00 covers. All maintenance and repairs to these tools are completed. One of six tools was removed from use. Secondary operations were established to drill control device mounting holes after operating mechanism covers manufactured with first piece run expected to be completed 11/15/2012.
- d. Revised P/N 707939A00 and 707939B00 Critical Characteristics to include control device mounting hole locations. (Action complete)

Because of the large potential variety of usages of the affected circuit breakers, ABB (Medium Voltage Service) cannot determine if the potential for a substantial safety hazard exists at any licensee's facility if control device plunger and secondary close latch are misaligned. It is recommended the Licensees determine if the circuit breaker control device plunger and secondary close latch are misaligned at the next convenient maintenance opportunity defined in the ABB K-Line circuit breaker Information Bulletin.
