March 20th, 2013

Document Control Desk
U.S. Nuclear Regulatory Commission
Washington, D.C. 20555-001
Subject: NP8320 solenoid valve

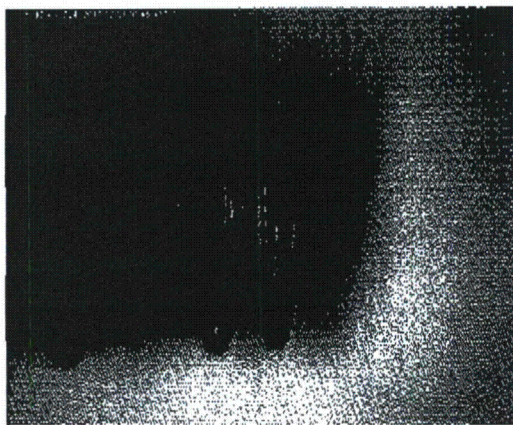
The valve was dis-assembled and the spring was observed to be not on the core completely, reference Figure 1 for the as-found condition. Figure 2 shows the spring completely on the core.

The valve was re-assembled with the spring properly on the core, as in Figure 2, and subjected to cycling. During cycle testing the second turn of the spring was shown to completely overlap the first turn coming over the edge of the core, pulling the first turn off of the core. The spring came completely off the core in 97 cycles.

ASCO identified that the spring was not properly manufactured as the beginning of the second turn was not wound to the same diameter of the first turn.

This condition may cause the spring to work itself off the core and present a situation where the valve would not shift to its de-energized position. ASCO believes the condition would present itself relatively early into its cycle life.

ASCO has implemented corrective actions to include inspection of the spring assembled to the core at nuclear dedication inspection to verify that the spring is properly seated and the second turn does not overlap the first at the springs working length.

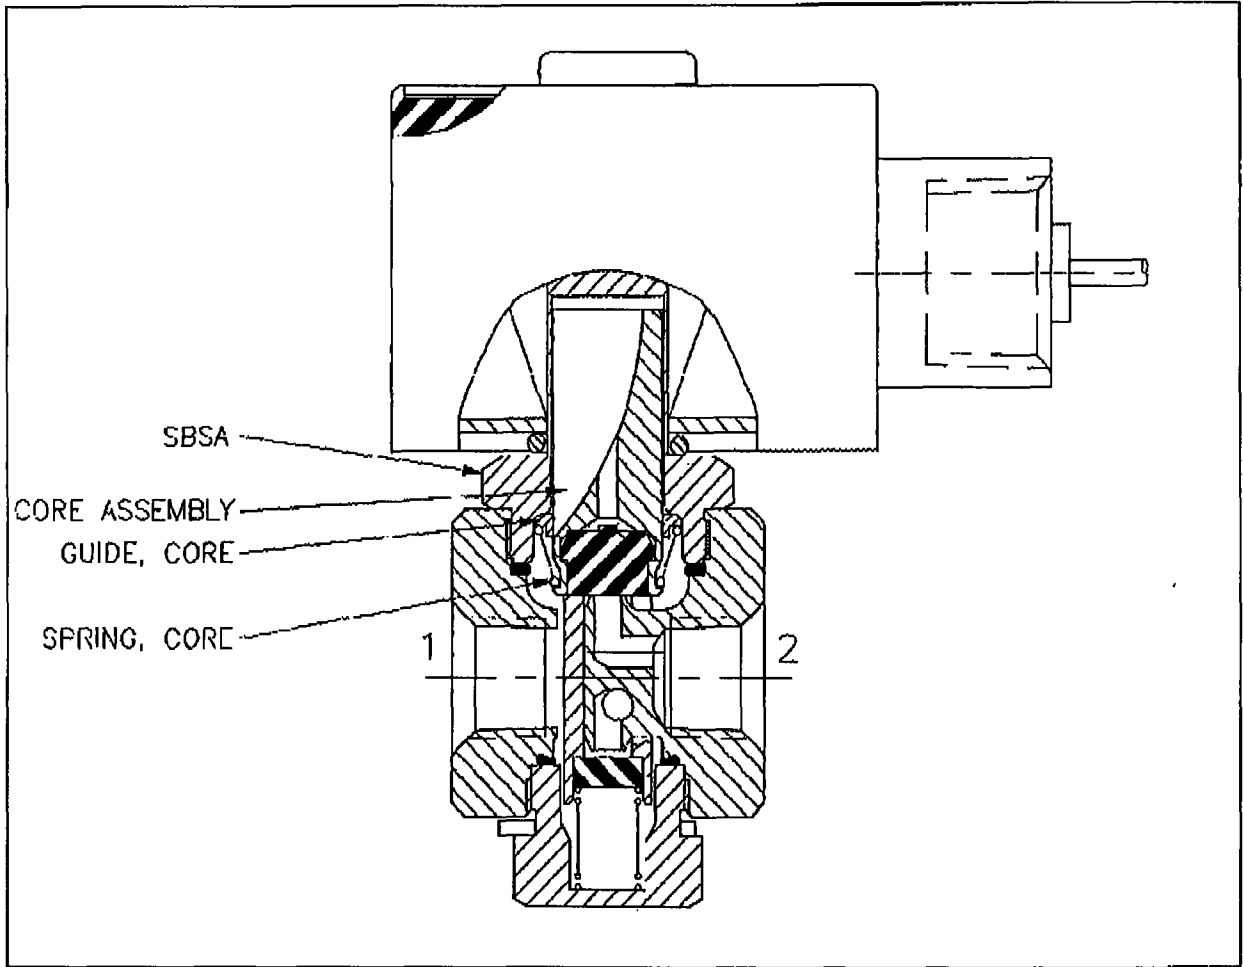
Figure 3

NP8320 valves are direct acting, 3-way valves for use as 1-E nuclear qualified valves. The returned valve is a normally open, stainless steel valve with EPDM elastomers (Figure 3, appendix). A normally open valve when pressurized at the inlet port (port 3) will have flow out of the cylinder (port 1) with the solenoid de-energized, as shown in Figure 4, appendix. The core is the magnetic component that moves when the solenoid is energized, opening the exhaust port. When the core moves, it allows a second disc to move, closing the pressure port. When the solenoid de-energizes, the spring attached to the core pushes it down, closing the exhaust port while pushing another disc, opening the pressure port. The core/spring assembly are separate components dedicated at nuclear assembly. ASCO has been manufacturing NP8320 valves since 1978.

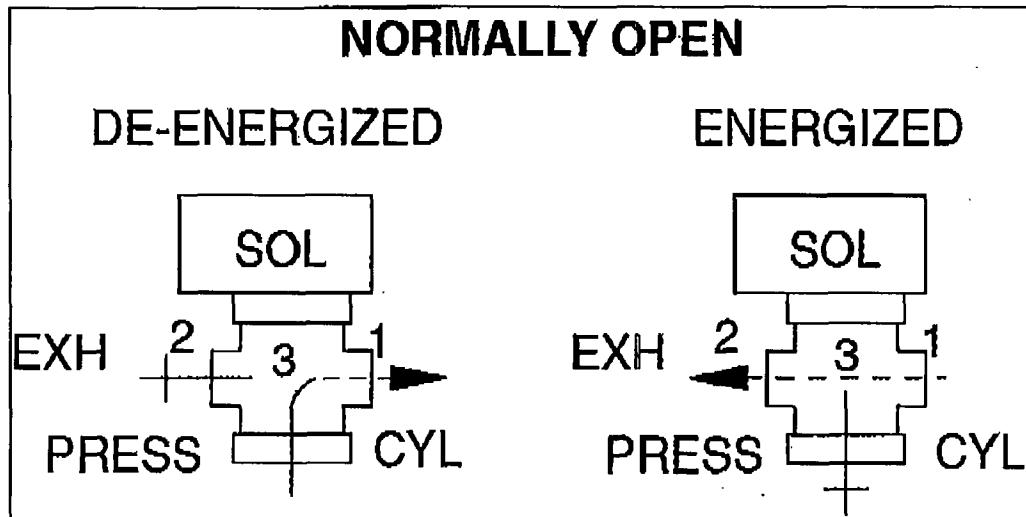
Figure 4

The returned valve was tested per our test procedure. Pressure was applied to the inlet port (port 3, Figure 4), and no flow was observed through the cylinder port with the solenoid de-energized. When the solenoid was energized, no change of state occurred. There was no leakage through the cylinder port or exhaust port.
