PART 21 REPORT - ESI REFURBISHED EMERGENCY DIESEL GENERATOR CYLINDER HEADS MAY HAVE VALVE KEEPER SEALS MISSING

Report No. 10CFR21-0108

COMPONENT: KSV Cylinder Head with Missing Keeper Seals
Head Part Numbers 10-KSV-11-3-RR, 12-KSV-11-3-RR, and 13-KSV-11-6-RR

SYSTEM: Emergency Diesel Generator

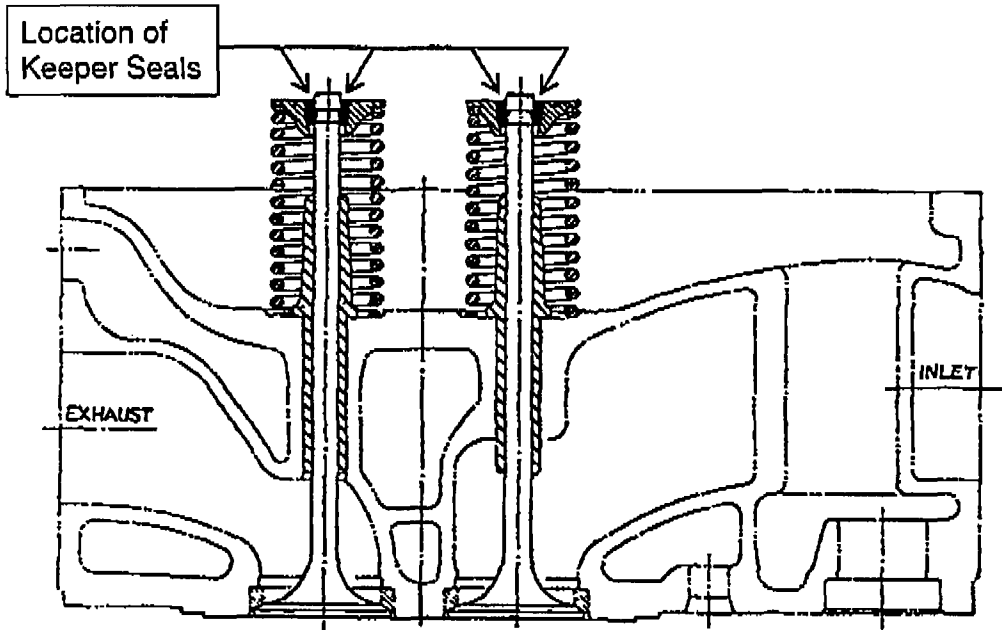
During the failure analysis investigation performed at the current Cameron facility in Casper, WY, it was noted that the intake and exhaust valve keeper seals, P/N W30C-1#1, were not installed. The purpose of the keeper seals is to deflect lube oil from draining into the cylinder head, and possibly the combustion chamber, during standby conditions. The source of this lube oil is the intake and exhaust rocker arms that are pressurized with heated lube oil during standby conditions to maintain the engine's fast start capability. The quantity of oil that travels through the rocker arms to the valve keeper area is dependent upon the component clearances within the rocker arm components. The absence of the valve keeper seals could allow a small amount of this lube oil to drain past the keepers, down the valve stem, through the valve guides and into the intake and exhaust ports of the cylinder head. In this particular case, the intake or exhaust valves were sufficiently open to allow oil to enter the cylinder (which is dependent upon the engine's position when it stops rotating following a shutdown). One or more cylinders on an engine will have open valves at any given position of the crankshaft, though not all cylinders are affected at the same time.

The seals are made of an elastomeric material in the form of a rectangular block and they are replaced during a rebuild as standard practice. Each cylinder head has eight seals (with two required for each valve and there are four valves per head). The seals are installed between the keeper halves on opposite sides of the valve stem. See figure and photo on the following page for a visual representation of the seal location.

Figure 1: Showing Location of Keeper Seals

Inspect the valve keepers for presence of the keeper seals. If seals are installed, no further action is required. If seals are not installed, it is recommended that a borescope inspection be performed to ensure no engine lube oil is in the combustion chamber. This inspection could be performed through the fuel injector bore or the Kiene valve passage (if equipment will allow).

If oil is present, then immediate action is required to remove the oil and rework or replace the cylinder head. Reworking the head can be performed on-engine as follows: With the Kiene valve open, the engine should be barred over until the piston is at top dead center. By doing this the oil will be pushed out of the Kiene valve. Lock the barring device to maintain the piston at TDC and connect a pressure test set to the Kiene valve. This pressure will be used to hold the valves against the fire deck of the cylinder head. An applied pressure of 50 psig should be used; however higher pressures may be utilized as required to maintain the valve against the fire deck. Remove the rocker arms to access the top of the valves. Using a valve spring compressor (such as P/N LS-44-AA#7), compress the spring retainer enough to loosen the keepers and insert the keeper seals. Replacement keeper seals are available from ESI as dedicated components. Relieve the spring compressor and ensure the keeper seals are fully inserted between keepers and flush with the top of the keepers. Repeat for the remaining valves.
