PART 21 REPORT - FOXBORO POWER SUPPLY POTENTIAL FAILURES DUE TO DEFECTIVE TIE WRAPS AND HOLDERS

Subject: 10 CFR Part 21 Report Notification, Foxboro, Co. N-2ARPS-A6 Power Supplies
Common Mode Failure of Thomas and Betts Model TC105A Ty-Rap Mounting Plates Adhesive
Final Report.

Title: FINAL REPORT ON IRI FOXBORO METER CO., POWER SUPPLY MODEL N-2ARPS-A6 SERIAL NUMBER 4935949 TIE WRAP HOLDERS.		Document Number: TMI-1201-100
Document Type: Technical Evaluation		Project No: TMI-1201
Client: Three Mile Island Nuclear Station	Purchase Order No: 80 046008	Page 1 of 5

FOXBORO NUCLEAR SPEC200 POWER SUPPLY POTENTIAL FAILURES DUE TO DEFECTIVE CABLE TIES AND CABLE TIE HOLDERS

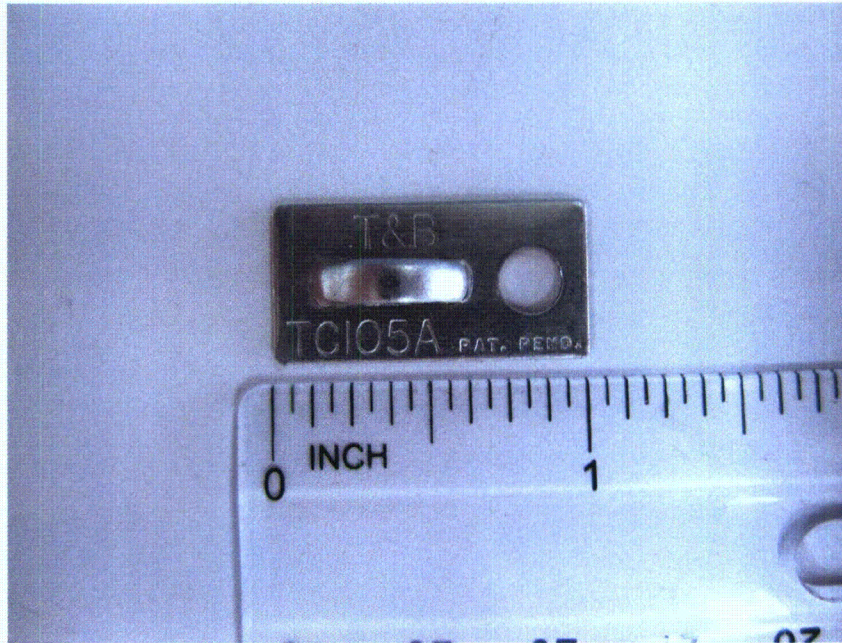
ATTACHMENT 1 - PHOTOGRAPH OF FAILED TIE WRAP HOLDER TC105A
Page 1 of 1

During the refurbishment of a safety related Foxboro Model N-2ARPS-A6 STYLE D power supply Serial Number 4935949 from Three Mile Island Nuclear Plant Integrated Resources, Inc. (IRI) found a one inch by ½ inch Ty-Rap aluminum mounting plate lying loose in the bottom of the power supply. (Attachment 1)

Further examination of the power supply found that the adhesive had failed on 14 of the 15 remaining aluminum mounting plates leaving the plates attached to the wire harnesses by age embrittled nylon wire ties. The only mounting plate that had not failed was not used (no tie wrap was installed).

Figure 1 - TC105A with failed adhesive

IRI concludes that removal of all wire tie holders and any aging wire ties, replacing the wire ties with TEFZEL wire ties.

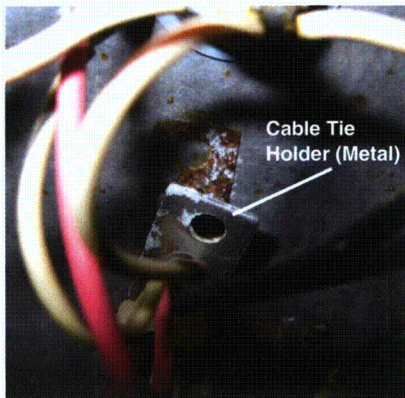
The adhesive that was integral to the aluminum cable tie holder was utilized in production from initial sales release until the year 1995. It has determined that this age group is at risk of adhesive failure based on the field reports and our own observations. (See the example of adhesive embrittlement in the photo to the left.)

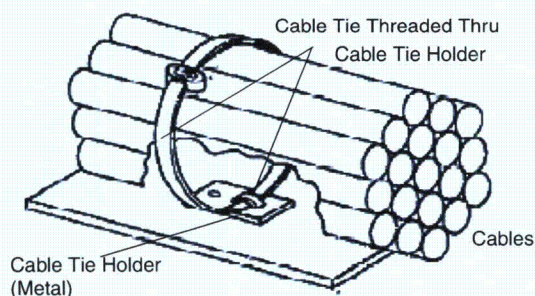
Cable Tie Holder

The adhesive that was integral to the aluminum cable tie holder was utilized in production from the initial sales release until the year 1995. It has been determined that this age group is at risk of adhesive failure based on the field reports and our own observations.

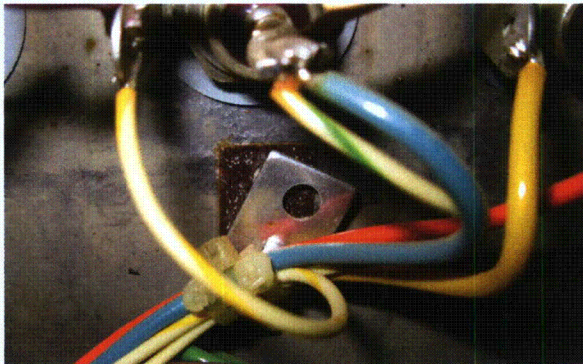
3. The following examples indicate a close-up of an aging cable tie holder in the rear heat-sink location and the chassis location.

Figure 6. Rear Heatsink Location

The cable tie holders serve no safety-related purpose and those that are loose or detached should be removed. Only the new cable ties supplied in this kit will be used for the cable bundle tie-down.

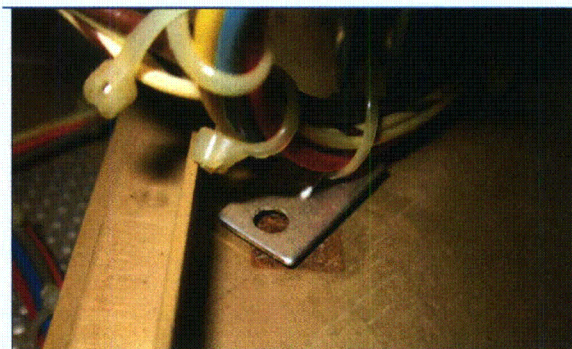
Figure 7. Chassis Location
