Part 21 (PAR)

PART 21 - BEARING DEFECT

**INITIAL REPORT 10CFR PART 21
REPORT OF A POTENTIAL SAFETY HAZARD**Report No. 46
Page 2 of 3

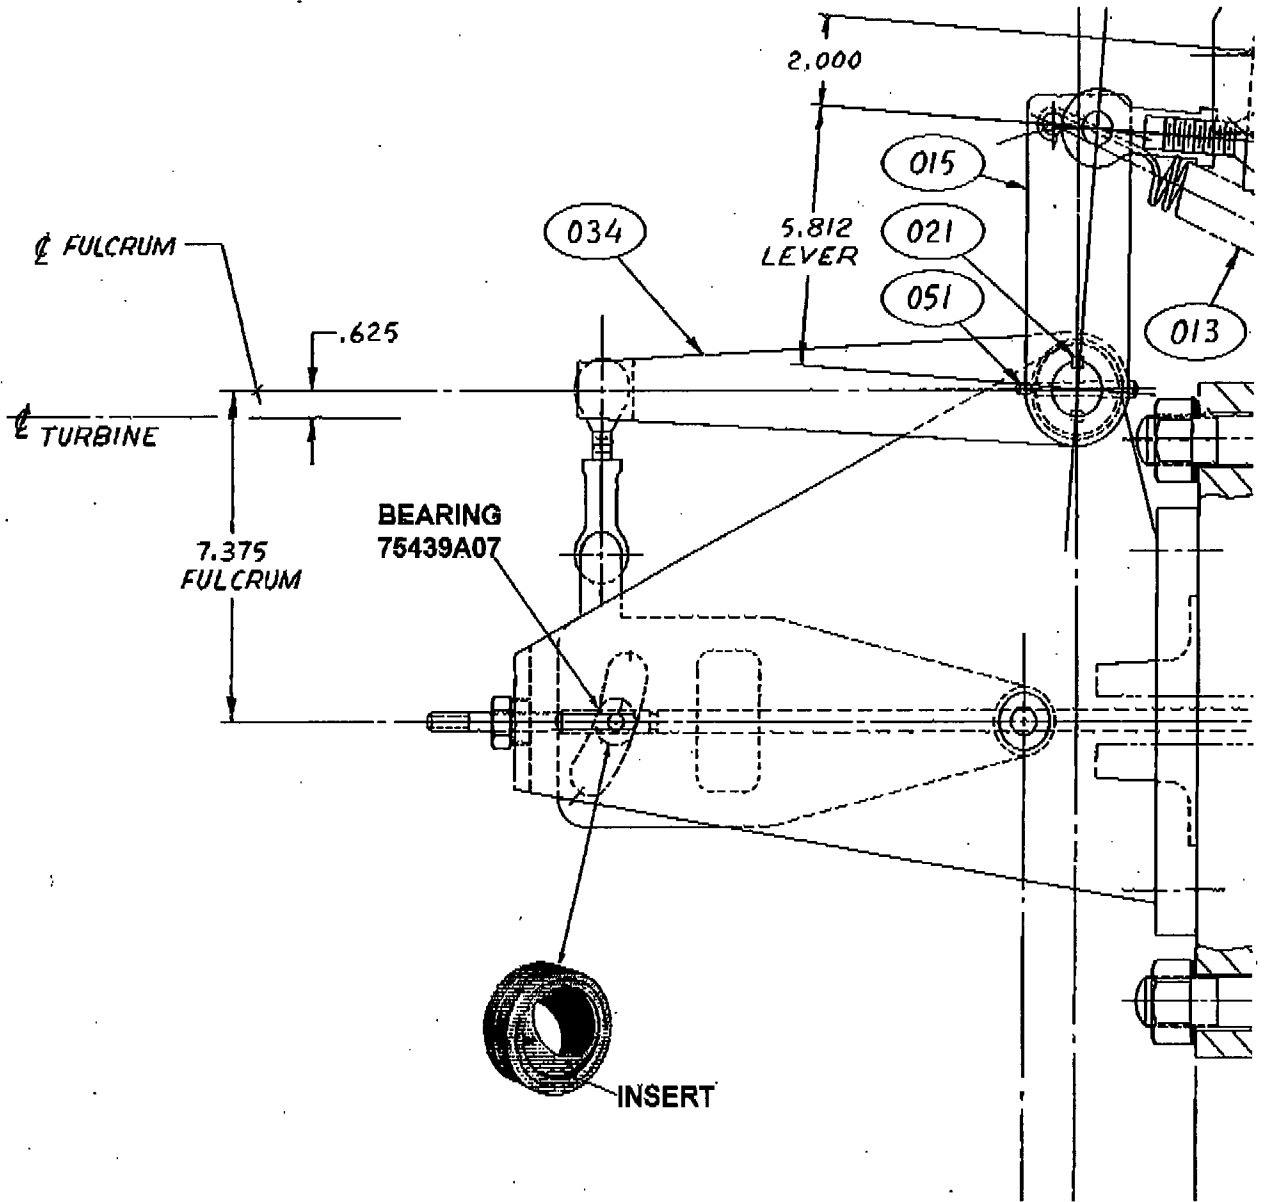
"On Dresser-Rand Drawing 75439A part number 07 is identified as a Heim LSS-8 bearing that has an Aluminum Bronze insert to accommodate a non-lubricated application. Dresser-Rand shipped 10 bearings part number 75439A07 to Dominion Nuclear in 2006 that were Seal Master Com 8 bearings that do not have an Aluminum Bronze insert.

"This bearing is used on turbines that have a PG type mechanical governor with the cam plate linkage. Extended operation without lubrication will result in the Seal Master Com 8 bearing seizing. The customer should visually inspect this bearing for the bronze insert. If no insert is visible then the bearing should be replaced at the first opportunity."
