## PART 21 - BEARING DEFECT

**FINAL REPORT 10CFR PART 21  
REPORT OF A POTENTIAL SAFETY HAZARD**

Report No. 47  
Page 1 of 3

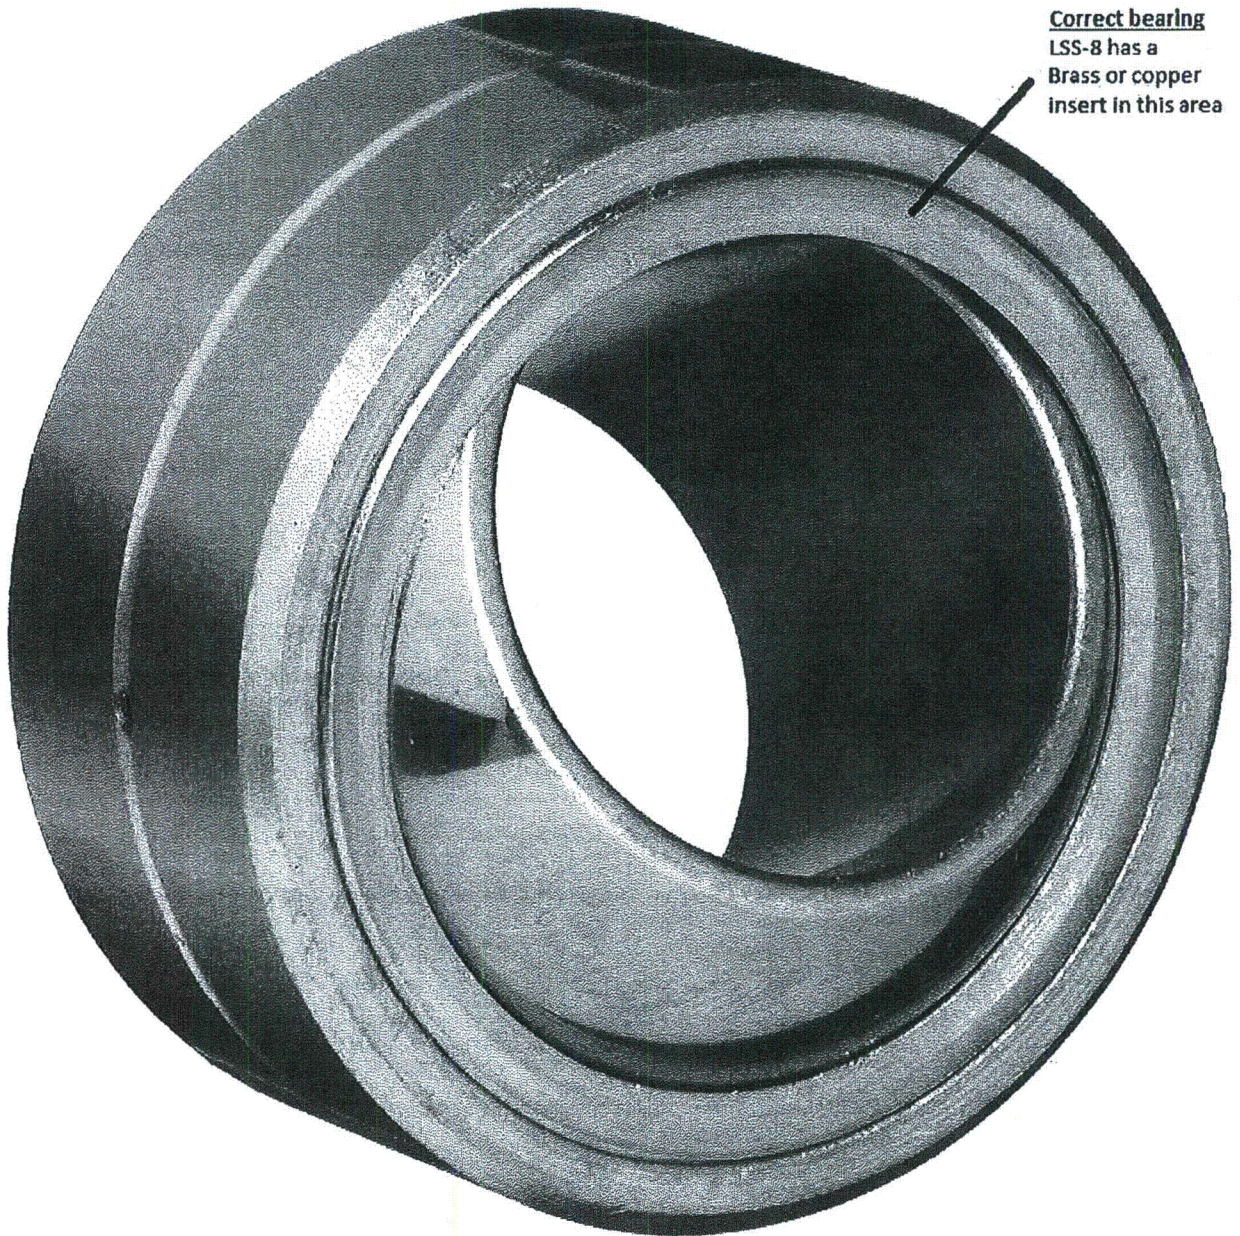
"On Dresser-Rand Drawing 75439A part number 07 is identified as a Heim LSS-8 bearing that has an Aluminum Bronze insert to accommodate a non-lubricated application. Dresser-Rand shipped 10 bearings part number 75439A07 to Dominion Nuclear in 2006 that were Seal Master Com 8 bearings that do not have an Aluminum Bronze insert.

"This bearing is used on turbines that have a PG type mechanical governor with the cam plate linkage. Extended operation without lubrication will result in the Seal Master Com 8 bearing seizing. The customer should visually inspect this bearing for the bronze insert. If no insert is visible then the bearing should be replaced at the first opportunity."

Correct bearing  
LSS-8 has a  
Brass or copper  
insert in this area

There are 18 turbines tabulated on page 2 that use this bearing, all have PG type mechanical governors.	
<b>4. CORRECTIVE ACTION BY:</b> <u>Staff</u>	<b>COMPLETED BY</b> <u>4/16/14</u>
The Part Design record was updated to emphasize copper alloy insert and the Inspection record was changed to require the vendor part number be recorded on the inspection form.	
<b>5. ADVICE TO AFFECTED CLIENT RELATED TO THIS REPORT</b>	
The customer should visually inspect this bearing for the bronze insert. See picture on page 3. If no insert is visible then the bearing should be replaced at the first opportunity.
