PART-21 NOTIFICATION - ASSEMBLY ERRORS DURING BREAKER REFURBISHMENT

Part 21 Report No: P21-06172014

Subject: Report of potential assembly error per 10CFR Part 21 on AMHG refurbished circuit breakers

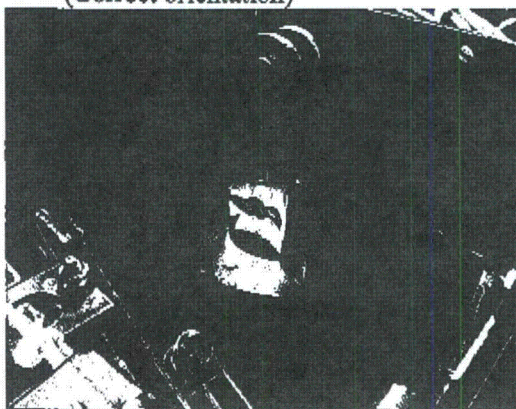
Figure 1
(Correct orientation)

In addition to the lock nuts not being sufficiently tightened, the closing springs were installed on the wrong side. There is a left and a right spring as identified by a red mark on the left spring. The left side spring is the shorter spring, and it was installed on the right side. Further evaluation by NLI determined that this may have been a contributing factor to the failure after the closing spring clamp started to move off the jackshaft.

Correct orientation with the marked spring assembly on the left side of the mechanism.

If the inspection results determine that the springs are not oriented correctly (see Figure 1) but the nuts have been properly torqued, ensure that the cam is fully engaged on the jackshaft (see Figure 2), the breakers will perform as required. The spring orientation can be corrected at the next refurbishment interval.
