Part 21 (PAR)

Event # 50299

PART 21 REPORT - POTENTIALLY DEFECTIVE PRESSURE & TEMPERATURE SWITCHES

SUBJECT: Notification of Defect

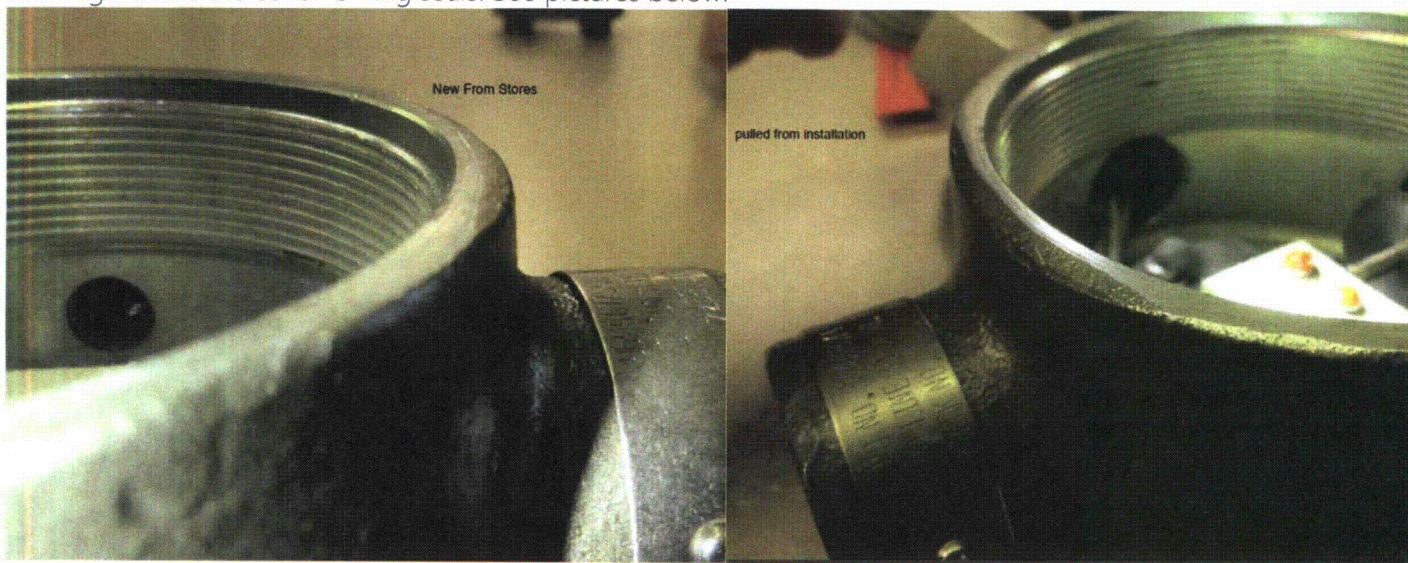
SOR Inc. began a 10CFR21 evaluation on 6/4/14 upon receipt of three SOR pressure switches, model number 5TA-B45-U8-C1A-JJTTNQ (SN's 041100627, 041100628, and 041100629). These were returned from Entergy Nuclear Vermont Yankee (VY) due to inspections which questioned the suitability of the sealing surfaces on the face of the housings where the cover O-ring seals. See pictures below.

The product evaluation was concluded on 6/24/14 and it was determined that this issue is a reportable defect as defined by 10CFR Part 21. If the switch housing has an inadequate machined sealing surface, the potential exists for steam permeation into the switch housing during accident conditions. This could result in an increase in set point as well as allow moisture into the housing potentially causing electrical consequences such as current leakage or a short. It is anticipated that the above noted condition represents a small percentage of the total number of housings from this batch of castings. Also, the potential risk is thought to be small due to a second redundant seal on the cover. This condition is being reported as a conservative measure.

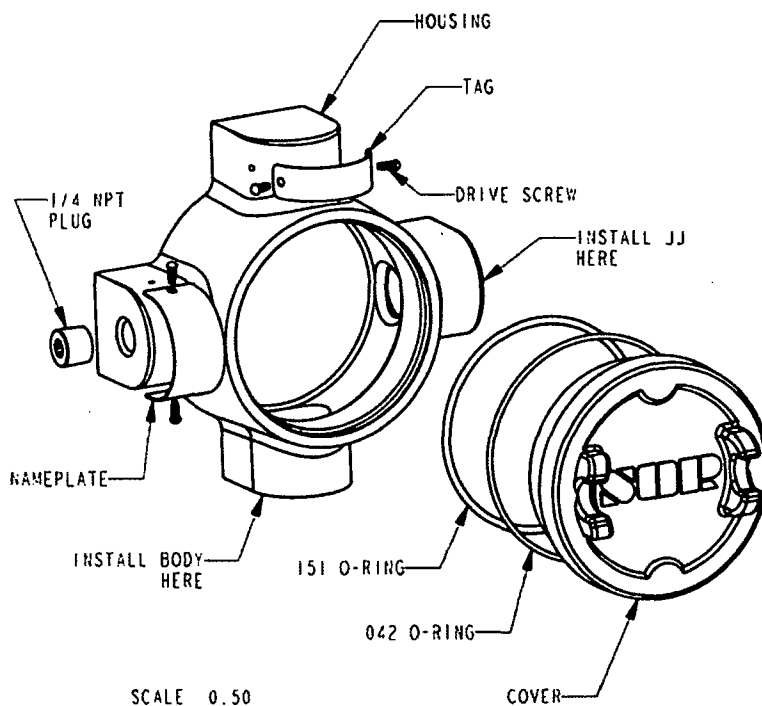
There are 2 (redundant) environmental seals on the cover of the nuclear TA housing. One O-ring seals on the undercut of the cover threads (151 O-ring). This seal is not in question and is not part of this evaluation. The other O-ring seals between the face of the enclosure and the O-ring groove on the cover (042 O-ring). This is the seal that is the subject of this evaluation. See illustration below.

Redundant O-ring seals are used on the SOR "TA" cover to minimize steam permeation into the housing during LOCA or HELB conditions. The consequences of permeation are that it can result in an increase in the set point and also allow moisture into the housing which could have electrical consequences. The returned switches have a suspect sealing surface on the face of the housing where one of the two O-rings (the 042 O-ring) is intended to seal. For the purposes of this Part 21 evaluation, consideration needs to be given to whether this suspect sealing surface could result in increased permeation into the switch enclosure.

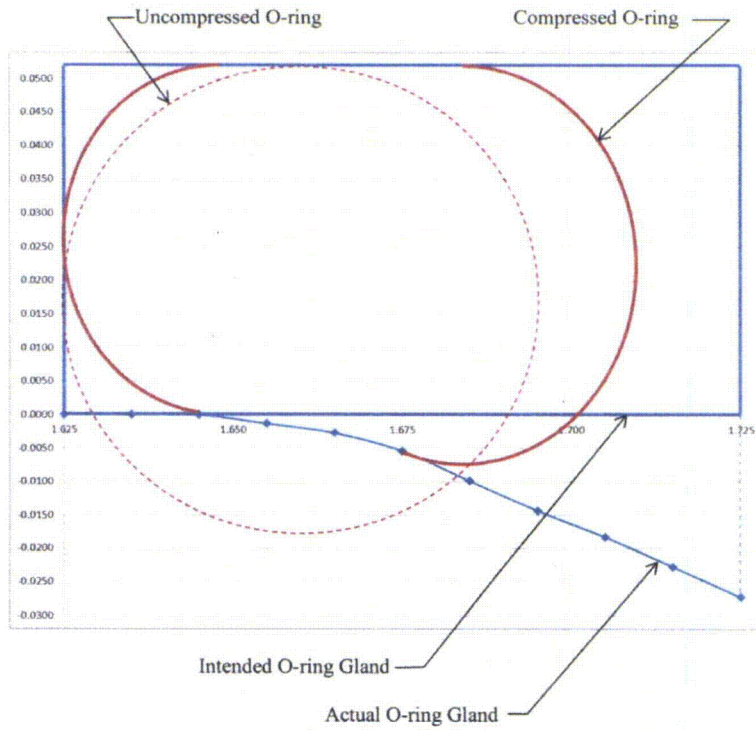
S/N 041100627
(Approximately to scale)

Switches #041100627 and 041100628 both have an area on the face of the housing where the casting did not have sufficient material for cleanup when the housing was machined. This area was characterized by use of the SOR CMM and measuring the area where the O-ring is expected to seal. The graphs below represent the worst case measurements taken on Serial #041100627 and 041100628. The "1.625" on the X axis represents the radius to the inside of the O-ring seal gland. Eleven measurements were taken at 0.010" increments. The Y axis represents the deviation from the machined surface on the face of the housing. The O-ring groove is 0.104" wide X 0.052+/-0.002" deep. The 042 O-ring has a 0.070" diameter cross section and will be a snug fit on the ID of the groove. From the illustration below, it can be seen that approximately 50% of the O-ring groove will have less than the intended compression. While the O-ring may be suitable with less compression, it was not qualified this way.

The TA housings on the returned switches are clearly out of tolerance. It is SOR's position that the environmental seals on any switch with a similar defect has the potential to not meet its' intended safety function. There must be at least 1/8" of machined sealing surface on the housing as measured from the 3-5/32" diameter counter-bore to ensure an adequate seal.

The returned TA housing castings did not meet print and therefore did not allow enough material for cleanup of the machined sealing surface.

SOR internal documentation is being changed to require 100% inspection of the raw casting height. Also, the 1/8" minimum finish dimension is being added to the housing machining drawings.
