Part 21 (PAR)

Event # 50371

## NOTICE OF DEVIATION REGARDING K-LINE CIRCUIT BREAKER SECONDARY CLOSE LATCH

Subject: 10CFR Part 21 Notification of Deviation re. K-Line Circuit Breaker Secondary Close Latch

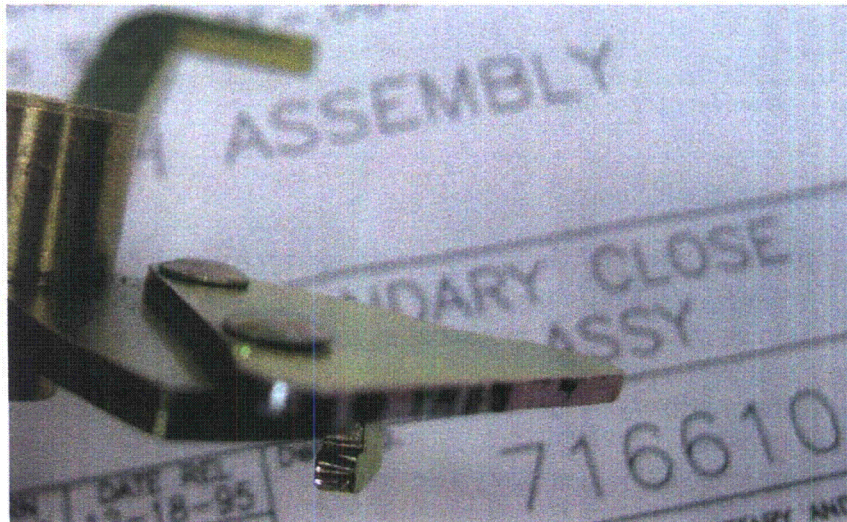
Figure 1 - Secondary Close Latch

1. This letter provides notification of a failure to comply with specifications associated with a secondary close latch, part number 716610K01 (see Figure 1), used in K-Line 225/800 and 1600/2000 amp electrically operated Model 7 circuit breakers. This does not affect previous models of these same breakers that have not been upgraded to include the interlocking primary and secondary close latches. It also does not affect manually operated Kline breakers or K3000/4000 circuit breakers. Information is provided as specified in 10CFR21 paragraph 21.21(d) (4).

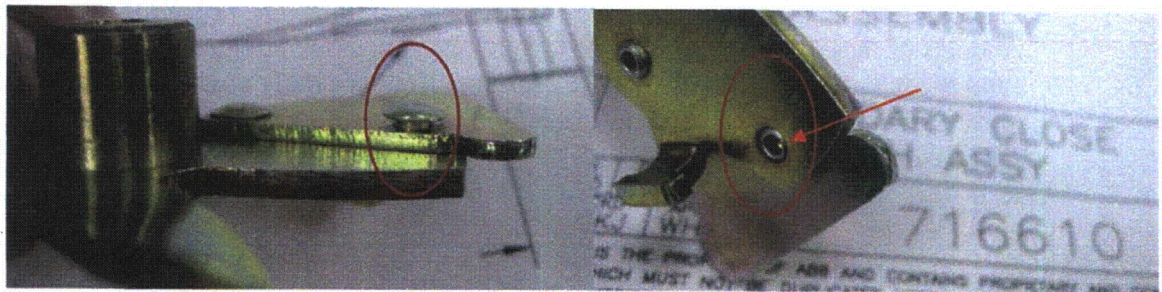
Figure 2 – Secondary Close Latch

During outgoing inspection a breaker went trip free during the operational phase of the testing procedure. The inspector found that the cam attached to the top of the secondary close latch, 716610K01, was not properly riveted in place. The head of the rivet was not pushed down flush against the side of the cam. Since the rivet was not seated properly, the other end of the rivet did not project through the other side of the latch and therefore the bradded end of the rivet was not deformed in a manner to sufficiently apply the required holding force to keep the cam in its proper and secure operating position. (see Figure 2)

- a. Perform 100% inspection all part number 716610K01 secondary close latches in inventory to identify the nonconforming latches. (Action complete)
- b. Trained inspectors and breaker assemblers on identifying this condition (Action Complete)
- c. Contact primary vendor to investigate cause and correct on future orders. (Action Complete)
- d. Verified that this is the only assembly with bradding that this vendor provides. (Action complete)
- e. Notification of the potential existence of this deviation to affected customers (Action to be completed by 18 August 2014)
