PART 21 REPORT - DEFECTIVE BARTON DIFFERENTIAL PRESSURE SWITCHES

PRODUCT ADVISORY

Model 288A, 289A, 580A and 581A Differential Pressure Switch Defect

DOCUMENT NO.: 210052426.01

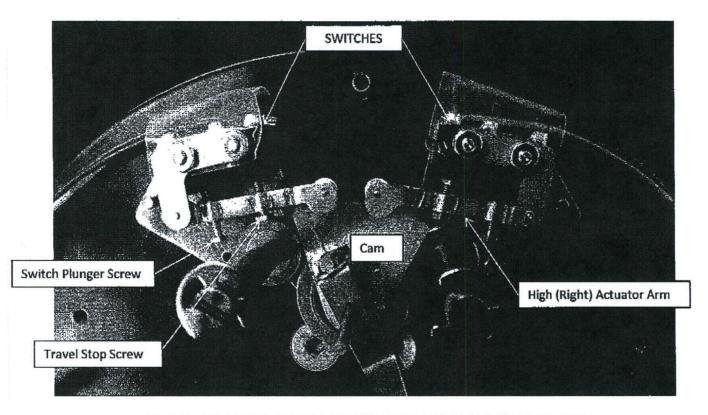
MODEL 288A/289A SWITCH OPERATING MECHANISM MOCKUP (Model 580A/581A Switch Operating Mechanism is similar)

The defect being reported is an out of specification thread on the screws that depress the switch operating plunger which can cause a change in the switch setpoint. The maximum change in screw position observed during testing equates to a switch set point change of approximately 8.4 percent of the instrument's factory calibrated span. The screws of concern did not enter the Cameron stock before February of 2014 for the ones used in the Model 580A and 581A instruments and not before June of 2014 for the ones used in Model 288A and 289A instruments.

Testing performed to evaluate the significance of the of the non-conforming condition revealed that the force of the miniature switch internal operating features can cause the thread "locking" material to be displaced allowing an undersized plunger screw to change its set position resulting in a change in the point where the switch will actuate (change in contact position). Screws with conforming threads did not demonstrate the same issue. The maximum change in screw position observed during this testing effort equates to a switch set point change of approximately 8.4% of the instrument's factory calibrated span.

Cameron recommends that utilities perform increased switch set point verifications on the instruments affected by this notification. It is not possible to determine which of the switches might have nonconforming switch plunger screws. Therefore, Cameron recommends that new switch actuator arm assemblies be replaced on any unit that is evaluated to be a concern by our customers. These replacement parts are available in the Cameron stock system and will be supplied free of charge for any of the products included within the scope of this notification. The P/N's for the replacement assemblies are identified on the following page.
