Challenges for Fuel debris retrieval with Robotics technologies at Fukushima Daiichi NPS

February 3, 2016

*Fukushima Daiichi Decontamination & Decommissioning Engineering Company,
Tokyo Electric Power Company*

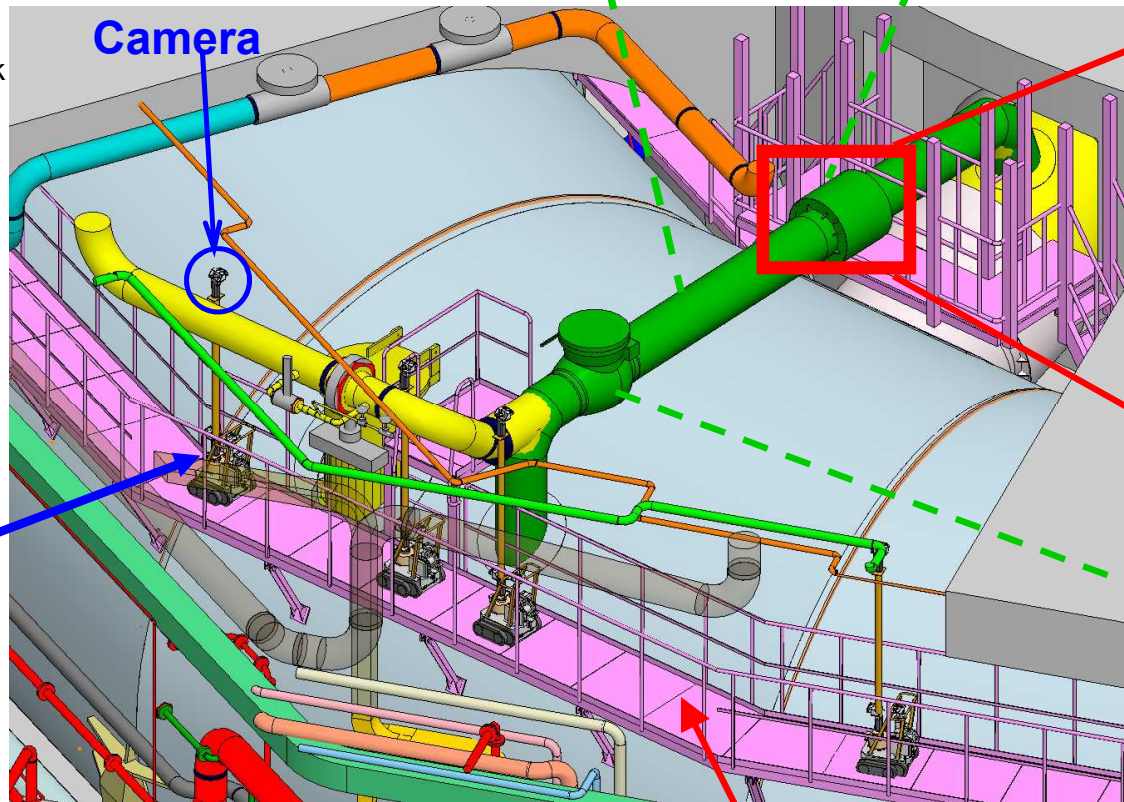
- Water leakage was found at the bellows cover on the vacuum breaker.
- No other leaks were found. line (May 2014)

Vacuum breaker line Bellows (expansion joint)

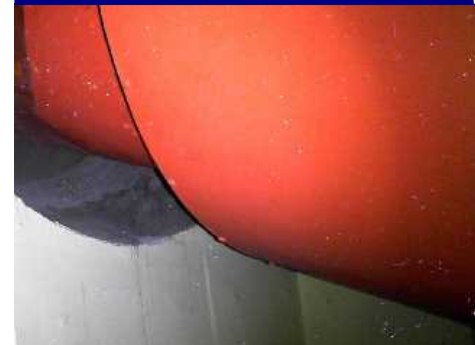
Venting pipes sleeve end

- A pair of Four-leg walking robot and small rover was used for survey.
- No leak was found.(December 2013 to March 2014)

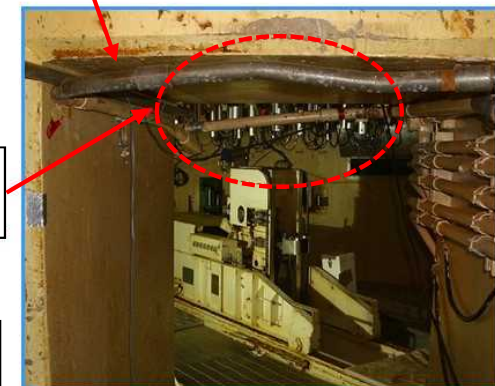
- Cables were identified at bottom of the RPV and suggested that huge collapse doesn't happen at bottom and under the RPV.
- Detected dose rate on the CRD rail was 24-36 Sv/h.
 - Significant increase doesn't appear at near the opening of pedestal.
