EMD-GM-17-02

January 12, 2017

Subject: Report of Potential Substantial Safety Hazard in accordance with Title 10 Code of Federal Regulations, Part 21

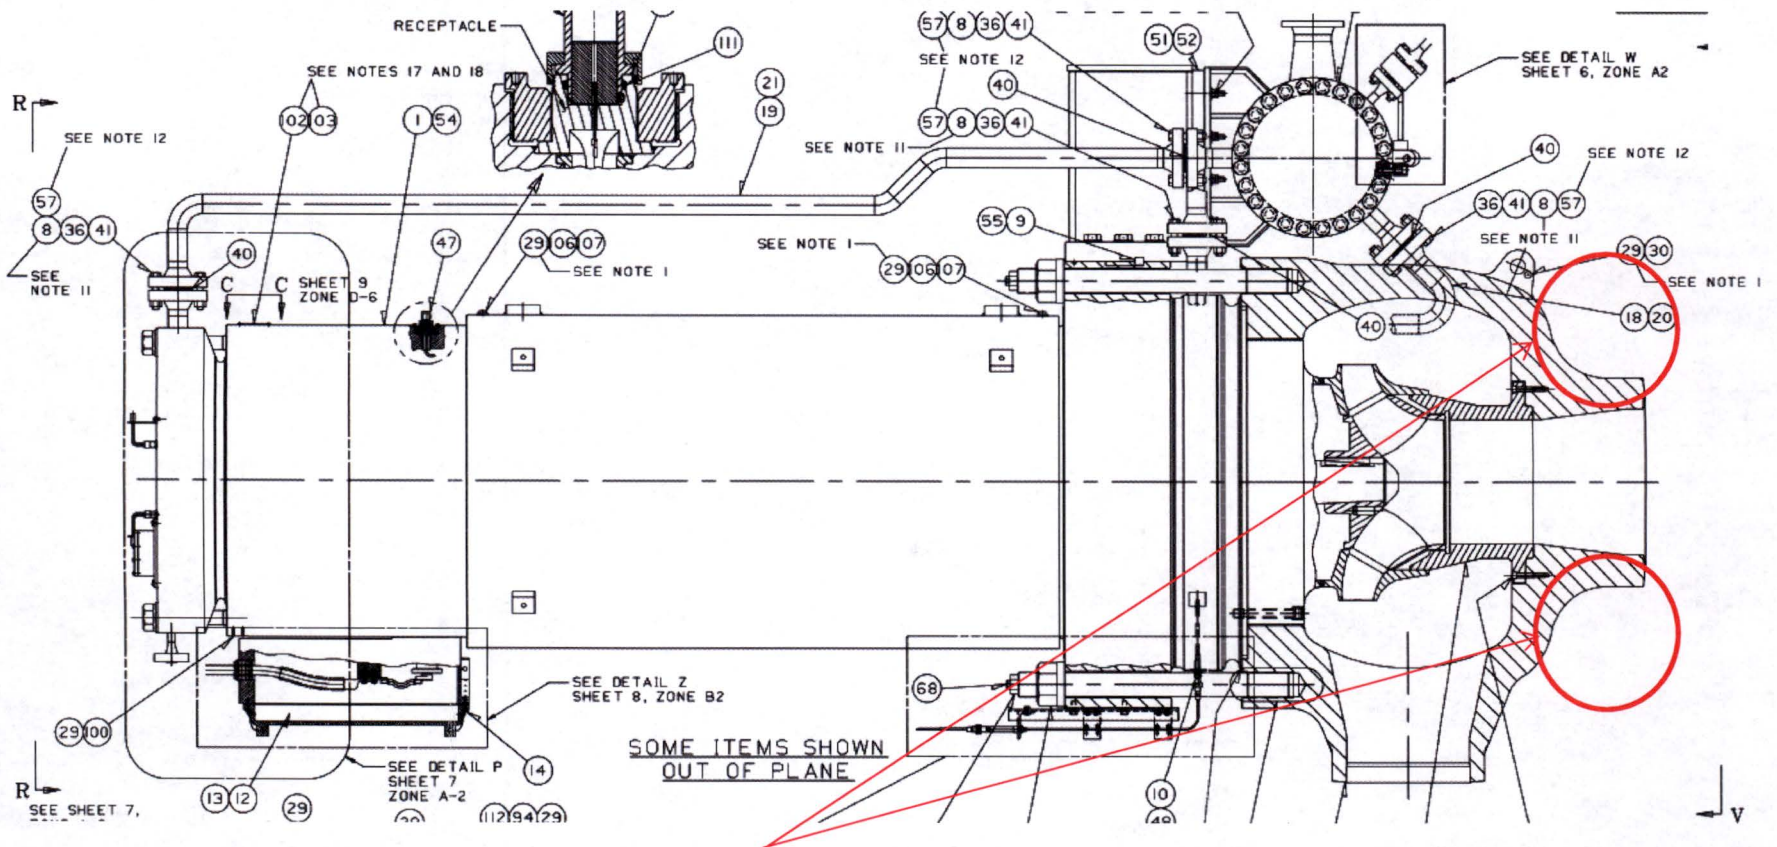
Region of excess material is at the transition between the cast bowl section and the machined suction nozzle OD on the casting exterior surface

There is a non-tangential zone of excess material in the transition between the suction nozzle and the cast casing bowl which has the potential to act as a stress riser and impact fatigue life of the component. The as-built transition feature on the casings has not been analyzed and is not included in CW-EMD Engineering Memorandum 7242, Revision 1, Volume 1, which is the applicable generic design report for the AP1000 RCP casing and main closure.

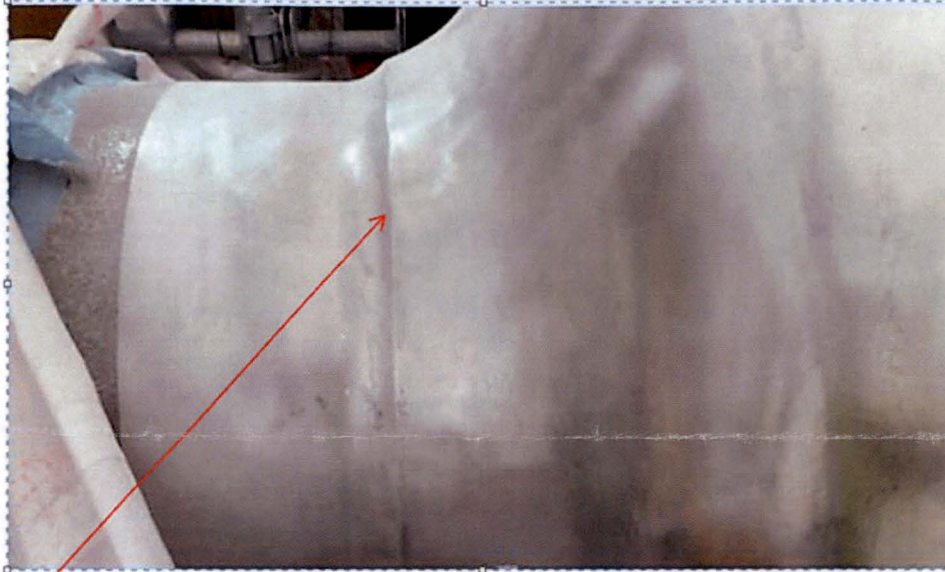
Photograph showing discontinuous excess material at the transition between the cast bowl section and the machined suction nozzle OD on the casing exterior surface
