Report No. 10CFR21-0116

10CFR21 REPORTING OF DEFECTS AND NON-COMPLIANCE

COMPONENT: Diode Surge Suppressor
P/N: 199-FSMZ-1

SYSTEM: Emergency Diesel Generator Control System

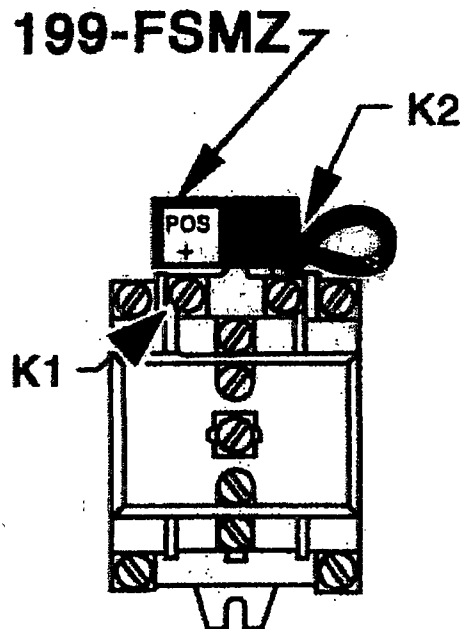
Figure 1: Typical Diode Installation

PNPP experienced two failures in 2016 of the aforementioned diodes supplied by ESI. The diodes are Allen-Bradley part number 199-FSMZ-1 and they were installed across the coils of Allen-Bradley 700DC series relays. The Allen-Bradley date code stamped on the side of the diodes is BX9. The failure in both cases resulted in a short circuit condition that resulted in a loss of class 1E control power to the EDG. See below for a visual representation of a typical diode installation.

The root cause of the failure is determined to be a manufacturing defect internal to the diode. Though an analysis of the diodes that failed at PNPP was unable to be performed due to their condition, the analysis performed on a degraded diode of the same date code, BX9, detected an internal manufacturing defect.

1. Review their inventory for suspect diodes listed in Table 1. Any suspect diodes should be removed from inventory and discarded.
2. Determine if suspect diodes listed in Table 1 have been installed. Thus far, ESI has identified degraded diodes from date codes BX9 and ZX9 and it is possible that diodes from the other date codes are degraded as well. ESI has been unable to determine an expected service life. Therefore, the recommendation is to remove or replace any installed suspect diodes as soon as possible. Note that the applications for which this diode has been supplied (Enterprise engine control panels) used the same style Allen-Bradley relays as original equipment but without diode surge suppressors. It is therefore acceptable to remove the diodes and expect no change or impact to the existing equipment.
