Part 21 (PAR)

PART 21 REPORT - DEFECTIVE MOTOR OPERATED POTENTIOMETER

Report No. 10CFR21-0117
Rev. 0: 06/09/17**10CFR21 REPORTING OF DEFECTS
AND NON-COMPLIANCE**

COMPONENT: Motor operated potentiometer without pre-position feature
P/Ns: 72-07900-100-ESI
2-04E-184-103-ESI
2-00G-009-002-ESI

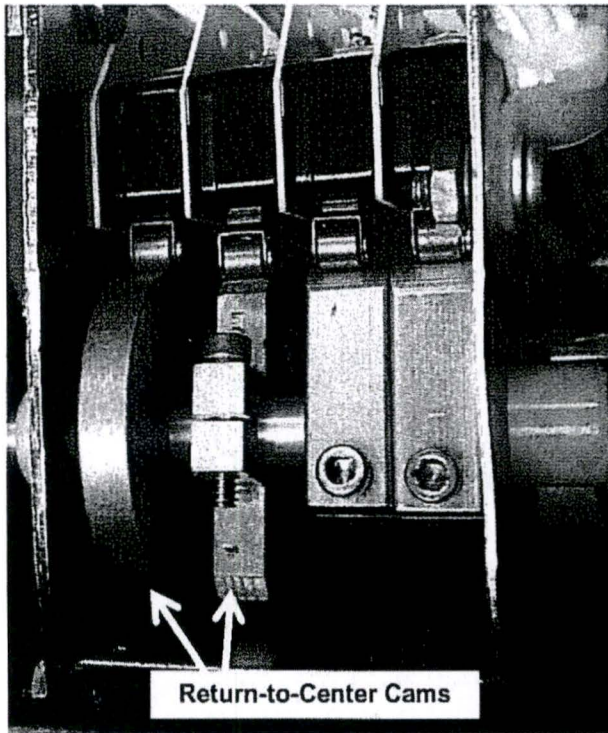
The Basler MOP selected by ESI for the assembly was model MOC2103. A review of Basler model MOC2103 indicates that it is not a return-to-center style device and instead contains a standard cam arrangement. Photos on the following page depict the differences between the two cam arrangement styles. ESI inadvertently selected the incorrect model for this application. Reviewing the qualification testing performed by ESI revealed that ESI's testing duplicated the original Portec test procedure (whereby one cam is set to close above setpoint and one cam is set to close below setpoint). However, the testing was shown to be inadequate to fully ensure the return-to-center functionality. Though the cams were properly set above and below setpoint, a further verification that the unit would return to center, even if sufficiently away from setpoint, was not performed. For installations that rely on the pre-position function, it is possible that the MOPs supplied by ESI would not return the potentiometer to setpoint. Since the MOP is used to set output voltage of the emergency diesel generator, the consequences of this issue are that the EDG may not maintain voltage within its required range to support its safety-related loads.

Photo 1: Desired Return-to-Center Cam Arrangement

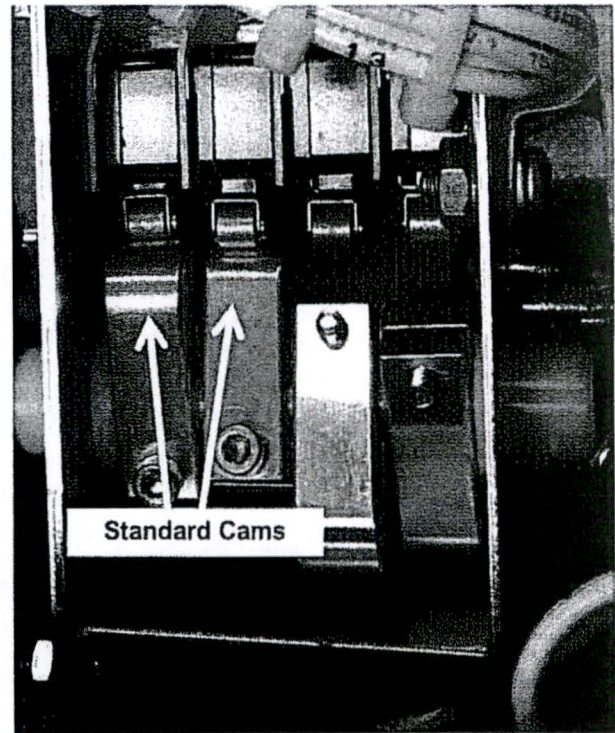
ESI selected the incorrect MOP to be used for this assembly. The original MOP used was an Portec/NEI P/N 72-07900-100 which became obsolete in the 1990s. ESI offered a replacement assembly (using the "-ESI" suffix) that included a Basler brand MOP, modified by replacing the factory supplied potentiometer to replicate the original Portec design. The original Portec MOP had the return-to-center feature and Basler offers some models with return-to-center and some without. ESI inadvertently selected the model without return-to-center.

Photo 2: As-Supplied Standard Cam Arrangement

- Customers that have installed the motor operated potentiometer must evaluate the impact on their specific system. It may be acceptable to continue to use the MOP if other provisions are in place to ensure the EDG voltage is within an acceptable range for safety-related operation. Credit may also be taken for site acceptance testing following installation of the MOP. If the MOP is deemed acceptable for the application, no further action is necessary.

- For those customers that have determined the MOP is unacceptable for their application and/or would simply rather ensure they have the correct MOP, it may be returned to ESI for warranty replacement. Once a warranty order and Return Goods Authorization (RGA) is issued, supply of safety-related replacement MOP(s) is expected to be complete within 90 days.

- To prevent recurrence of this issue, ESI is implementing a revision to the procurement process for this assembly to update the part number of the MOP utilized. In addition, the dedication inspection and testing activities are being revised to ensure testing properly validates the return-to-center feature. This action is currently underway and will be completed prior to any future shipments.

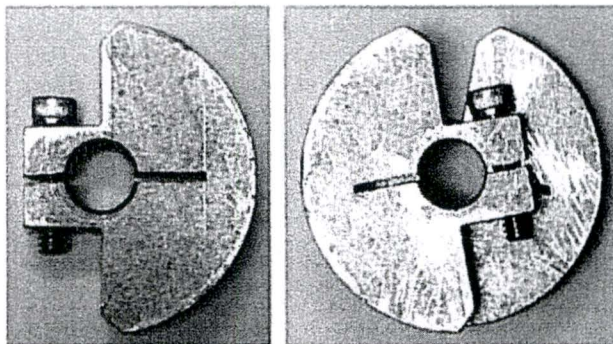
Photos 3&4: Return-to-Center Cam Profile & Arrangement

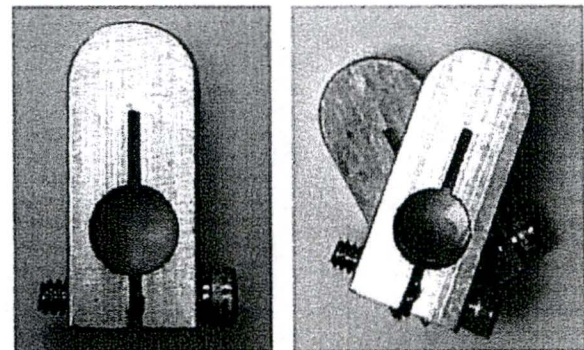
Photo 5&6: Standard Cam Profile & Arrangement
