Subject: 10CFR21 Reporting of Defects and Non-Compliance -  
Engine Systems, Inc. Report No. 10CFR21-0118, Rev. 0

**Report No. 10CFR21-0118**

**10CFR21 REPORTING OF DEFECTS  
AND NON-COMPLIANCE**

COMPONENT: Speed Switch  
P/Ns ESI50267C, ESI50267E, ESI50267H, and ESI50267K

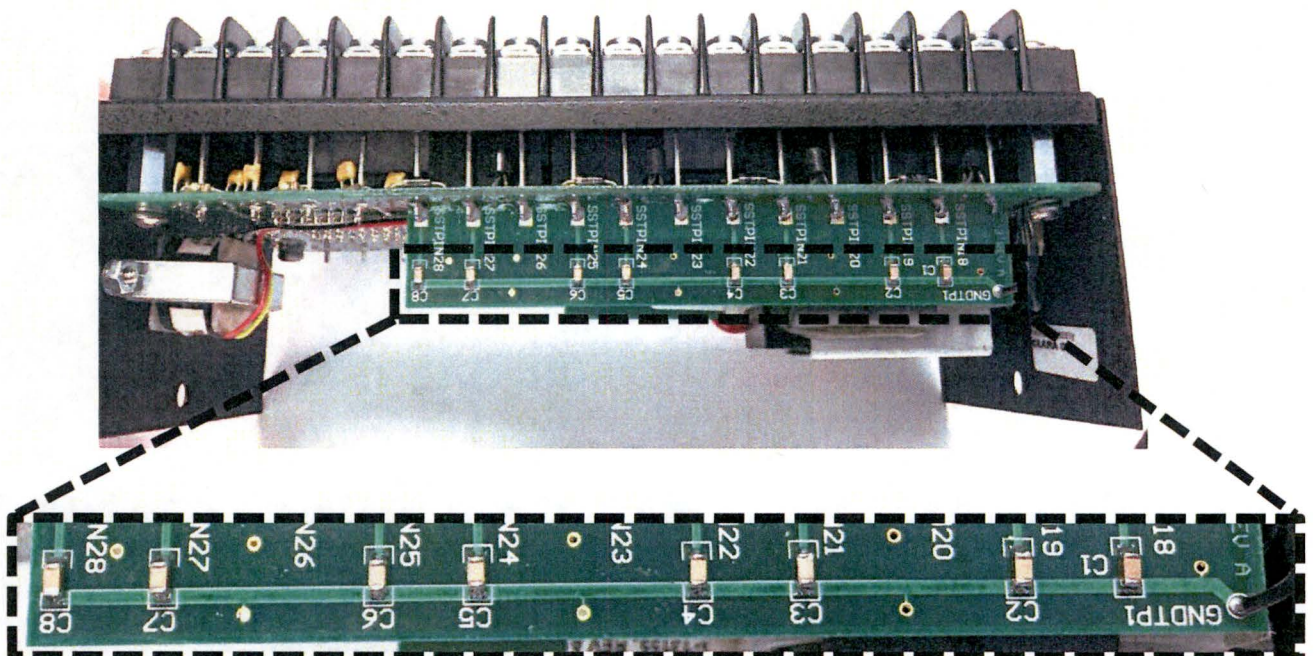
Photo 1: View Showing Capacitors C1 through C8

The failed speed switch at Hope Creek was sent to Exelon PowerLabs for analysis. It was determined that capacitor C4 (terminal 22 to ground) had degraded and exhibited a low-resistance path to ground. Capacitor C4 is rated for 200 VDC working voltage and has a withstand voltage of 500 VDC. Further investigation revealed that although the nominal system voltage is 120 VDC, the customer's external relay coils that are connected to the speed switch output contacts do not have transient suppression, such as with a flyback diode. In these cases, the voltage transient produced when de-energizing the relay's coil is large enough to damage the capacitors. Hope Creek recorded a voltage spike exceeding 1467 VDC.

- (1) For those customers that have transient suppression across the associated relay (i.e. VSR or ESR relays at the Exelon plants), there is no negative impact. The speed switch will operate properly in this system.
- (2) For those customers that do not have transient suppression across the associated relay (i.e. CRR, ASR, LSR, and HSR at Hope Creek), this speed switch design is not appropriate for their system. Any speed switch(es) that are installed should be removed from service.
- (3) ESI is currently evaluating options for re-designing the speed switch while maintaining the EMC compliance desired by many customers. This evaluation is underway and is expected to be complete within 60 days.

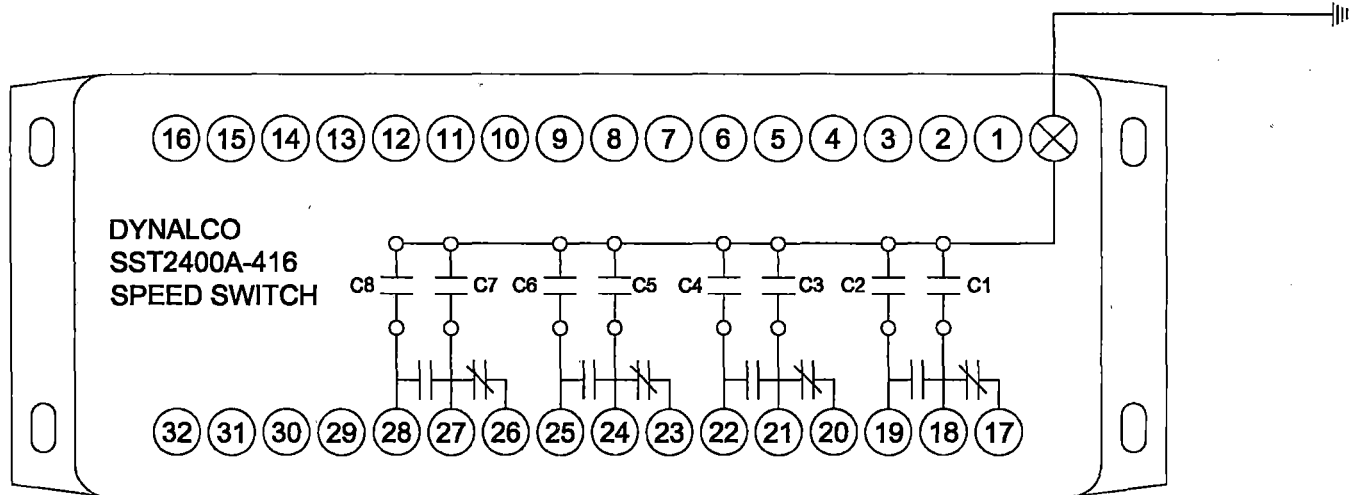
Figure 1: Schematic Representation of Capacitors Installed on Relay Output Contacts

The root cause of the failure is a deficiency in the design and selection of the EMC mitigating components. Consideration was not given for the impact of voltage transients imparted on the capacitors during coil de-energization. For customers without suppression from the inductive kick, the magnitude of voltage transients may be sufficient to damage and ultimately degrade the capacitors to the point of failure.
