**Report No. 10CFR21-0120**

## 10CFR21 REPORTING OF DEFECTS AND NON-COMPLIANCE

COMPONENT: Thermostatic Valve Assembly  
P/N 6BOCF14001

SYSTEM: Emergency Diesel Generator

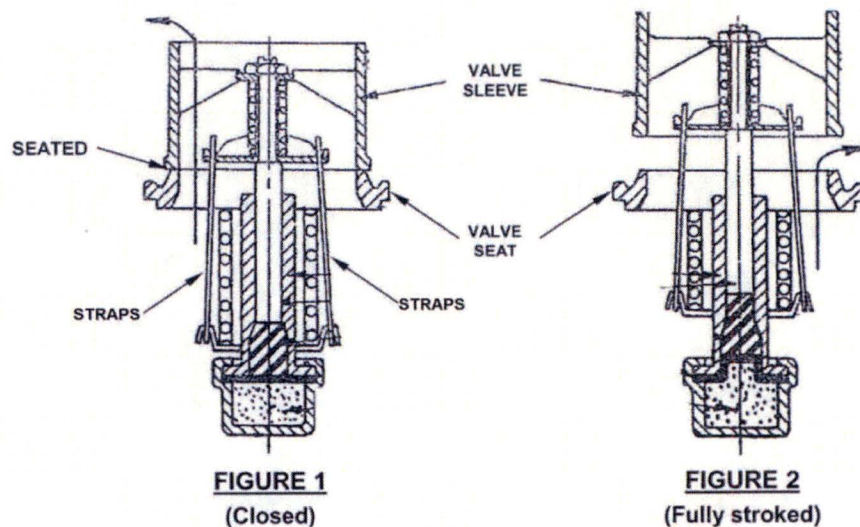
*Two thermostatic valve assemblies were supplied by ESI that were found to have retaining straps, subcomponents of the internal thermostatic element, detached from the correct position. For each valve assembly, one of the thermostatic elements (the centrally located element) contained this defect. The straps are used in conjunction with a spring to retain the element in a closed position. As the temperature of the sensed fluid increases, a temperature sensitive wax expands to open the element while acting against the spring. As the temperature of the fluid decreases, the wax contracts and the spring returns the element to its closed position. Absence or failure of the straps would prevent proper operation of the element. See Figures 1 and 2 below for visual representation of an element.*

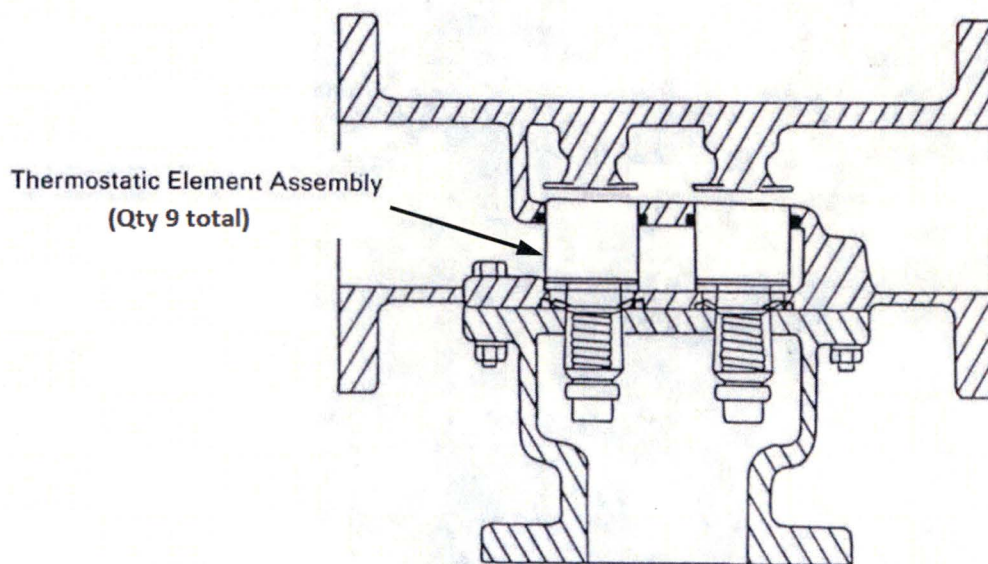
**FIGURE 3**  
Thermostatic Valve Assembly

*The thermostatic valve assembly is used on an emergency diesel generator set to regulate the temperature of lubricating oil (other EDGs use this same type of valve for jacket water temperature regulation). If one of the elements within the assembly were to fail, as is the case with a missing strap, regulating capacity of the thermostatic valve could be affected. However, the failure mode in the case of missing straps is in the open position (element does not return closed) and the remaining eight elements would compensate by closing to regulate the fluid temperature. More importantly, detached retaining straps could migrate to other components in the lube oil system. Acting as foreign material, the straps could adversely affect the ability of these critical components to perform their safety-related function within the emergency diesel generator's lube oil piping. The foreign material aspect of this defect makes it a reportable issue. See Figure 3 on the following page for an outline drawing showing typical installation of elements in the valve assembly. Appendix A contains photos of the assembly.*

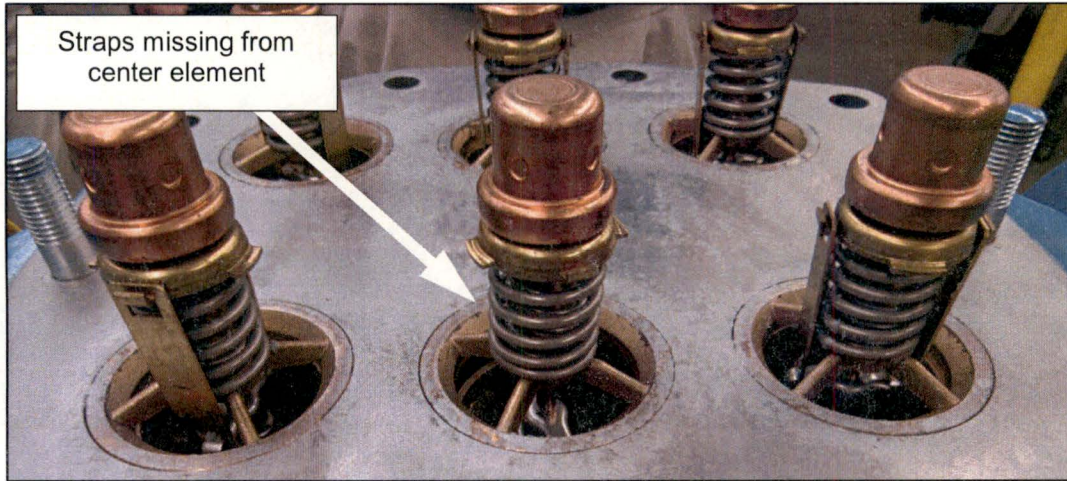
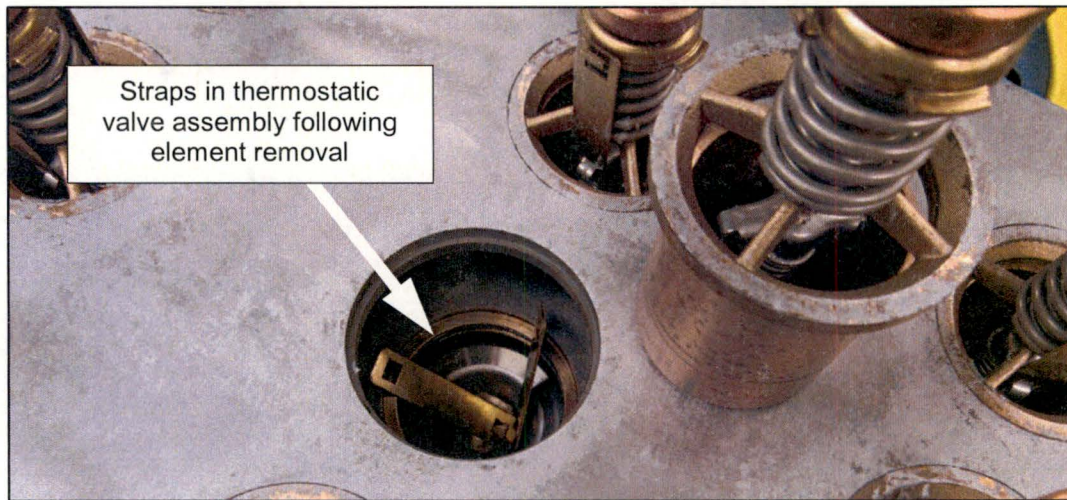
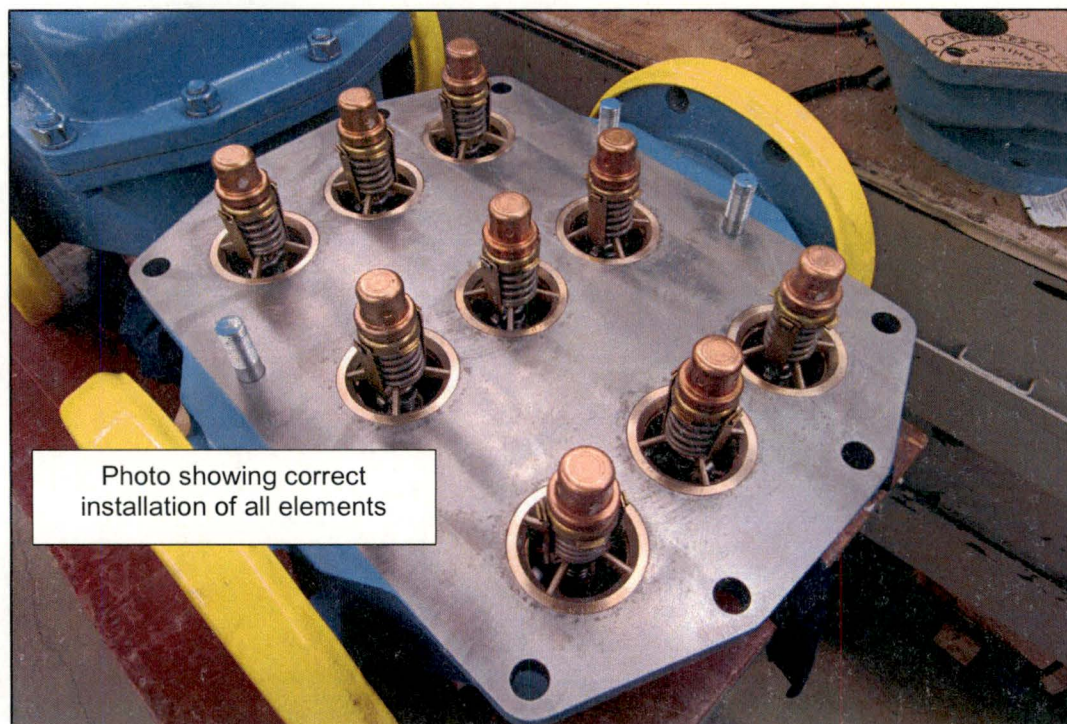
*ESI's investigation revealed that this issue was induced by a test technician who, in an effort to minimize the amount of test fluid remaining in the assembly after pressure testing, manually actuated the center thermostatic element (there are 9 total elements) to drain a small pocket of residual fluid. This effort to prevent the formation of oxidation had an unintended consequence and resulted in a more serious issue. Though this is an isolated incident as it pertains to items supplied from ESI, this same model thermostatic valve assembly is used extensively on EDGs in the nuclear industry. Those customers that perform valve maintenance, including thermostatic element replacement, should be aware of the possibility of the straps becoming detached if care is not taken.*

*For ESI: The dedication package for this assembly has been revised to add inspection criteria for the strap inspection and clarification has been added to the functional test procedure to ensure the assembly is drained following hydrostatic testing by tilting the assembly, not by manually actuating the element.*
