Westinghouse Non-Proprietary Class 3

Subject: NSAL-18-1 Revision 0, "Thermal Sleeve Flange Wear Leads to Stuck Control Rod"

Subject: Thermal Sleeve Flange Wear Leads to Stuck Control Rod	Number: NSAL-18-1		
Basic Component: Thermal Sleeve in CRDM Reactor Head Penetration	Date: July 9, 2018		
Substantial Safety Hazard or Failure to Comply Pursuant to 10 CFR 21.21(a)	Yes	No	N/A
Transfer of Information Pursuant to 10 CFR 21.21(b)	Yes		
Advisory Information Pursuant to 10 CFR 21.21(d)(2)	Yes

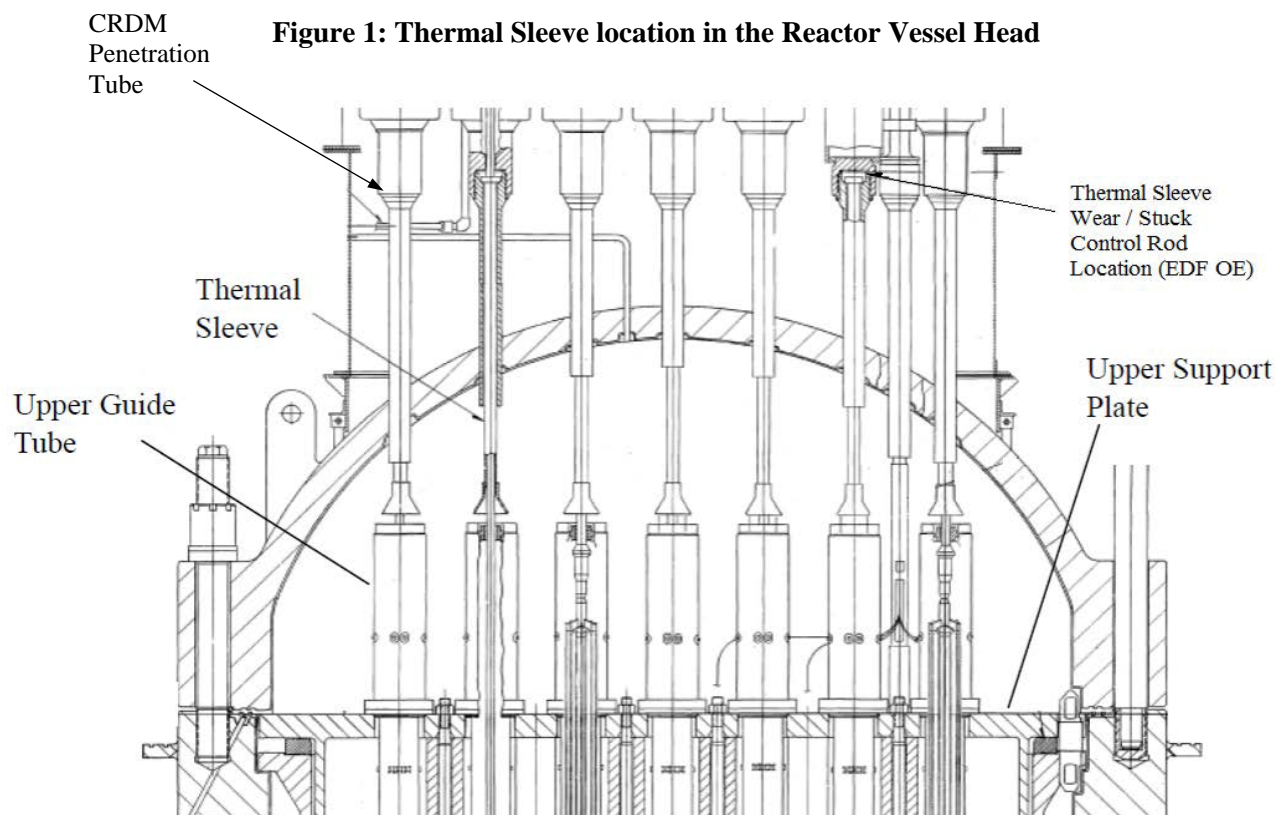
As described in the preceding Summary, the reported defect pertains to inspection guidelines for the thermal sleeve flange, located in the upper reactor vessel internals. Figure 1 depicts the label – Thermal Sleeve Wear/Stuck Control Rod Location (EDF OE) – in the upper right portion which identifies the specific area of observed wear which led to flange separation and interference with control rod movement.

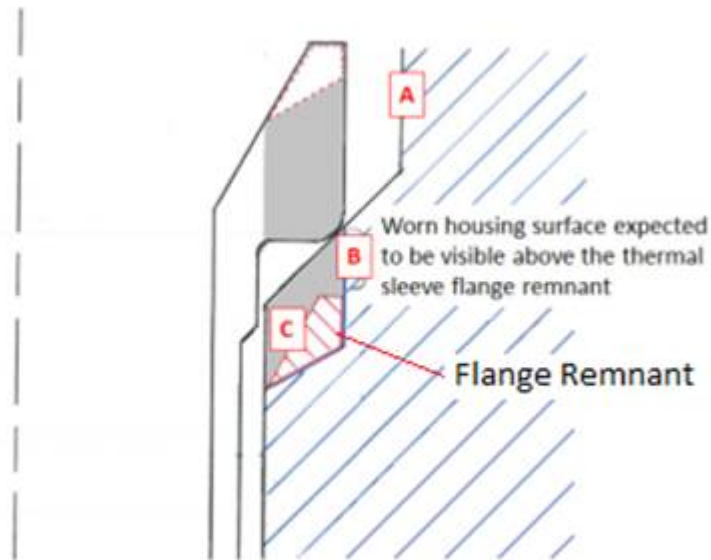
Figure 2: Worn Thermal Sleeve Flange and Image of Worn CRDM Housing

Examination of the failed sleeve in 2014 showed that the upper thermal sleeve flange, which rests inside the CRDM penetration tube, had worn through and become separated. Further inspection of the failed thermal sleeve and the CRDM penetration tube concluded that a mutual wear mechanism existed between the two components. Figure 2 shows the original CRDM housing surface (A), the worn CRDM penetration tube surface (B), and the thermal sleeve flange remnant (C). The shaded regions of the figure represent material removed by the wear. The result was separation of the remaining remnant (dotted red outline) of the upper flange and a worn pocket in the adapter tube.

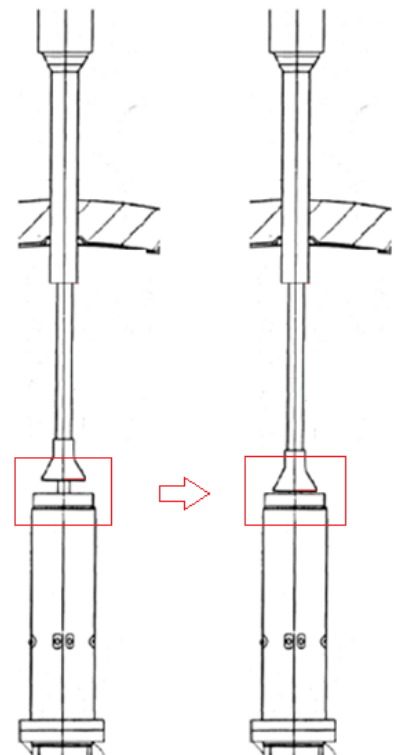
Figure 3: Potential Contact between the Guide Funnel and UGT

For plants with 14x14 guide tubes, the upper guide tube configuration is an open box-shaped tube with a top plate recessed from the top of the tube. These designs have either a fixed or a removable insert installed in this top plate which results in the top surface of the insert being flush or slightly recessed from the top edge of the tube. The width of the box tube for these guide tubes is smaller than the diameter of the funnel, so any contact would likely show up as intermittent shiny marks on the top edge of this tube. Furthermore, for the majority of the plants with 14x14 guide tubes (exceptions noted in Table 2) the spacing between the guide funnel and the upper guide tube is smaller than the lowering required for separation to occur. Therefore, with the exception of the two plants noted in Table 2, the wear markings on 14x14 guide tubes are likely to occur earlier in operation but are not necessarily an indication of imminent flange separation. For the two exceptions noted in Table 2, the spacing between the guide funnel and the upper guide tube is nearly the same distance as required for flange separation. Therefore, wear markings on the upper guide tube may or

may not signify complete separation of the thermal sleeve flange; however, it is a clear indication that significant wear of the thermal sleeve flange has occurred and will likely require action.

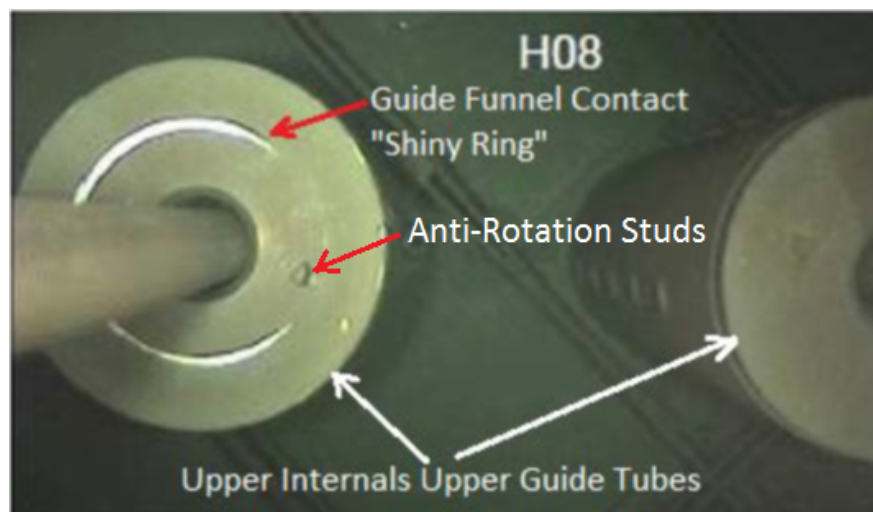
Figure 4: “Shiny Ring” Evidence of Guide Funnel Contact Wear on the UGT at Belleville Unit 2

For plants with 17x17 and 16x16 guide tubes, actual contact of the guide funnel with the UGT top housing plate will likely only occur after the flange has completely separated from the thermal sleeve. In December 2017, a 4-loop 1300 MW EdF plant in France, Belleville Unit 2, experienced complete wear-through and separation of one of the thermal sleeve flanges at a rodded location (Core Location H-8). Figure 4, taken from Belleville Unit 2, illustrates the wear marking (“shiny ring”) that may be visible on the UGT top housing plate after the reactor vessel head is removed, if a plant has been operating with a failed thermal sleeve.

Figure 4 also shows the anti-rotation stud design used on the EdF guide tubes. Westinghouse NSSS plants have an anti-rotation stud/nut configuration on the top housing plate which results in the stud protruding slightly higher and the nut extending more into the diameter of the wear ring. This difference in configuration may result in slightly different wear markings on the stud and nut as compared to what is shown in Figure 4. While signs of contact between the guide funnel and the anti-rotation stud/nut may be visible before flange separation occurs, this wear pattern indicates that significant thermal sleeve flange wear has occurred.

- For plants with 17x17 and 16x16 guide tubes, look for the “shiny ring” shown in Figure 4.
- During the next under-head inspection (i.e., the volumetric inspections required by ASME Section XI Code Case N-729-4 [5] and 10 CFR 50.55a), and at subsequent under-head inspections:
