Subject: Senasys Selector Switch P/N 910CMC-5240X, Part 21 notification

This letter serves as an official report in accordance with 10CFR Part 21.21 pertaining to post-installation test failure of Senasys Selector Switch P/N 910CMC-5240X.

Project: CCN-00852

Subject: Failure Analysis of a Selector Switch
Manufacturer: Senasys, Inc.
Model: 910CMC-5240X
Stock Code/Cat ID: 0001774009
AR/CR/WO: 04130071/ MO C93664356
Quantity Received: 1

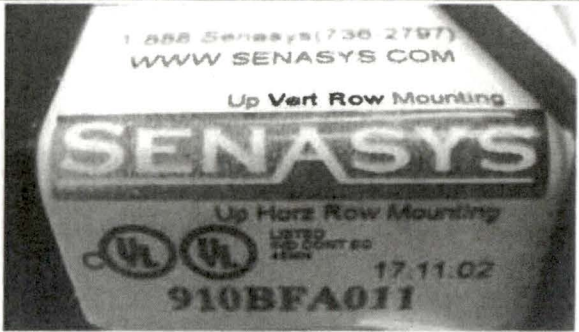
Photos 1, 2 & 3: Switch Nameplate

Model: 910BFA011 <u>910</u> – Grey knob <u>B</u> – Position 1, 2, 3 <u>F</u> – Orientation 1 <u>A</u> – Maintained <u>01</u> – 5 Terminals, 120V Transformers, No.755 Lamps <u>1</u> – Turn Cam Orientation	
Part No.: 910CMC-5240X	
Date Code: 17.11.02 (likely Nov. 2, 2017)	
Dedication: Switch was dedicated by Curtiss-Wright under Exelon PO 00630804

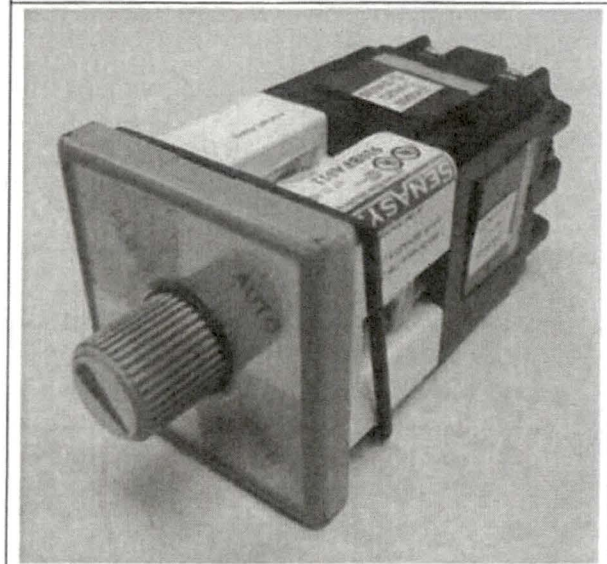
Photo 4: Selector Switch

The selector switch was in good condition. There were a few minor scratches on the body and cover lens. and no evidence of physical damage.

The switch had a solidly constructed feel. There was no exterior evidence of physical, electrical or thermal damage. It emitted no unusual aroma.

The mounting gasket was intact and the (4) mounting fasteners were loose on the screws.

When manipulated, there was a slight rattle in the bulb area of the switch.

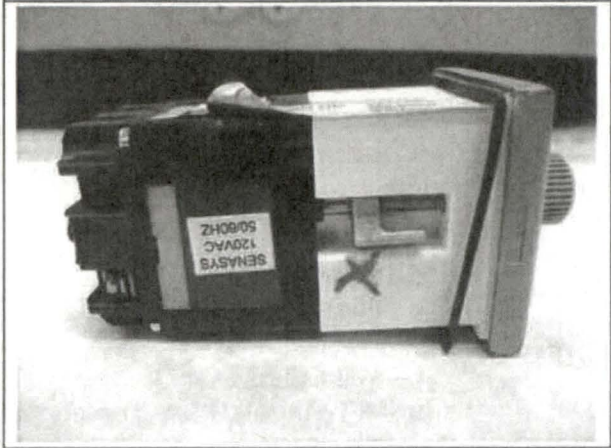
Photo 5: Station Marking on Switch

Switch was new from stock, installed in 2018 RFO (April 2018) and found failed during subsequent testing. Control circuit found grounded isolated to inside hand switch. Appears that switch mounting screw penetrated one of the internal lighting transformers. Marked on switch with "X".

There was a blue 'X' on the side of the body near one of the mounting fasteners.

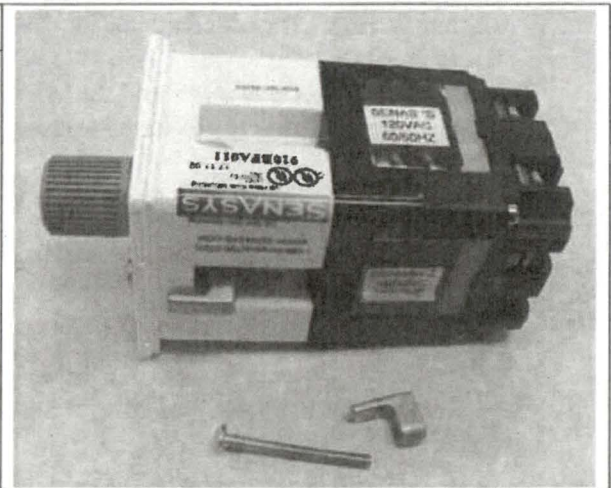
Photo 6: Switch Disassembly

The selector switch was disassembled to investigate the issue. The photo shows one of the mounting fasteners removed from the switch and one still installed. The fasteners swing out when the switch is installed in the panel cutout and draws it in snug to the panel when tightened. There are (4) mounting fasteners, one on each side.

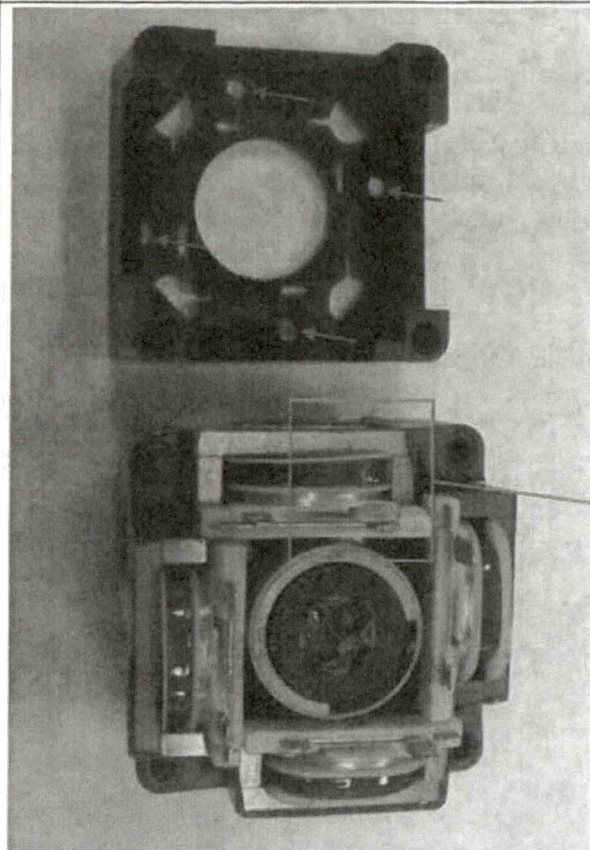
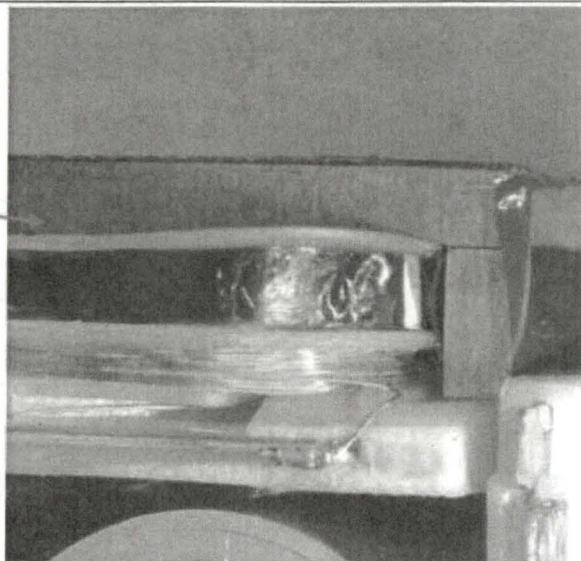
Photos 7 and 8: Switch Lamp Transformers

PowerLabs confirmed that one of the four mounting fastener screws penetrated the associated internal lighting transformer, causing it to short to the grounded panel board. The cause was a wrong length screw being supplied with the switch. Three of the mounting fastener screws were 1-3/8" long, but the fourth screw was 1-1/2" long. The extra 1/8" allowed it to puncture the transformer when the fastener screw was tightened as part of switch installation. All (4) switch lamps had previously been illumination tested satisfactorily at PowerLabs as part of Parts Quality Initiative (PQI) testing, substantiating the theory that the damage occurred as part of switch panel mounting.

When the switch was disassembled far enough to expose the lamp transformers, the suspected damage was evident. The mounting fastener screw appeared to have punctured the transformer windings. There are (4) holes in the molded plastic cover (blue arrows) that help keep the fastener screws in place, but the screws should not be able to reach the transformer.

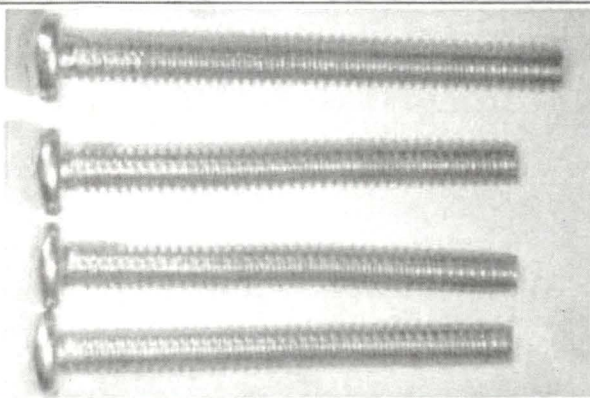
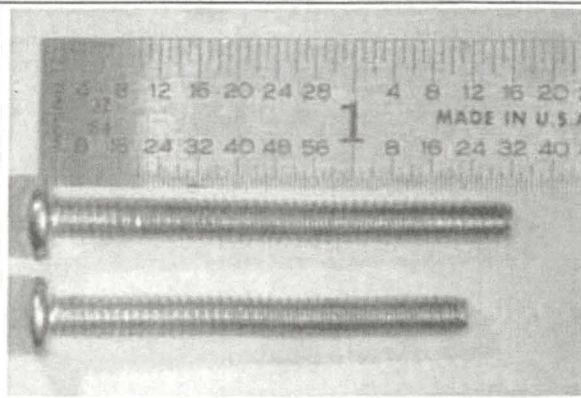
Photos 9 and 10: Mounting Fastener Screws

The root cause was determined in our inventory – it seems the ‘found’ screws had been dumped into an open box of screws for the CMC units and they were not correct. This created the issue you are seeing. This was reported as a handful of screws - After they first reported problem, our inventory was quarantined and all the screws were inspected. The time frame has been determined to be the end of 2017 (seems to be November and December).

The mounting fastener screws were inspected and one was found to be 1/8" longer than the rest. When the switch was installed in the panel and tightened, the longer screw punctured the lamp transformer causing a short to ground. During CCN-74260 PQI testing at PowerLabs, a lamp illumination test was performed satisfactorily on this switch. This confirmed the switch was not damaged when shipped from Curtiss-Wright, but the incorrect screw caused the damage during installation.

Curtiss Wright’s dedication plan will be revised to include a note to ensure no selector switches, for this part number are manufactured with the November and December 2017 date codes.

Any remaining switches should be checked to confirm none of the mounting fastener screws are the wrong length. There were (5) switches PQI tested in January 2018, so there is likely at least (3) in stock. Based on the nature of this failure installed switches would not be impacted by this issue since the problem would be apparent during post-installation testing.

The PowerLabs PQI testing templates for this switch and similar models will be revised to include inspection of the mounting fastener screws to confirm proper length.
