**Flow Control Division**

Subject: Spring Deflection Causing Potential Hang-Up of the Flapper (Disc), Worcester Series 44 Swing Check Valve

This is to notify the US Nuclear Regulatory Commission that, in accordance with the provisions of 10CFR Part 21, we have identified a potential issue and are submitting our evaluation of the event.

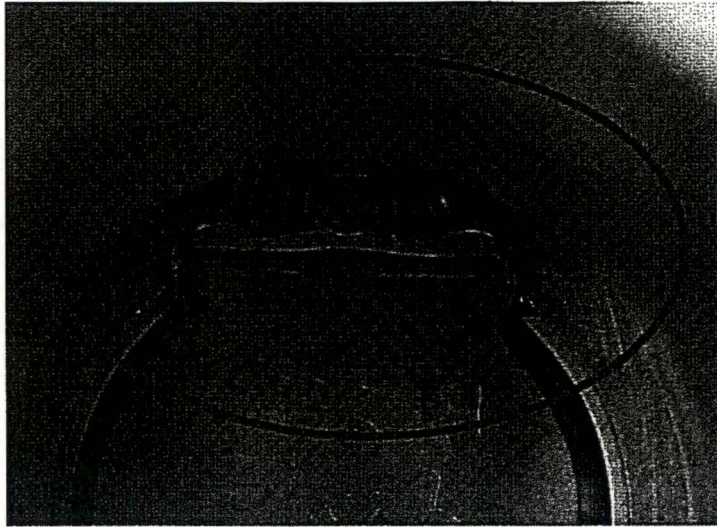
Picture of Adverse Condition

Evaluation: Shop inspections of the returned valves confirmed the potential for the spring legs to rotate outwards and potentially wedge between the flapper and seat retainer. Of the five valves evaluated, two of the valves had the spring legs rotate outward and after repeated cycles got caught between the flapper and disc; on one of the instances the spring legs prevented full closure of the flapper.

The evaluation determined the cause is an inadequate spring design which allows the spring to deflect and permit the legs to move outward.

- Owner's may remove the springs. The valves will check-off and seal under low pressure conditions without the assistance of the spring; this was demonstrated in shop tests using tap water pressure (approximately 60 psig) and will initiate closure when full open without the assistance of the spring.
- Flowserve is evaluating alternate spring designs along with the possibility of adding guides to prevent the undesired spring movement. Any new design will be proof tested.
