Report No. 10CFR21-0124
 Rev. 0: 03/21/19

**10CFR21 REPORTING OF DEFECTS
 AND NON-COMPLIANCE**

COMPONENT: Excitation Transformers for Vickers Voltage Regulator System

SYSTEM: Emergency Diesel Generator – Voltage Regulator System

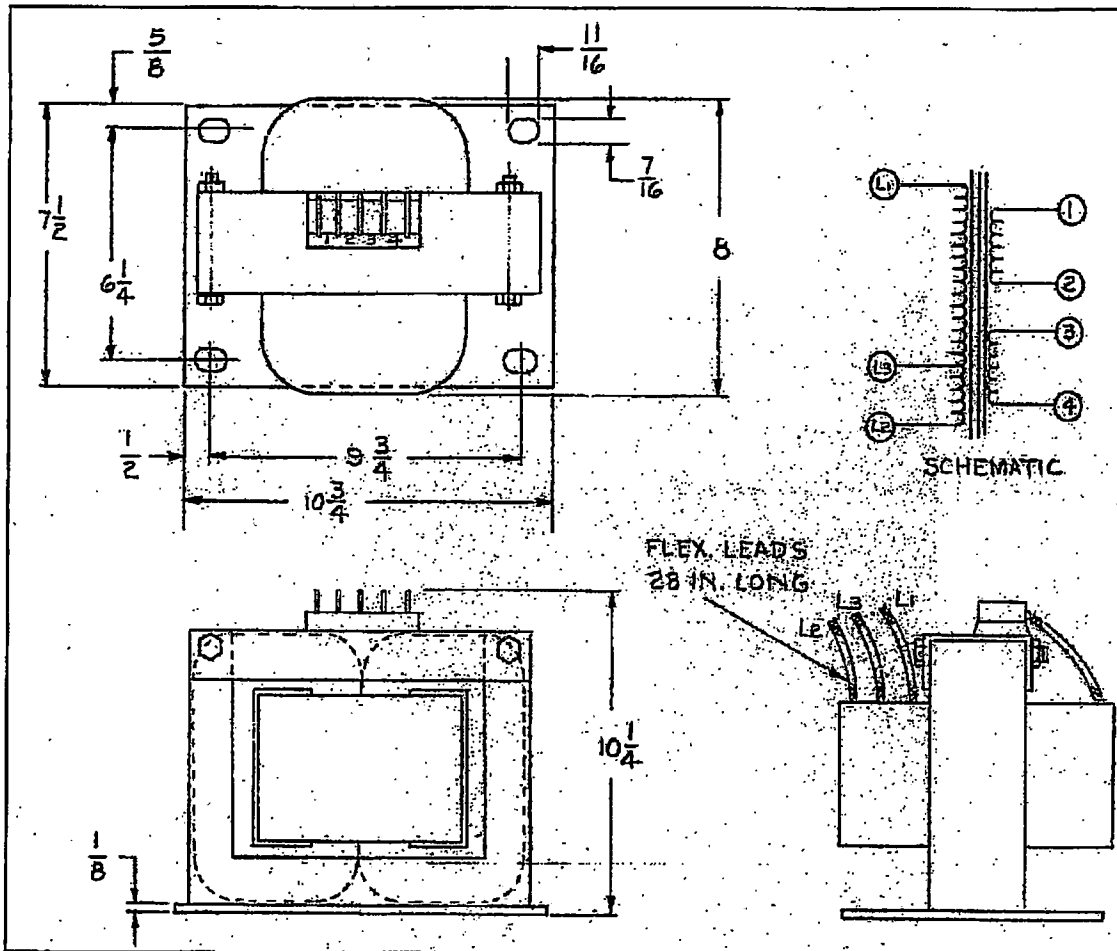
Figure 4: Reactor Outline Drawing

In conjunction with a rectifier diode, the saturable reactor acts as a magnetic amplifier. Six of these magnetic amplifier assemblies are used in the rectifier bridge of the voltage regulator system. The reactor receives a bias and control current from the voltage regulator which varies the level of saturation in the reactor core. As the level of saturation changes, the reactor impedance varies which increases or decreases generator field voltage. It has been determined the saturable reactor supplied by ESI has coil winding and core winding differences from the originally supplied reactor that may cause subtle, but undesired performance differences.

Return to ESI for replacement.
