ITT ENGINEERED VALVES

Final Report to the NRC of
10 CFR 21 Event 54118, reported by ITT 06/14/19
Concerning #25 AM diaphragm valves

1.0 INTRODUCTION

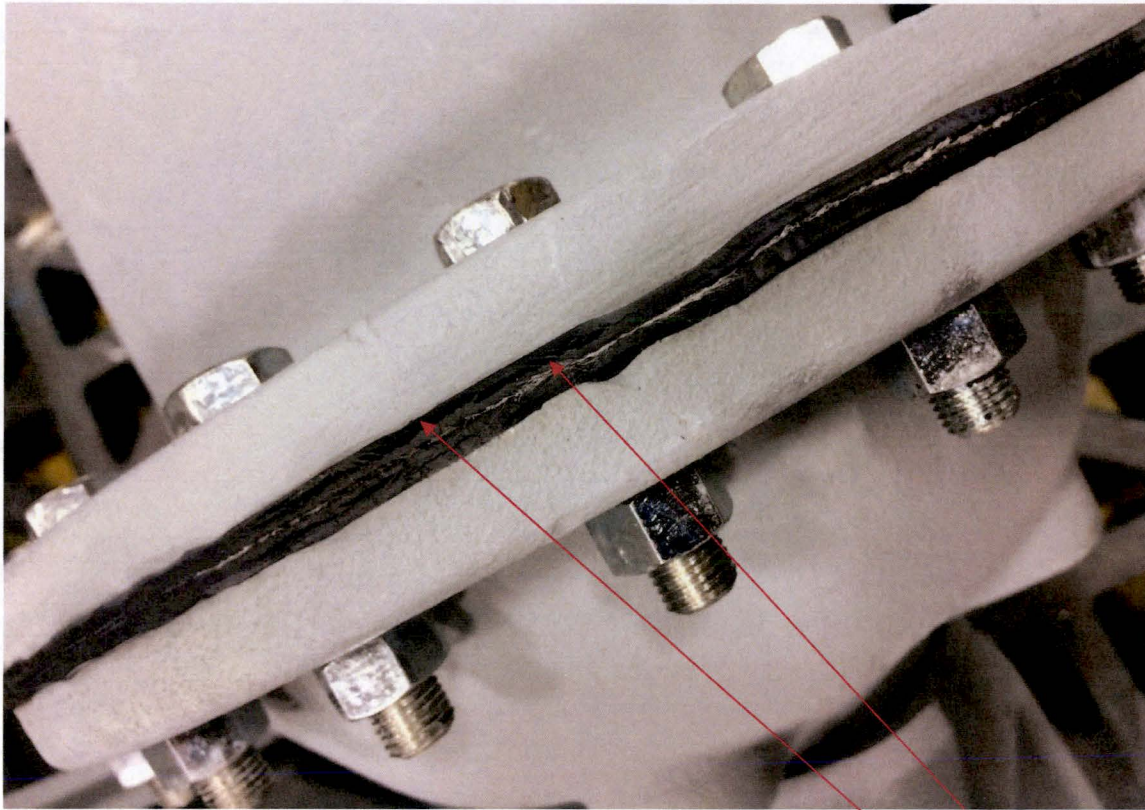
The damage to the airmotor diaphragms was evident once the valves were retrieved from storage and brought out for disassembly. Splitting of the elastomer was visible on the edge of the diaphragm, even before the valves were taken apart, see Figure 1. After disassembly, the splitting could no longer be easily seen, but the delamination of each diaphragm was now plainly visible, see Figure 2. All five diaphragms showed the same type of splitting and delamination, with the delamination ranging from 30% to 75% of the circumference. The delamination in all cases began at the outer diameter of the diaphragm and extended radially to the inner edge of the flange clamping area.

The reason that excessive torque was applied in this case was that the joint formed by the upper and lower cover and the diaphragm was not able to pass the 110 psig production test using the specified assembly torque of 72-79 in-lb. The finish of the covers is as cast, and was not sufficiently flat enough to accommodate the seal without compensating by applying torque well in excess of the specified value.

Figure 1: Diaphragm damage noted before disassembly. Note splitting of elastomer on edge of diaphragm.

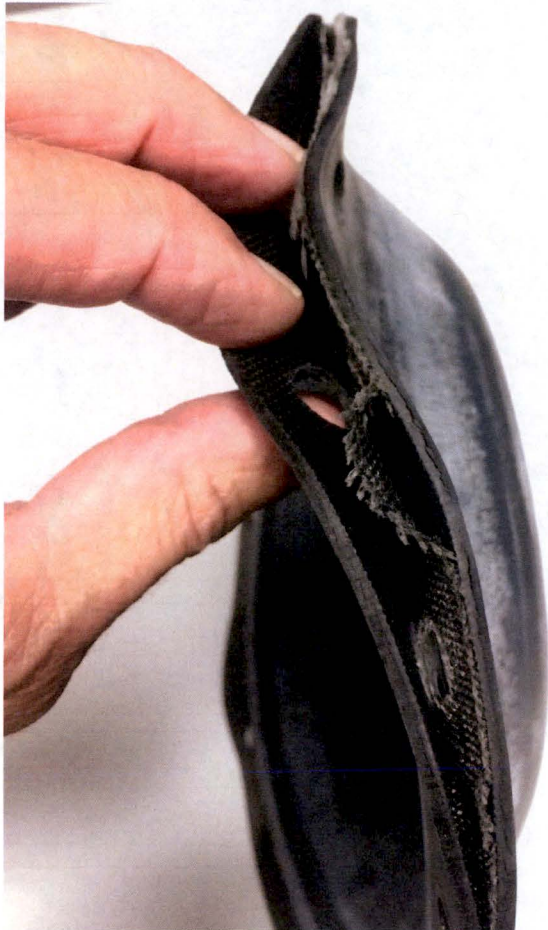
Figure 2: Delamination of fabric from elastomer

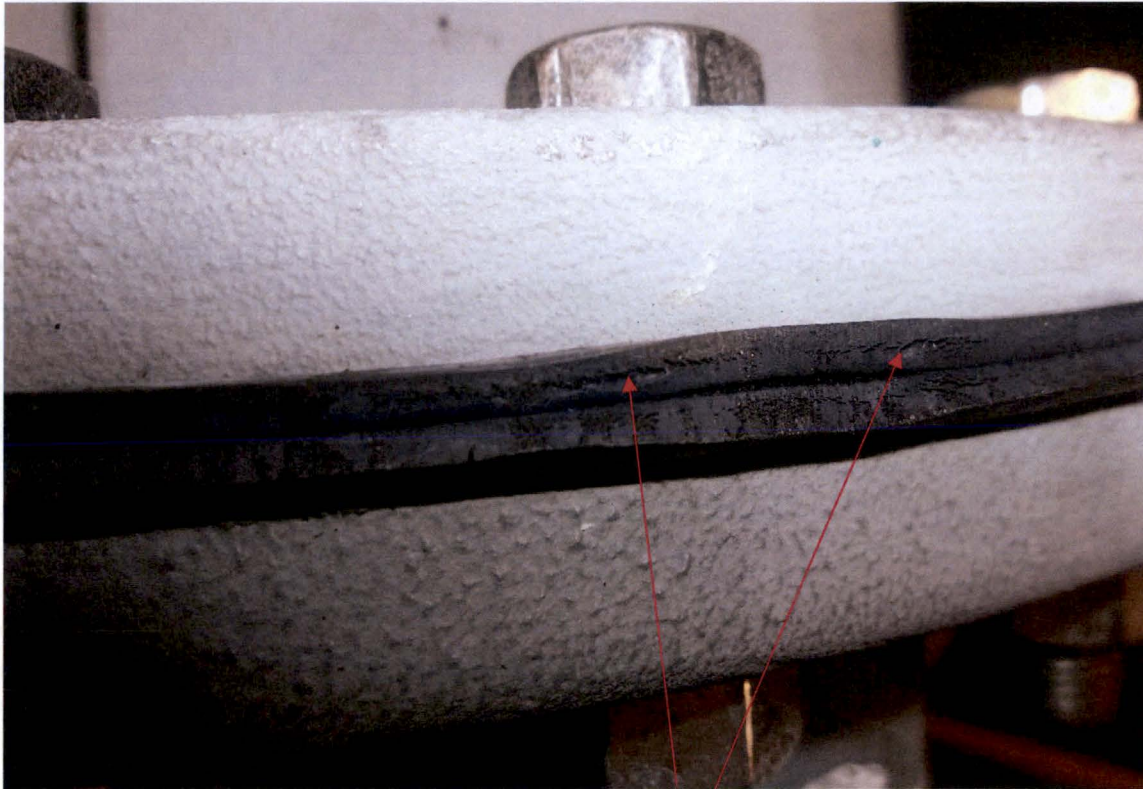
time. At the four week point, cracks were observed on the outer edge of the diaphragm that were not present at initial assembly, similar to those that were seen on the damaged diaphragms (see Figure 3). Repeated observations of the diaphragm over time showed that at week seven more cracks were found that had not been previously seen. In addition, some delamination was observed on the edge of the diaphragm, corresponding to the bolt location, see Figure 4. It became apparent that as time went on more cracks would initiate and existing cracks would deepen. This was seen as clear evidence that the cause of the damage was the high level of assembly torque that in time would manifest itself in permanent damage.

Figure 3: Splitting of diaphragm on simulated test unit

The simulation test proved that over time, the effect of the high bolt torque generates forces that have a long term, deleterious effect on the airmotor diaphragm such that the elastomer material will split and the fabric will delaminate from the elastomer.

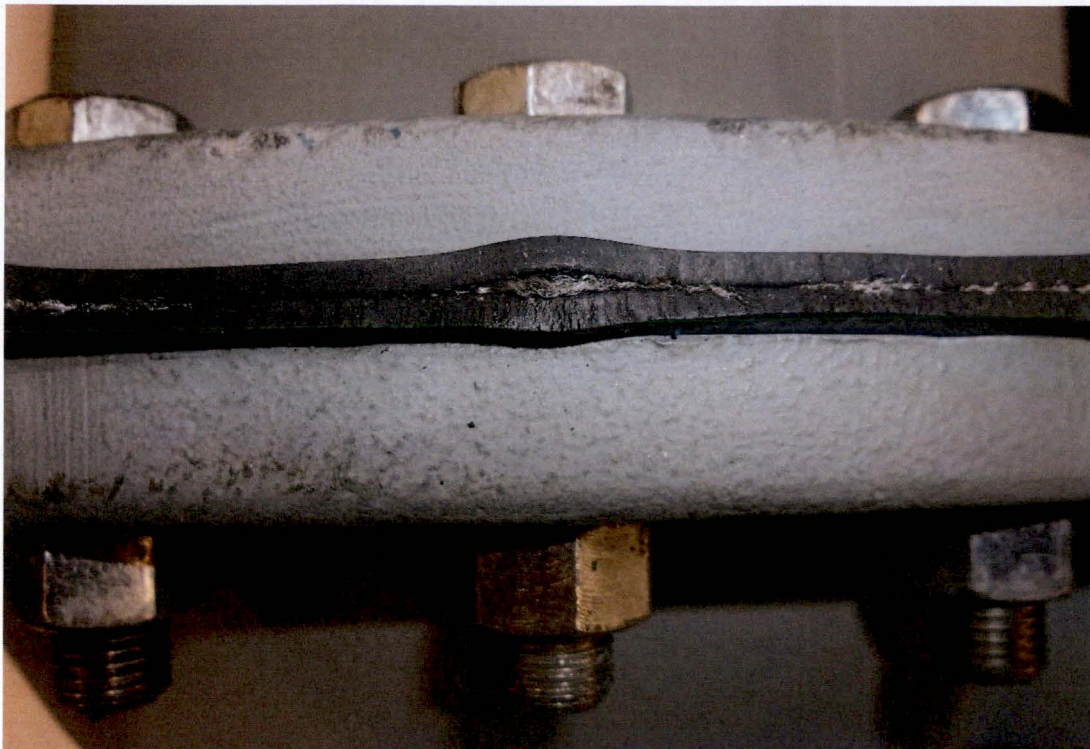
On August 9, after the 8th week of observation, it was concluded that the root cause of the diaphragm damage was the excessive torque.

Figure 4: Delamination of simulation unit

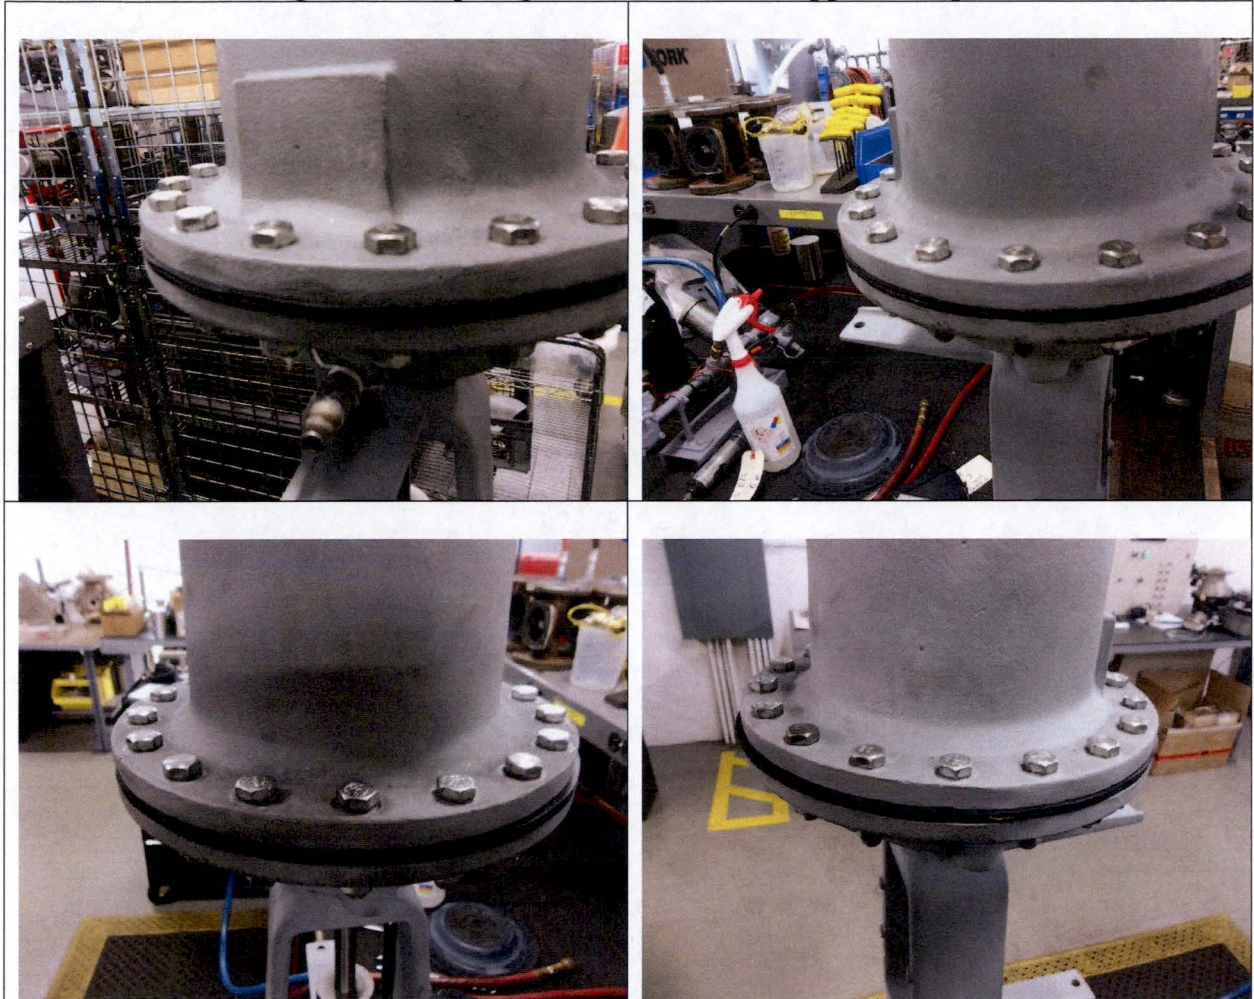
Excessive bolt torque causes damage to the airmotor diaphragm, but it also provides visual indications that enable a user to identify problematic assemblies. See Figures 5 and 6 for a comparison of a properly assembled airmotor versus one with a known excessive bolt torque. Normally the OD of the assembled diaphragm is the same diameter as the metal covers. If excessive torque is applied the elastomer diaphragm may extrude and extend as much as 0.12" beyond the OD of the covers, see Figures 6 and 7.

Figure 5: Diaphragm with 72 in lbs of applied torque

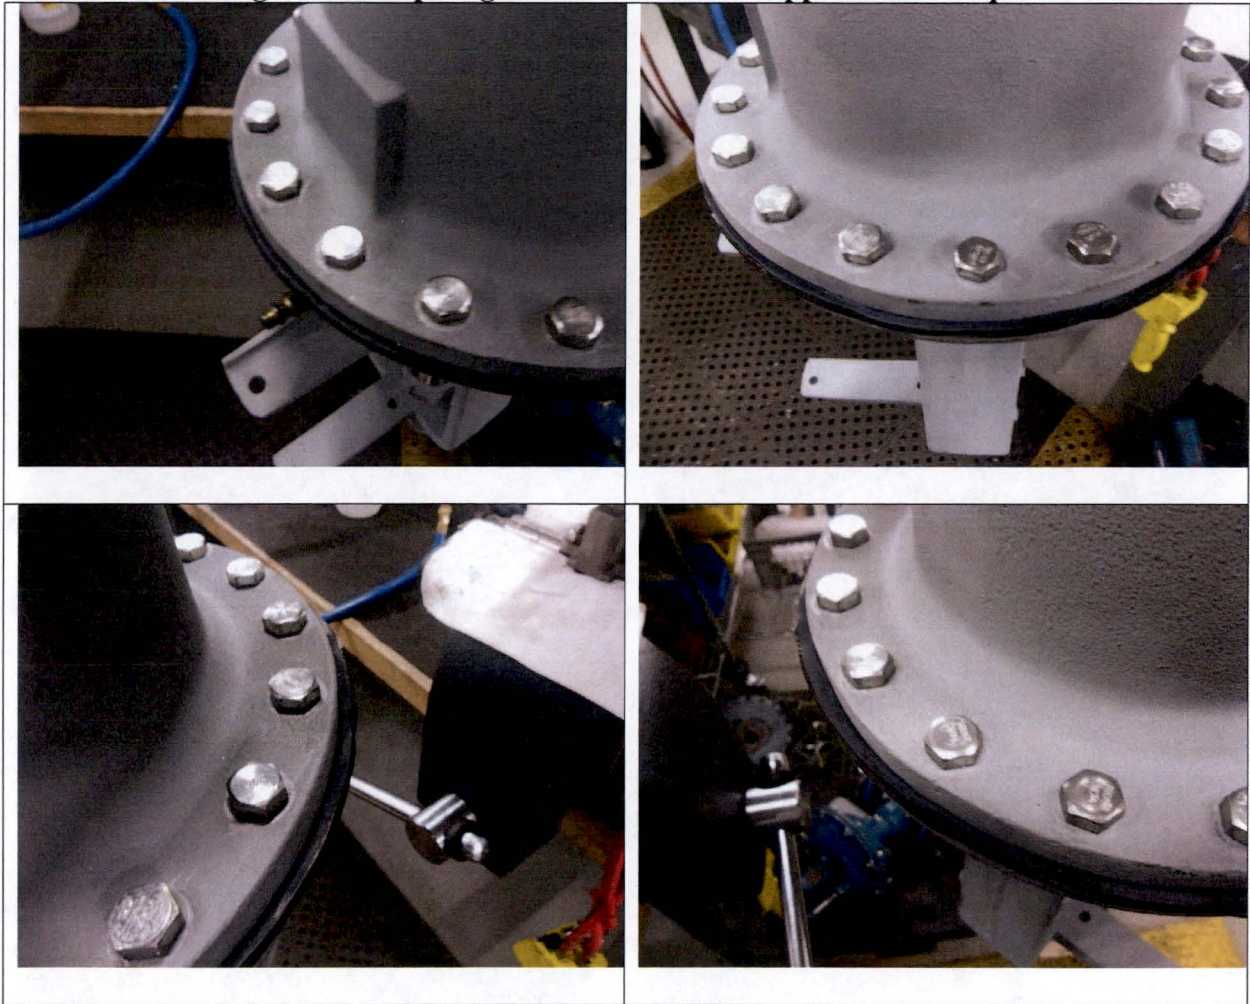
Figure 6: Diaphragm with 300 in lbs of applied bolt torque

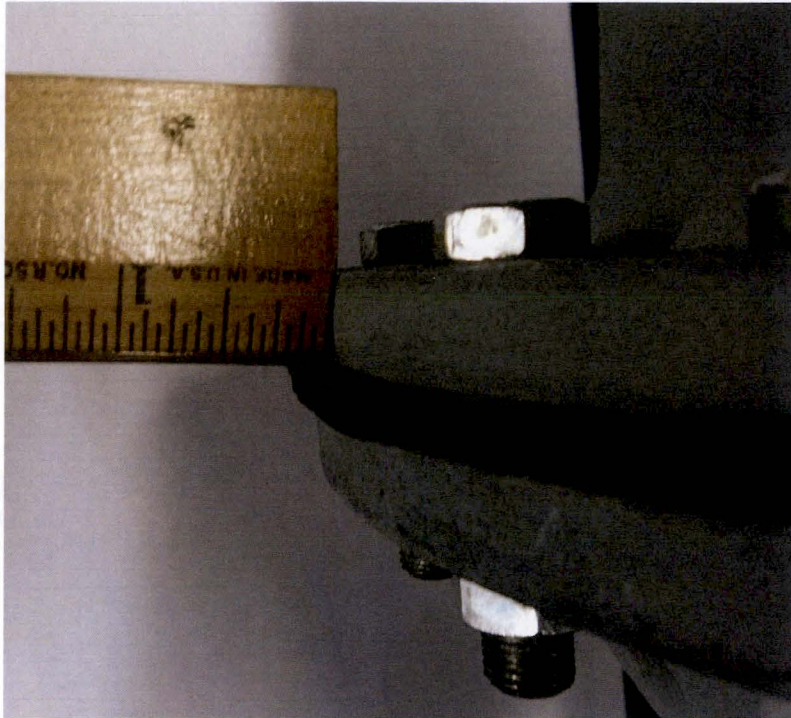
Figure 7: 300 in-lb - Extrusion of edge by 1/8"

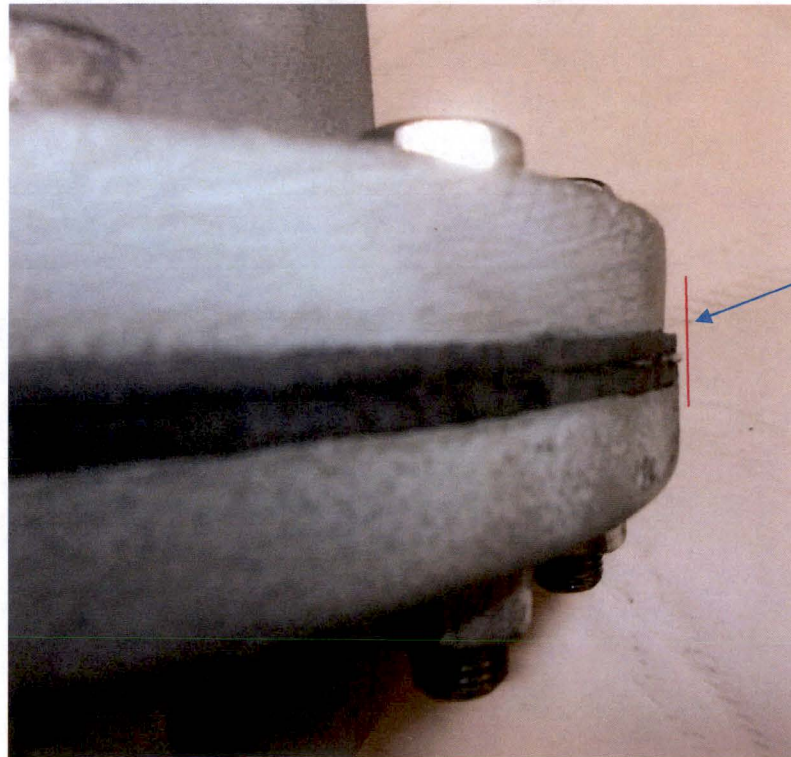
Figure 8: 72 in-lb – nominal extrusion, square edge

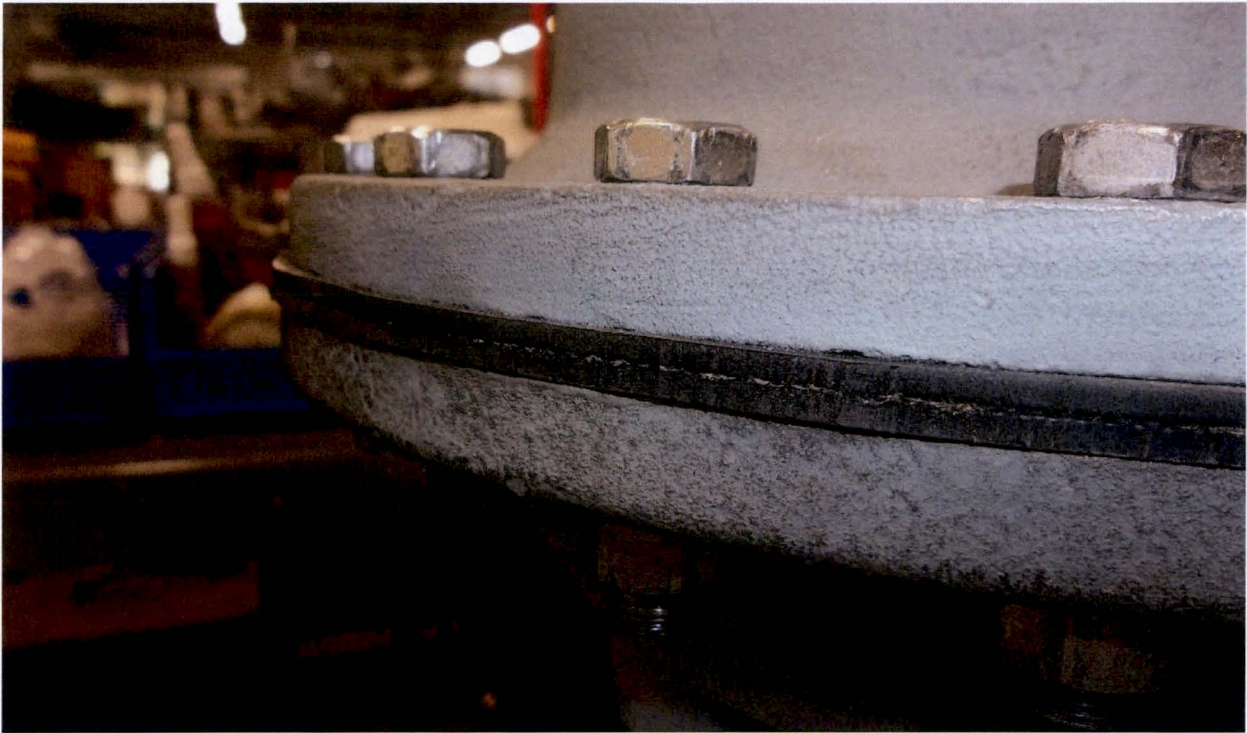
Figure 9: Diaphragm with 72 in-lb applied torque – undistorted, square edge

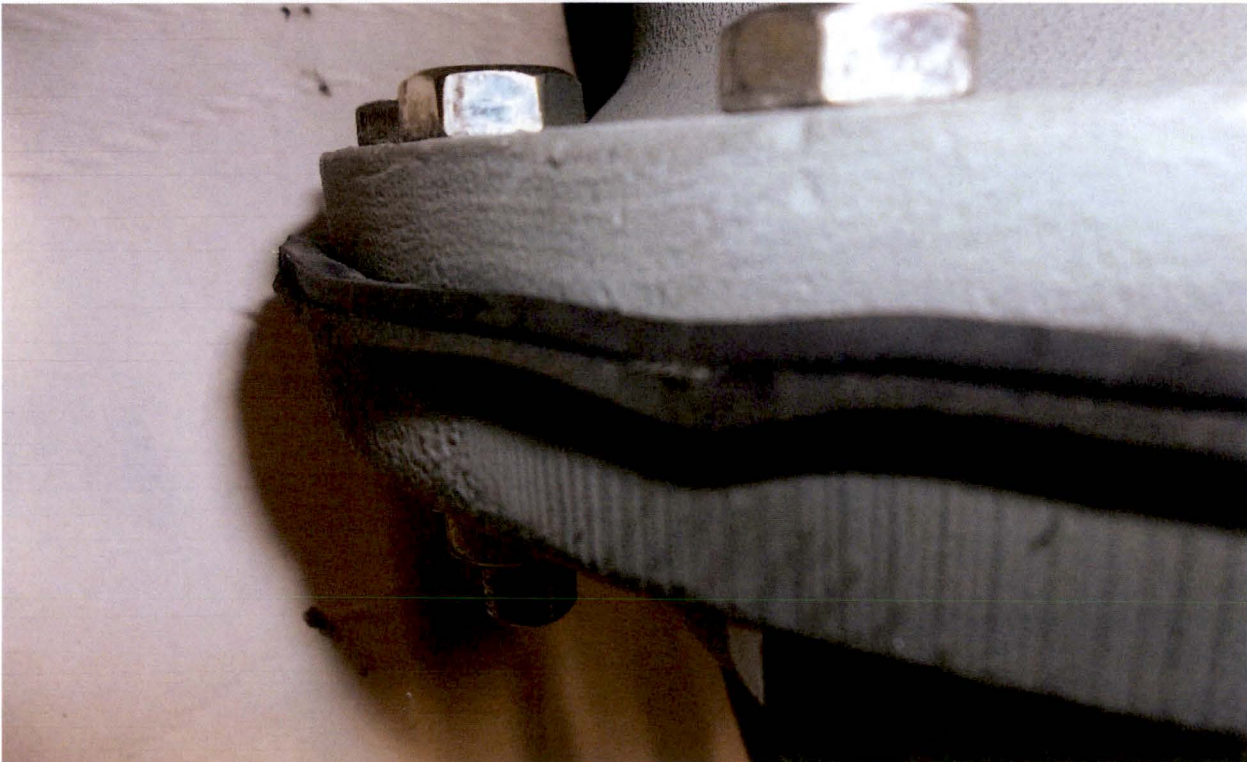
Figure 10: Diaphragm with 300 in-lb applied torque – Distorted, edge not square

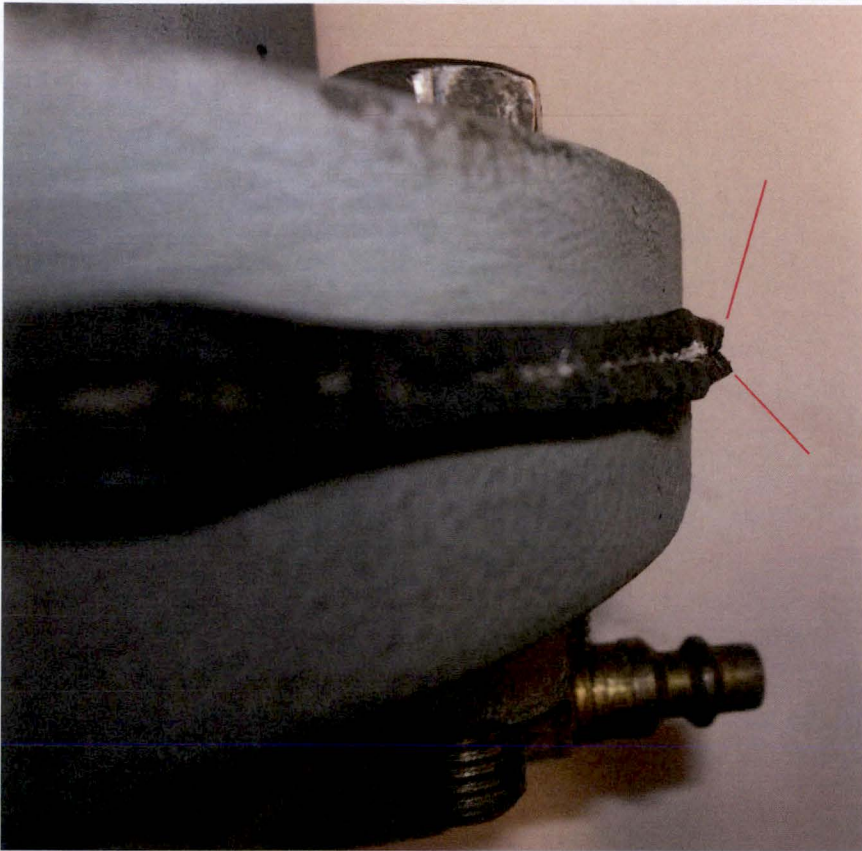
Figure 11: Diaphragm with 300 in-lb applied torque – Distorted, edge not square
