ITT ENGINEERED VALVES

Final Report to the NRC of
10 CFR 21 Event 54118, reported by ITT 06/14/19
Concerning #25 AM diaphragm valves

Original submittal was 8/13/19; this revision 1 is dated 8/20/19

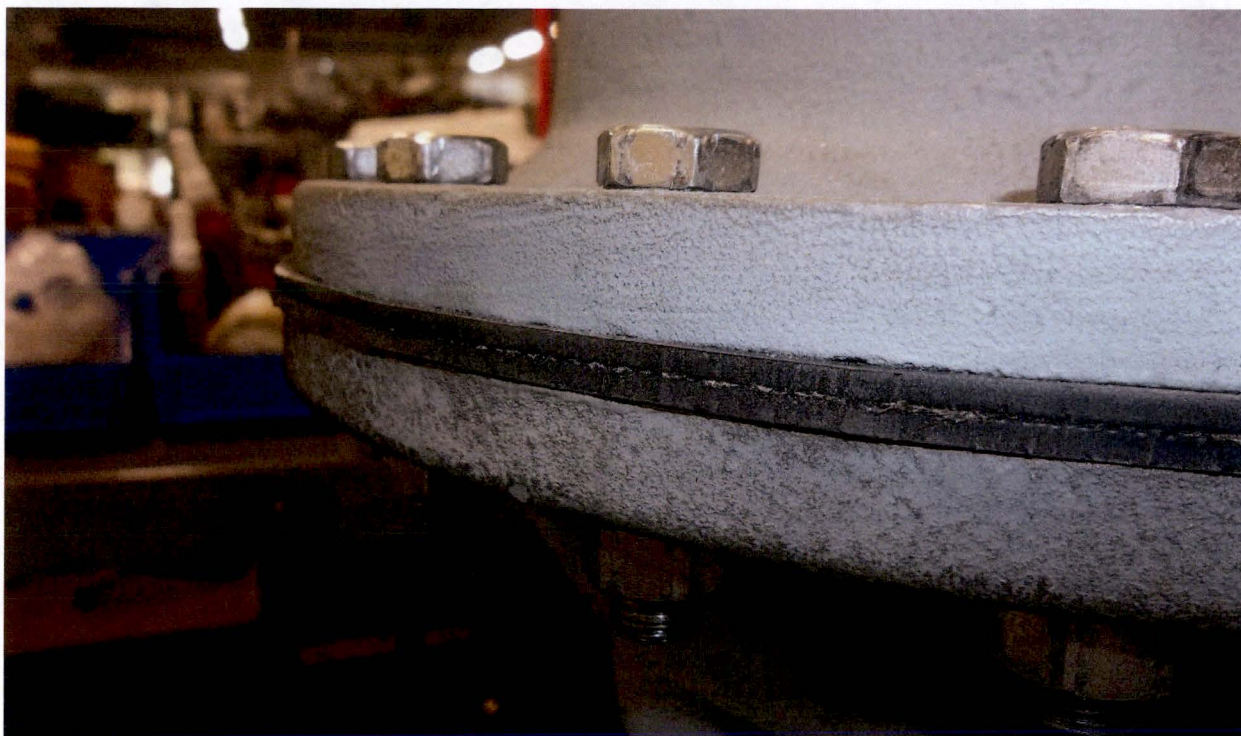
Another indicator that is visible is the shape of the edge of the diaphragm. The elastomer surface on the OD should remain square if the assembly was properly assembled, see Figure 8. If excessive torque is applied the edge of the diaphragm will not remain square, instead the outer edges will grow out further than the part of the edge that contacts the fabric in the middle, see Figure 11 and the comparison between Figures 9 and 10.

Figure 9: Diaphragm with 72 in-lb applied torque – undistorted, square edge

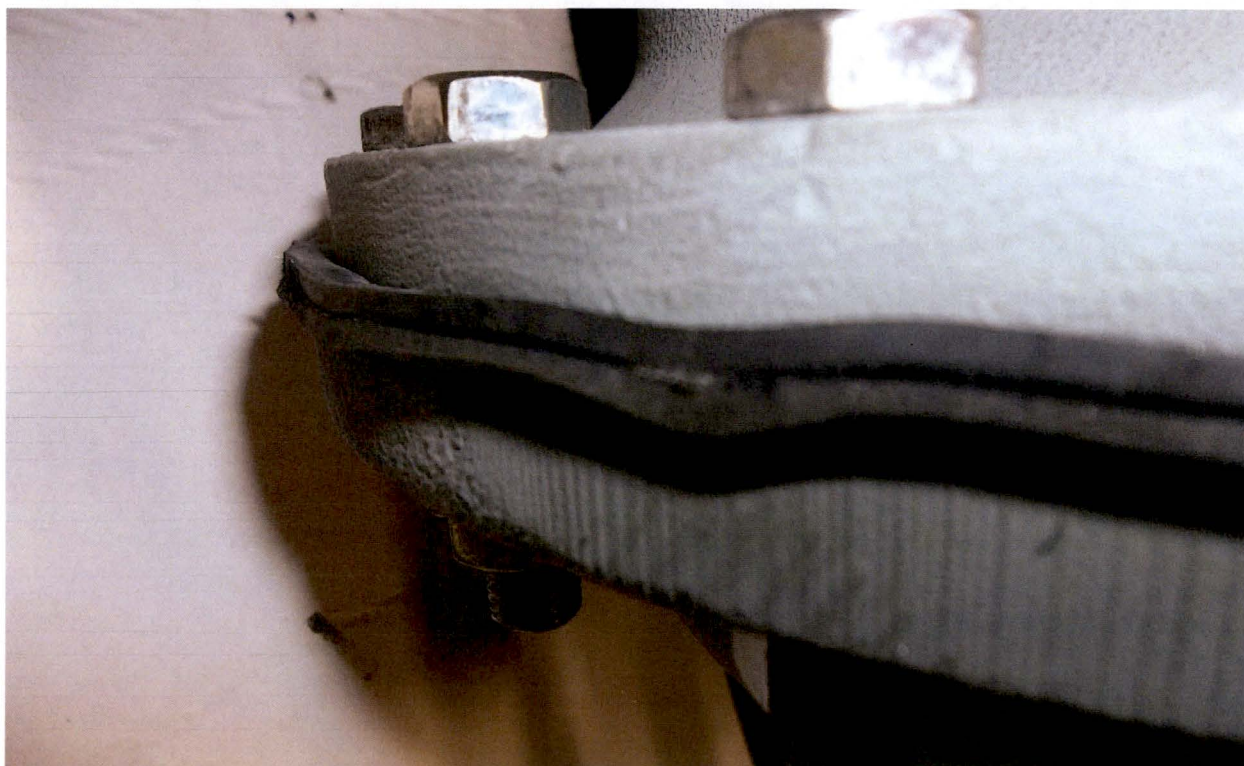
During the first week of the investigation a simulation test was started, with the intention of trying to replicate the damage seen on these valves. Using the same valve hardware as before, one brand new #25 airmotor diaphragm of March 2019 construction date was installed in a valve assembly. This assembly was intentionally over torqued to 300 in-lb in order to accelerate the effect seen on the problematic valves. The airmotor diaphragm was examined at the perimeter to see if the same cracks and delamination as seen in the damaged diaphragms (Figure 1) could be observed. While the diaphragm was extruded beyond the diameter of the covers and some distortion was noted (see Figure 10 in Appendix A), no cracks or delamination was initially visible.

Figure 10: Diaphragm with 300 in-lb applied torque – Distorted, edge not square
