Subject: 10CFR21 Reporting of Defects and Non-Compliance -
Engine Systems, Inc. Report No. 10CFR21-0126, Rev. 0

EMD Fuel Injector – Cracked Spray Tip, P/N 5229250

Report No. **10CFR21-0126**

**10CFR21 REPORTING OF DEFECTS
AND NON-COMPLIANCE**

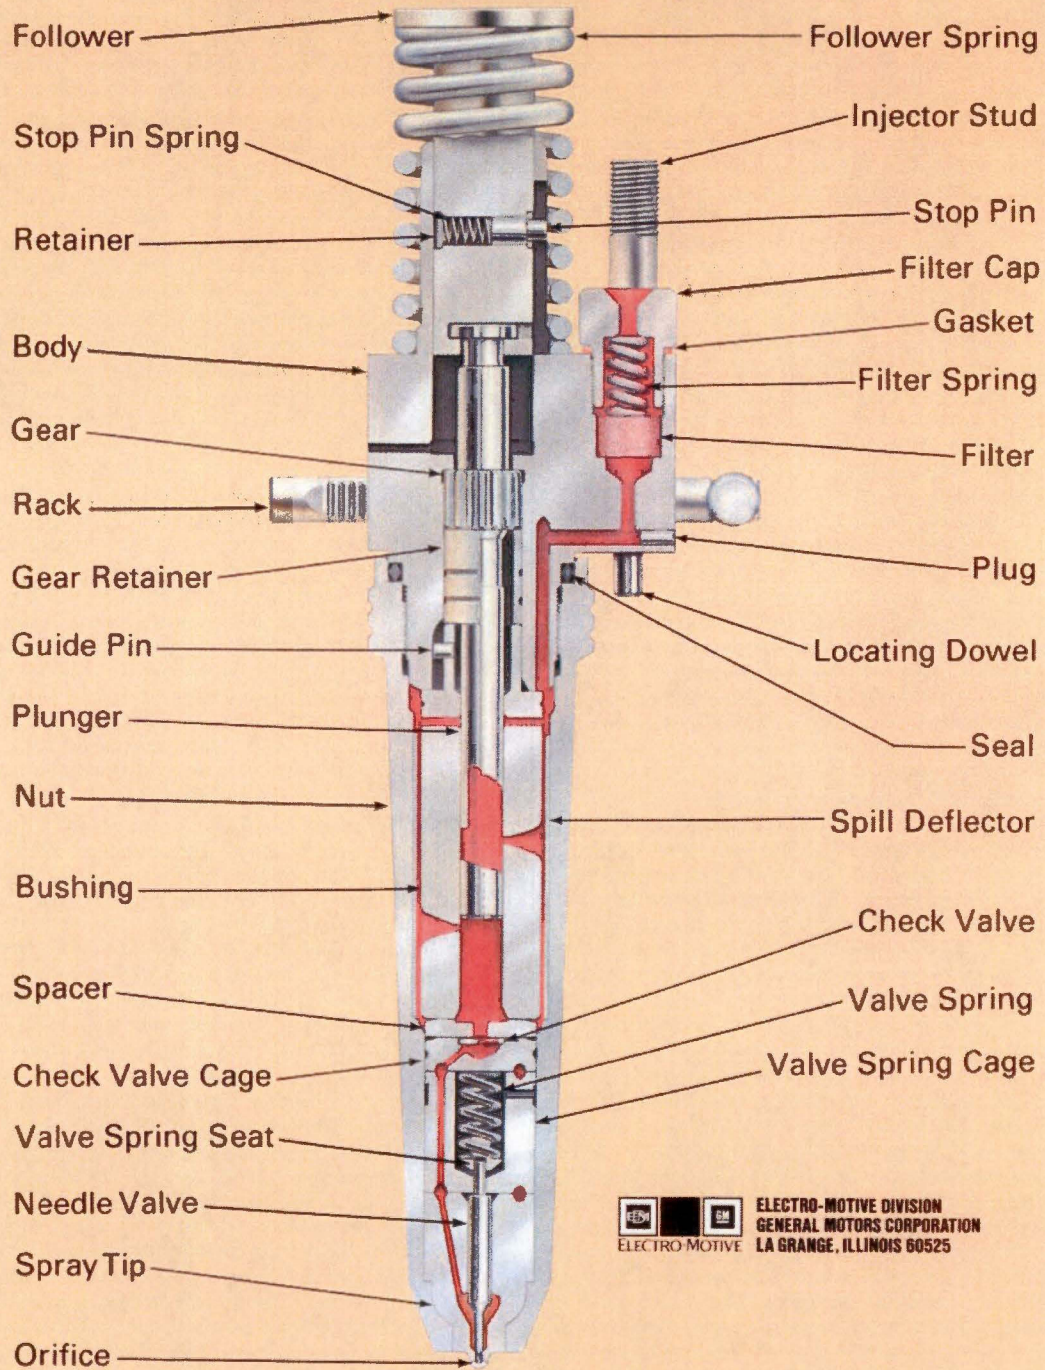
Figure #1
EMD Unit Injector

The injector was placed in operational service in December 2018 and failed soon afterwards. The injector failed to chatter, wouldn't build pressure, and leaked at the nozzle. Disassembly inspection revealed a cracked spray tip. Refer to injector assembly, Figure #1.

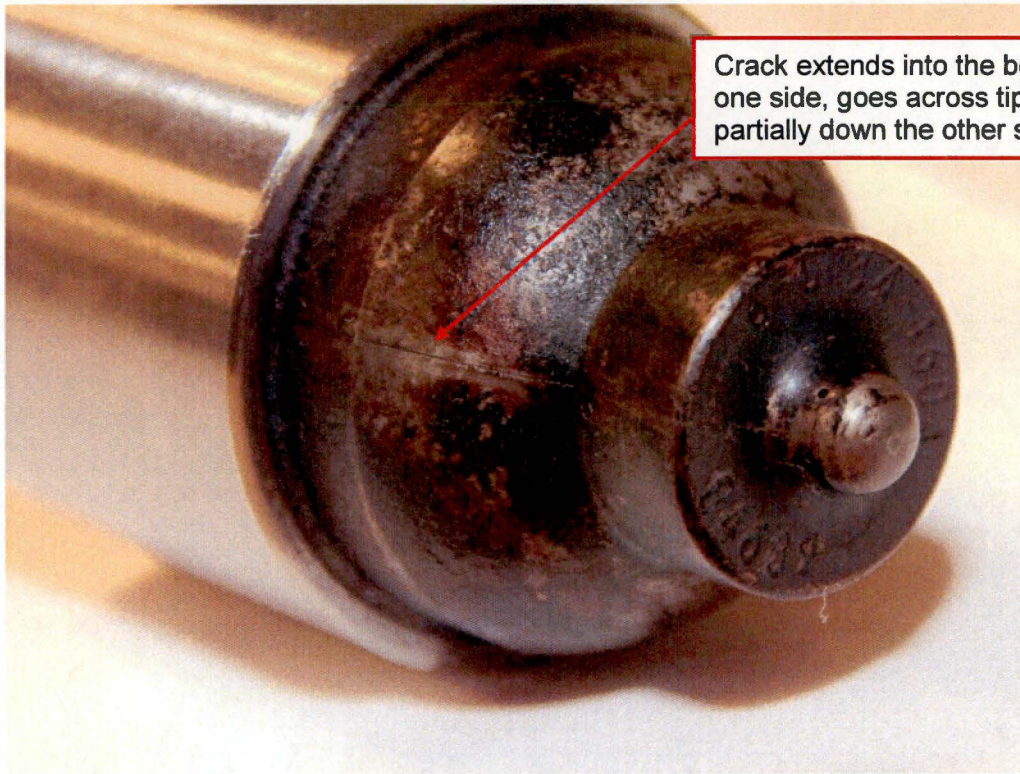
Photo #1
Cracked Injector Spray Tip

The crack was visible without magnification and extended from the machined outside diameter on one side across the tip and partially down the other side. See Photo #1. It was decided to section the spray tip and inspect the internal machined reservoir.

Crack extends into the body on one side, goes across tip and partially down the other side.

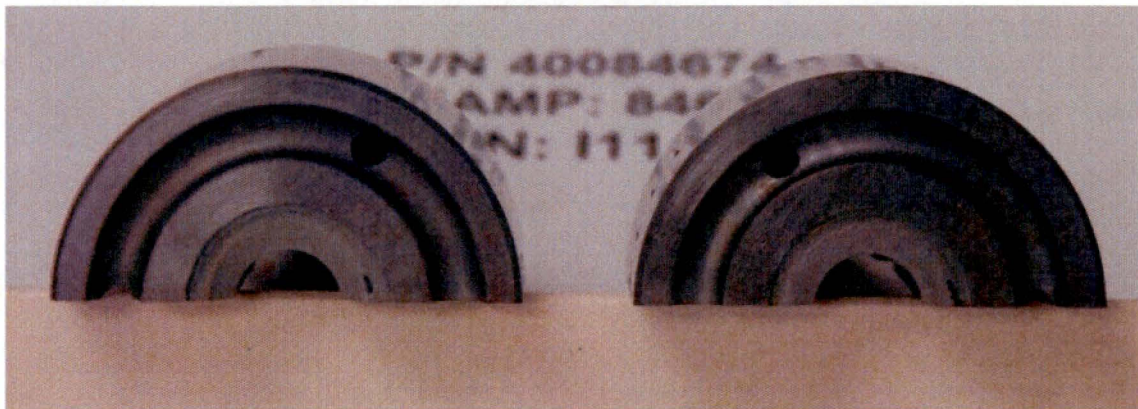
Photo #2
Tip sectioned through one feed hole

The section was made to bisect the spray tip through one of the fuel feed holes, as shown below. See Photo #2 for end view of sections.

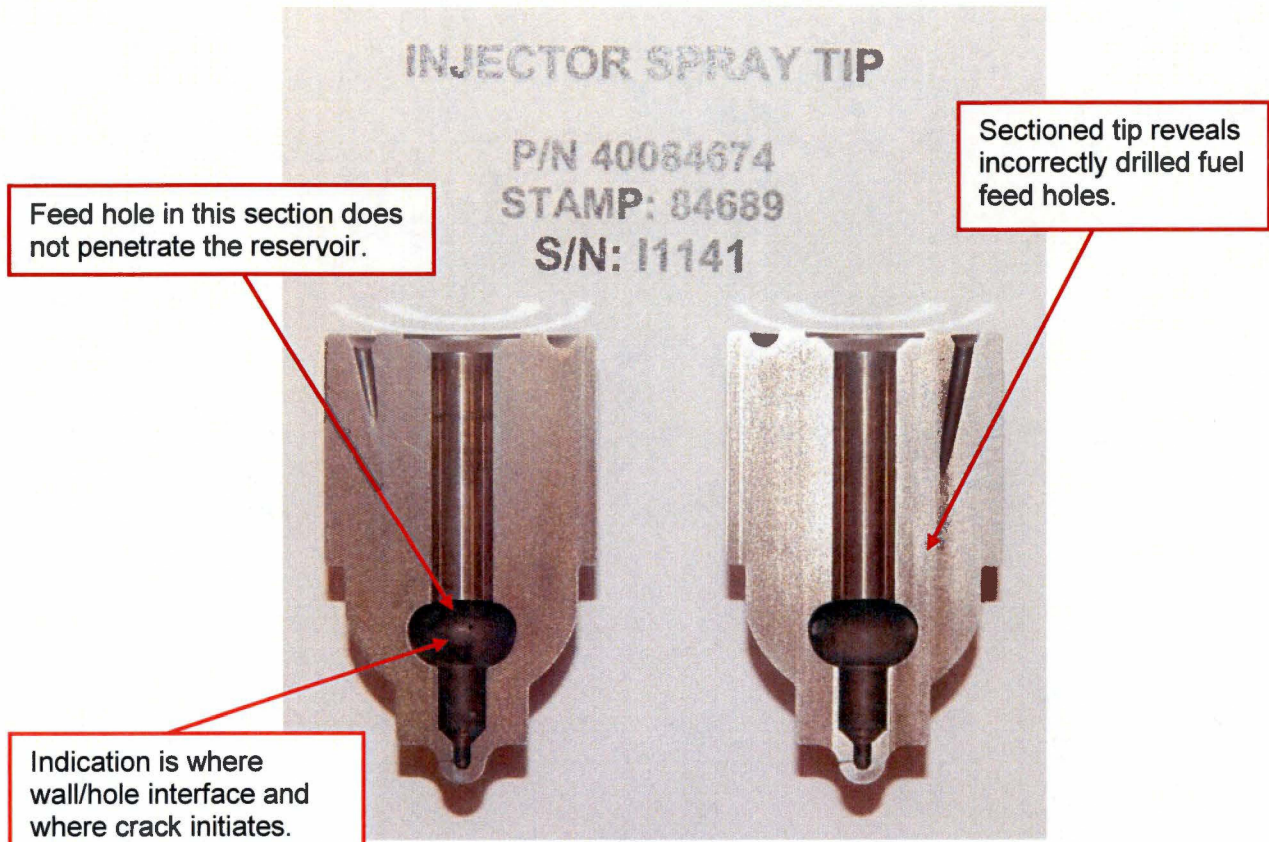
Photo #3
Incorrectly drilled feed holes

The sectioned spray tip identified the fuel feed holes were not properly oriented. The axis of the feed holes are supposed to be on the centerline of the body, and tilted 10° off vertical. The as-found holes are not on the body centerline as shown in Photo #3.

The incorrect drilling resulted in one of the holes not properly penetrating the reservoir. A small indication is visible in the left hand section where the reservoir and hole have joined. It is in this area where the crack initiated and propagated through the full section of the spray tip. See Photos #3 through #5.

- *The injector repair kit (P/N 40084754) that contained the spray tip has been discontinued and is no longer utilized.*
- *ESI has implemented an inspection for all new injectors to verify proper fuel feed hole drilling in the spray tip prior to assembly of the injector.*

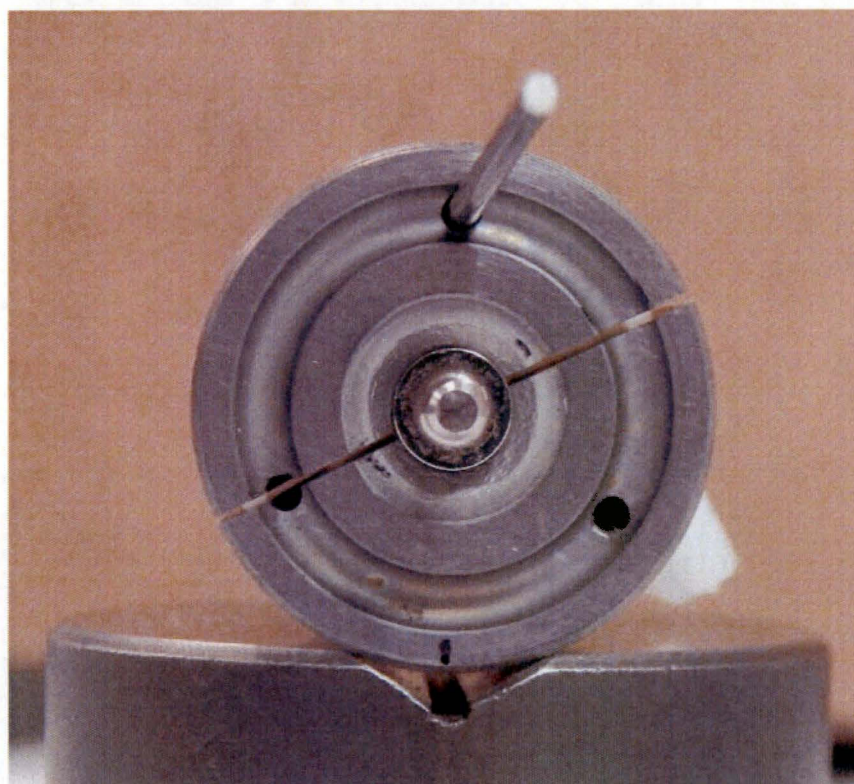
Photo #6
Spray Tip with 0.062" dia pin gage inserted, end view

A visual indication of the hole axis orientation is shown in Photos #6 & #7. In these photos a 0.062" diameter pin gage is inserted in the feed hole that doesn't penetrate the reservoir. The needle is inserted in the center of the tip to provide a reference for the centerline of the body. When properly oriented, in Photo #7 the pin gage and valve needle should appear parallel. The angle between these was measured to be approximately 8°.

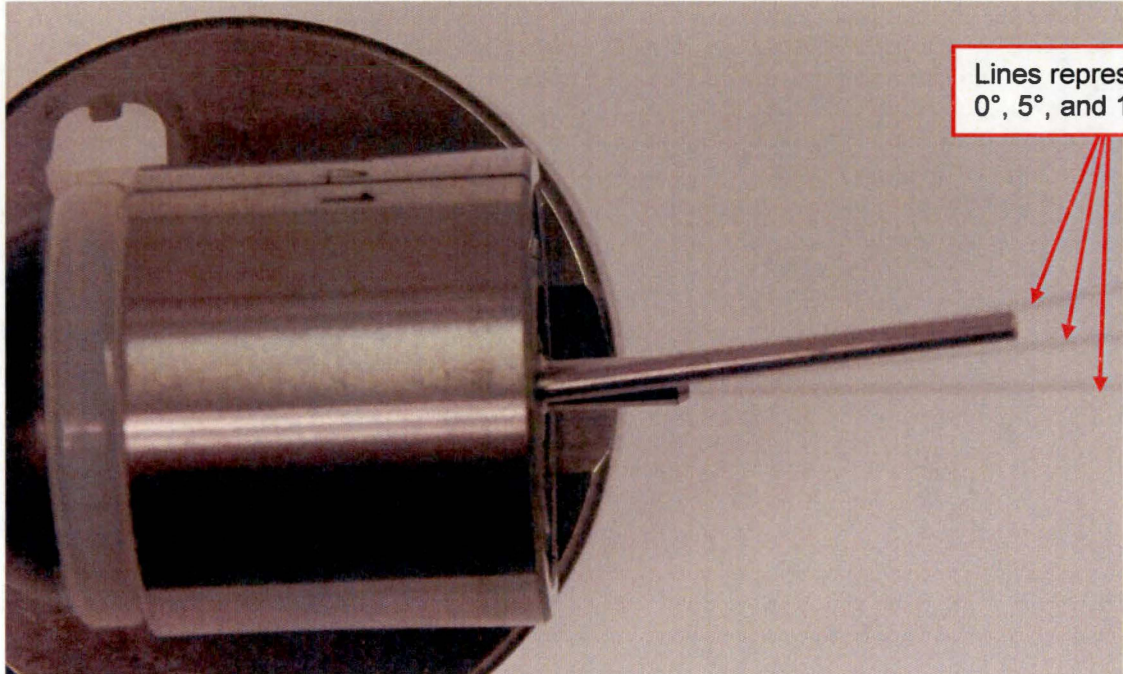
Photo #7

Spray Tip with 0.062" dia pin gage inserted, side view
