**Please find Attached a Part 21 notification from Rotork Controls Inc. concerning a safety related "Outer Clutch Ring", part number N40039.**

Subject: NA Actuator, Model NA1, Outer Clutch Ring Anomaly

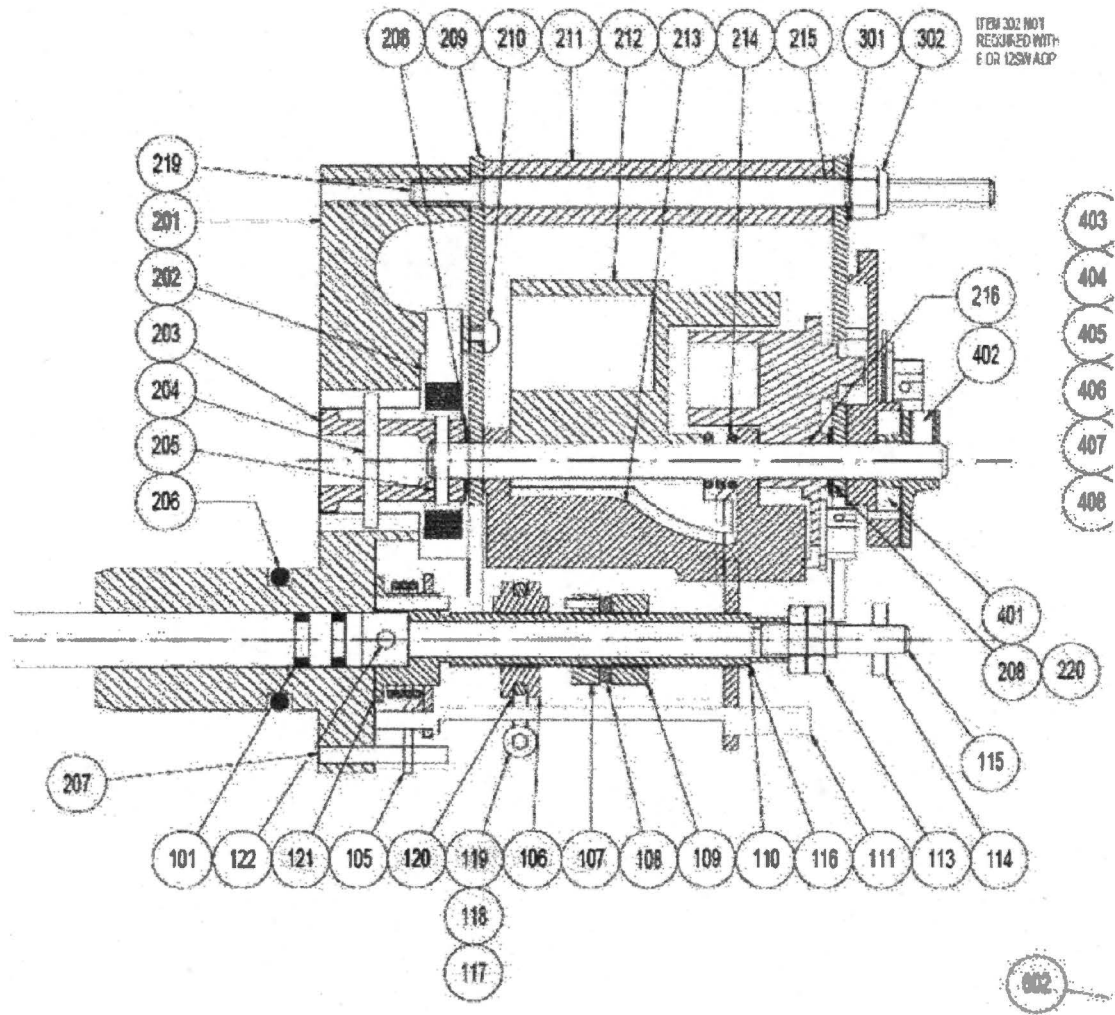
Fig 1

Failure of the Outer Clutch ring prevents the actuator from stopping on travel limit. Should this occur the actuator will over travel and eventually stop on output torque limit set by the customer. The Outer Clutch Ring (Fig1, 120) wraps around a component called the inner traveler (Fig 1, 106) and prevents it rotating until it reaches the set travel limit position (Fig 1, 107 & 121). The Outer Clutch Ring slips on the inner traveler if necessary. Slip in service should not occur. Slip may occur during commissioning and test.

Rotork have developed a repair kit (WN 84122) which replaces the beryllium copper Outer Clutch Ring with a spring steel version.

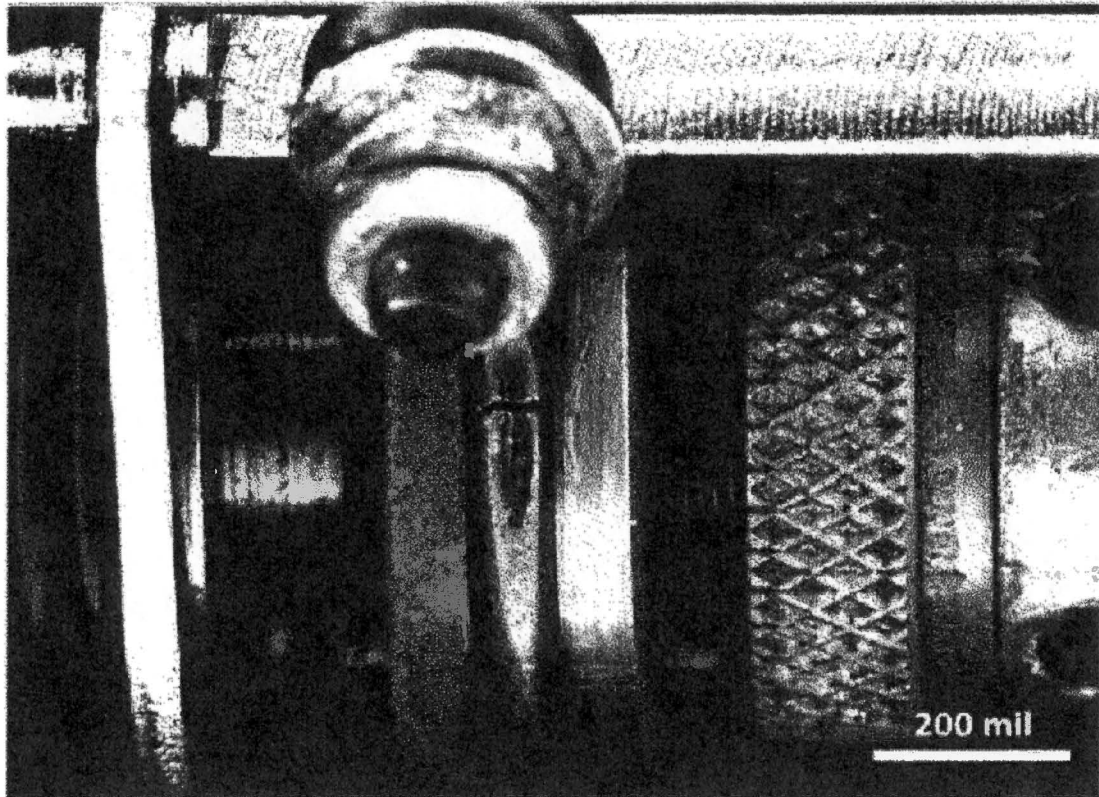
Fig 2

The cause of the component failure is not understood. All failures occurred at the same point in the component. The form of the fractures are similar (Fig 2). The Outer Clutch Ring is seated onto the inner traveler by initially over tightening the cap-screw (Fig 1, 119) used to set the torque at which the Outer Clutch Ring slips on the inner traveler. Over tightening to seat may have introduced a weakness. The same method is used to seat spring steel Outer Clutch Rings. There are no records of
