LTR-NRC-20-12

March 2, 2020

Subject: NSAL-20-1 Revision 0, "Reactor Vessel Head Control Rod Drive Mechanism Penetration Thermal Sleeve Cross-Sectional Failure"

Subject: Reactor Vessel Head Control Rod Drive Mechanism Penetration Thermal Sleeve Cross-Sectional Failure	Number: NSAL-20-1
Basic Component: Thermal Sleeve in CRDM Reactor Head Penetration	Date: February 14, 2020
Substantial Safety Hazard or Failure to Comply Pursuant to 10 CFR 21.21(a)	Yes <input checked="" type="checkbox"/> No <input type="checkbox"/> N/A <input type="checkbox"/>
Transfer of Information Pursuant to 10 CFR 21.21(b)	Yes <input type="checkbox"/>
Advisory Information Pursuant to 10 CFR 21.21(d)(2)	Yes <input type="checkbox"/>

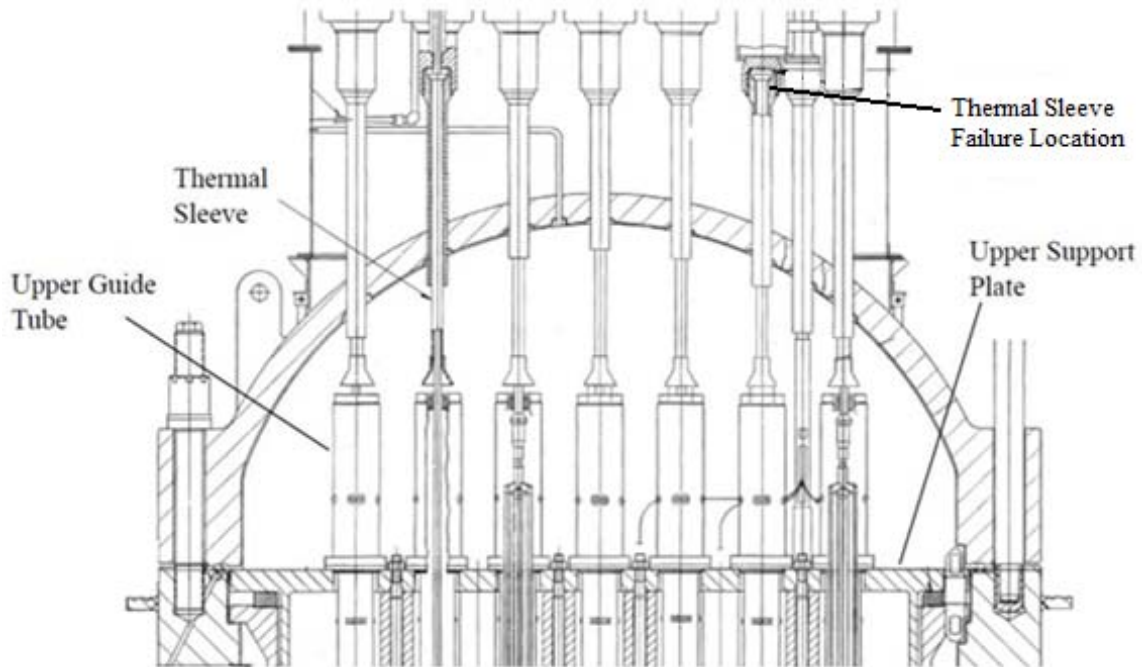
Figure 1 Thermal Sleeve Location in the RVCH

During a planned 2019 refueling outage at a Westinghouse NSSS plant, a thermal sleeve (Figure 1) was observed to be fractured and resting upon an upper internals upper guide tube (UGT). The OE showed that a mechanical failure of the thermal sleeve had occurred across its cross-section. The failure mechanism was different from the thermal sleeve flange wear discussed in NSAL-18-1 and TB-07-2, Revision 3 [3]. The fracture occurred beneath the “collar” (illustrated in Figure 2) which is present on a subset of thermal sleeves supplied by Westinghouse (The affected plant was operating with its original reactor vessel closure head [RVCH] and CRDM thermal sleeves.)

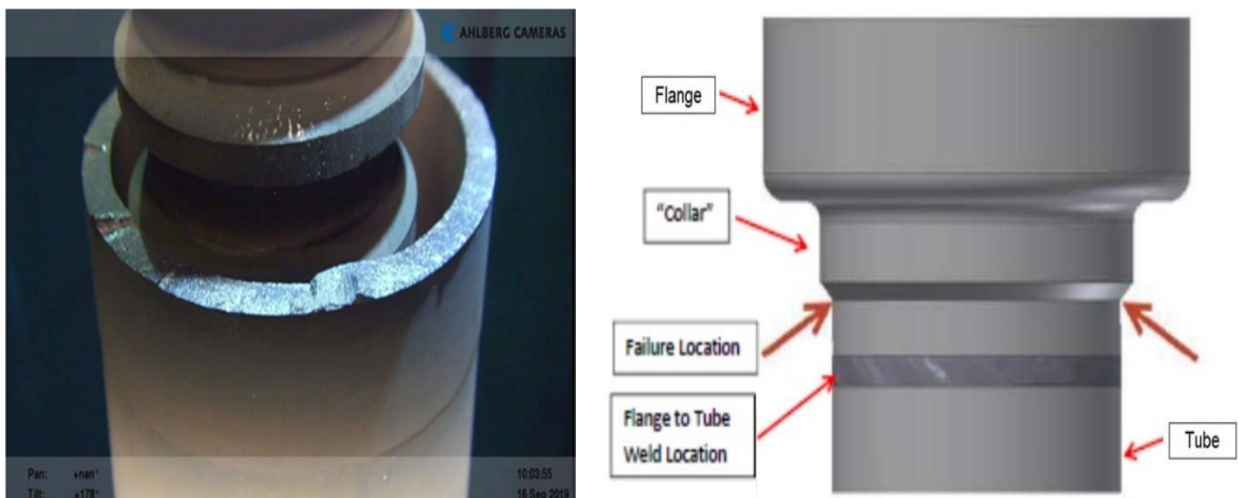
Figure 2 Thermal Sleeve Flange Failure Location

New operating experience (OE) has shown that Westinghouse nuclear steam supply system (NSSS) plants that operate in a T-cold configuration and have control rod drive mechanism (CRDM) thermal sleeves with a collar below the flange (Figure 2), are potentially susceptible to cracking and separation of the flange from the sleeve. This separated condition, when combined with the type of flange wear discussed in NSAL-18-1 [1], can potentially impede control rod movement and RCCA insertability. To date, two plants at the same site identified crack-like indications. One plant experienced complete flange separation at one location; however, the separation did not impede control rod motion.

In response to this OE, the affected utility performed a causal analysis with support from Westinghouse. Based on metallurgical examination of the separated sleeve, the analysis concluded that the most likely cause of failure was fatigue crack propagation. The analysis identified the transition between the collar and the tubular section on the outer diameter of the thermal sleeve to be a potential contributor, due to the stress concentration resulting from the tube wall thickness transition and potentially sharp transition radius in this location; however, this was not substantiated through the identification of a crack initiation site. Thermal sleeve designs without the collar have a large controlled transition radius between the tubular section and the flange. This transition results in a much lower stress concentration, which is less susceptible to this failure mechanism. Therefore, plants operating with thermal sleeve designs without a collar below the flange are not included in Table 1.
