Report No. 10CFR21-0114

**10CFR21 REPORTING OF DEFECTS
AND NON-COMPLIANCE**

COMPONENT: Subcover assembly P/N 1A-7846 and machined subcover P/N 03-362-04-AH

SYSTEM: Emergency Diesel Generator

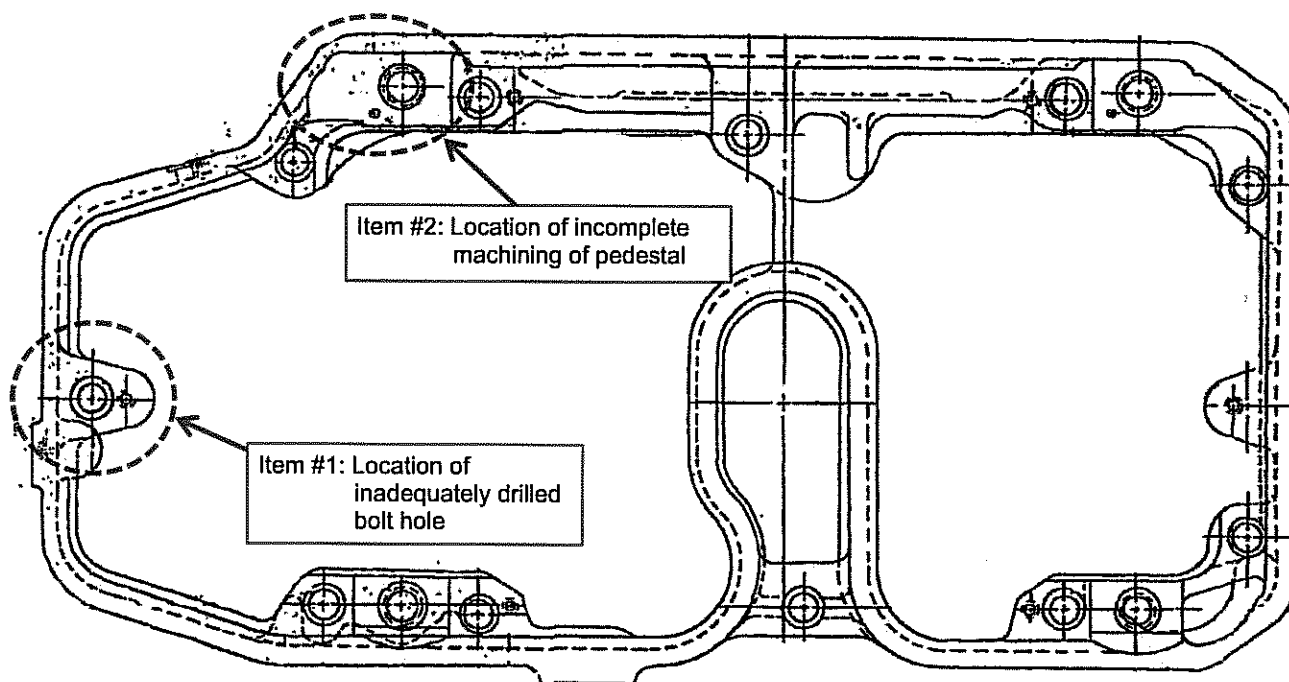
Figure 1: Outline Drawing of Subcover

Engine Systems Inc. (ESI) began a 10CFR21 evaluation on November 18, 2016 upon notification of an issue with a subcover assembly at Perry Nuclear Plant. Attempts to install the subcover on their Enterprise diesel engine revealed two issues that prevented successful installation. First, one of the bolt holes was not fully machined through the entire depth of the subcover. Though the bolt could be inserted into the top of its corresponding hole, it would not pass completely through. The second issue was an interference between the rocker arm shaft and its mating pedestal. It was found that incomplete machining of the pedestal prevented the shaft from sitting flat on the pedestal.

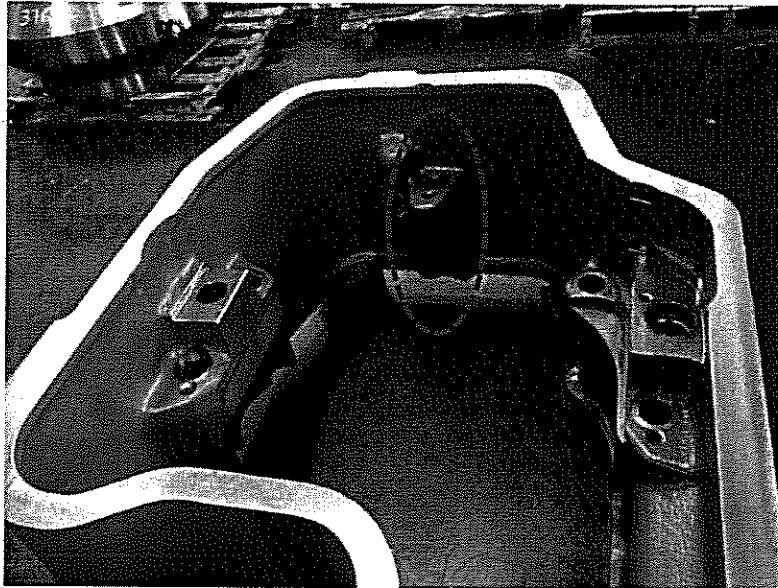
Photo 1: Visual Depiction of Inadequately Drilled Bolt Hole

The issue regarding the inadequately drilled bolt hole would be detected during installation since it would prevent the bolt from passing through the hole. Therefore, it is determined this issue would have no impact on operability since the cover could not be installed with an incompletely drilled bolt hole.

- a) Inspect for the bolt hole (item #1). If rework is necessary, drill through to a diameter of 13/16".
- b) For the incomplete machining of the rocker arm pedestal (item #2), first remove the installed dowel which has 0.000" to 0.001" clearance. Then machine a 2" radius relief at the affected area. All other dimensions such as pedestal height shall remain unchanged.

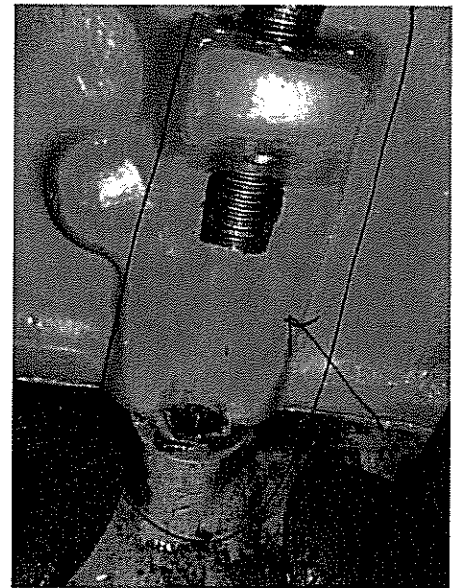
Photo 2: Attempted Bolt Install

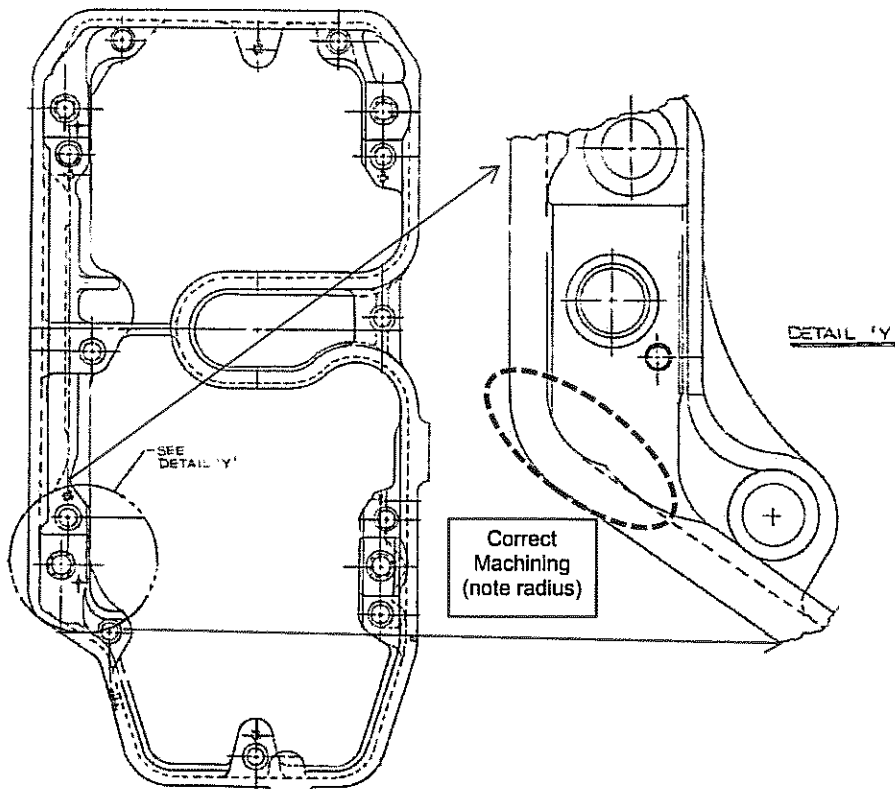
Incorrect Machining (insufficient radius)

Photo 3: Actual Machining

With regard to the incompletely machined pedestal, there is the potential that a customer could install the rocker arm shaft without detecting this issue. In this situation, the shaft will partially fit on the pedestal and the bolt will thread into subcover; however, the shaft will not seat fully on the pedestal. This prevents full contact with the pedestal and inhibits adequate preload throughout the bolted joint. If a customer were to install the rocker arm shaft (with mating rocker arms, pushrods, etc) onto the engine without realizing this issue, operability and durability of the engine would be compromised. This could present a substantial safety hazard.
