**Technical Letter Report  
TLR-RES/DE/CIB-2021-06**

**Technical Assistance to Review American Society of  
Mechanical Engineer's Boiler and Pressure Vessel Code  
Case and Licensee Relief Requests for Carbon Fiber Repairs  
Task-3: Mockup Testing and Physical Evaluation of Proposed  
Carbon Fiber Reinforced Polymer Repair  
Technical Letter Report**

Engineering Mechanics Corporation of Columbus (Emc<sup>2</sup>)  
3518 Riverside Drive - Suite 202  
Columbus, OH 43221-1735

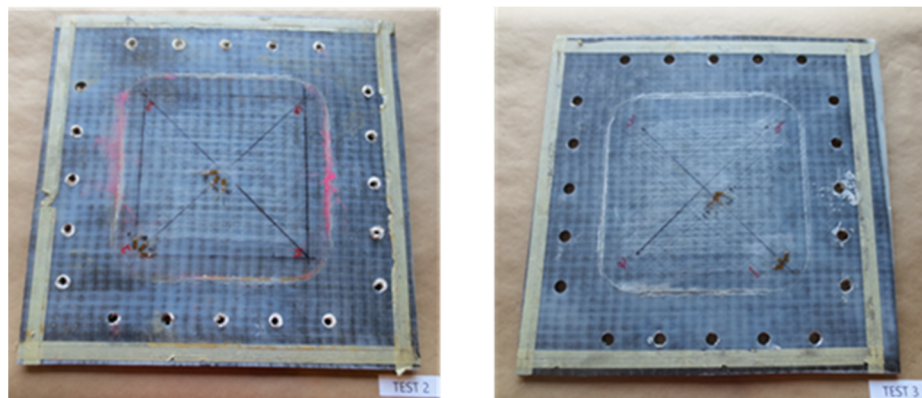
Table 9 shows the watertightness test results where the maximum pressure for Test-2 and Test-3 were 460 psi and 550 psi respectively. In both tests, the watertightness pressure was significantly higher than the minimum requirement of twice the design pressure ( $2 \times 84 \text{ psi} = 168 \text{ psi}$ ). However, the onset of leak for Test-2 was through the sealant while the failure mode for Test-3 was a leak through the CFRP system. However, both test specimens showed “river-like” matrix cracking on the Cut-out region as shown in Figure 12. In that regard, Test-3 represents the watertightness pressure more appropriately which showed higher watertightness pressure than Test-2. A summary video of Test-3 watertightness test is also attached with the report. As discussed later, the failure mode for Test-3 was very similar to the failure mode observed in the full-scale hydrostatic test.

**Figure 12 The watertightness test panels showing matrix cracking after test**

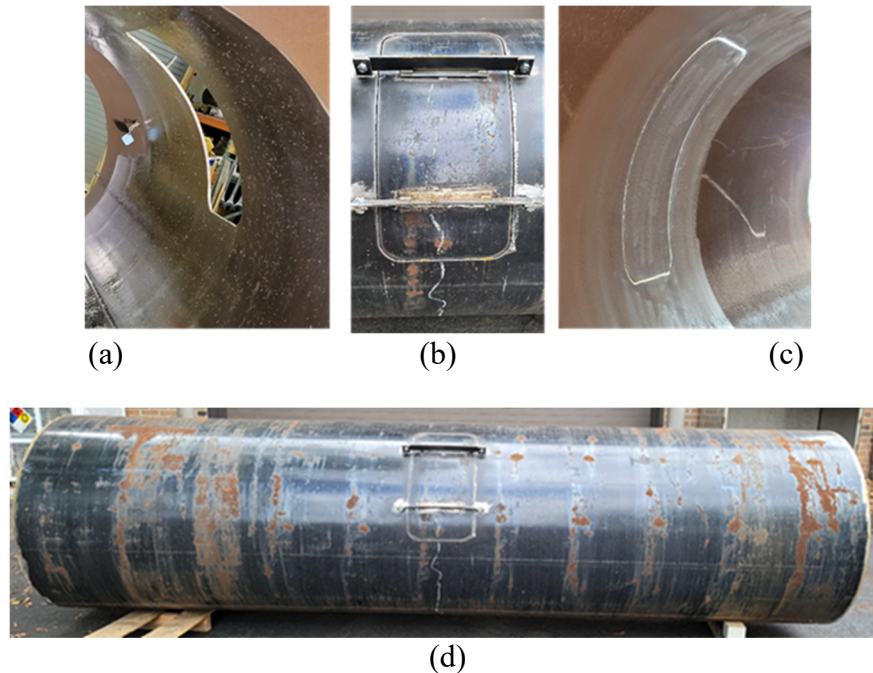
**Figure 18 The test pipe with 12" × 24" cut-out before CFRP installation**

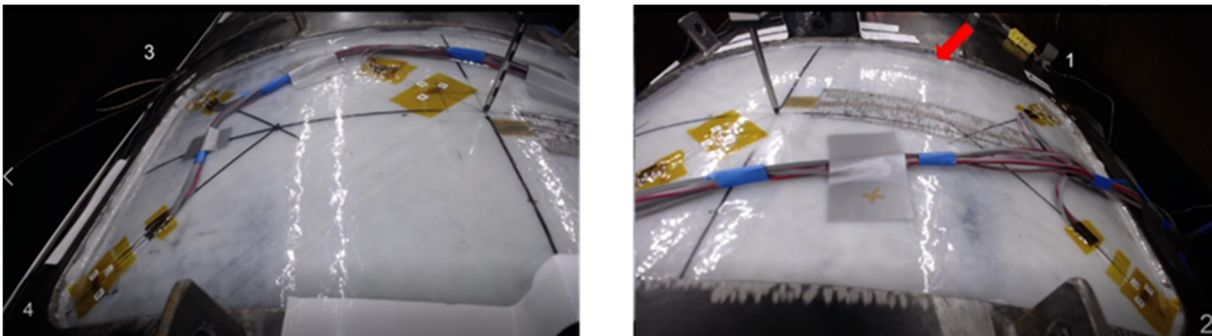
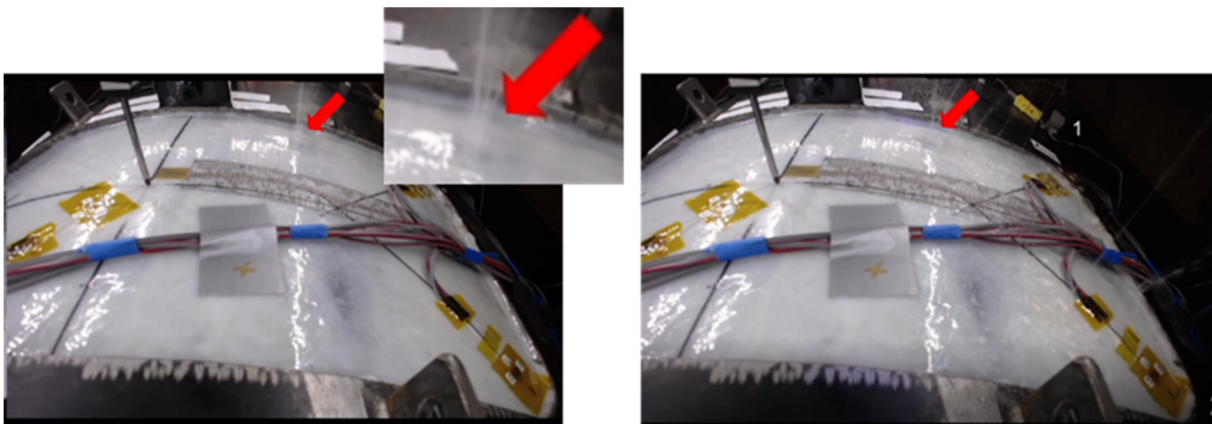
Figure 29 shows the pressure versus time plot for the full-scale hydrostatic test which took about four hours to complete. As seen in the figure, the onset of initial leak started at 600 psi after about 168 minutes. At initial failure, a low energy water leak occurred through a small pinhole near the edge of the cut-out between Corner 1 and 4 as shown in Figure 30 (a). After initial leak, the pressure was held at 600 psi (leak pressure) for another 40 minutes when a significant cracking noise in the matrix was heard followed by the observation of several pinhole type leaks in the area between Corner 1 and 2 as shown in Figure 30 (b). At this stage, the pressure started to drop and at around 580 psi, the release valve was opened to quickly drain the water to preserve the failure modes in the CFRP for post-test analysis. This failure was designated as final leakage failure. The failure mode for the full-scale hydrostatic test with CFRP repair was designated as a “leak” preceded by significant matrix cracking noise, and the failure (leak) pressure for this test was 600 psi. A summary video of the full-scale hydrostatic test is also attached with the report.

(a) Onset of initial leak

(b) Onset of final leak

Figure 30 Onset of initial and final leak during the hydrostatic test

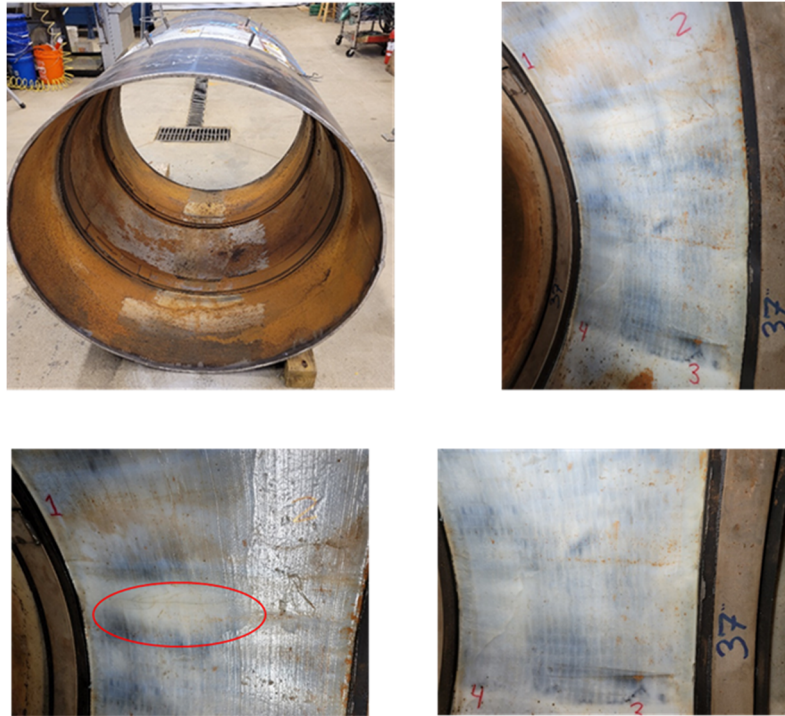
**Figure 34 River-like matrix cracking on CFRP system inside the pipe after hydrostatic test**
