Subject: NSAL-20-1 Revision 1, "Reactor Vessel Head Control Rod Drive Mechanism Penetration Thermal Sleeve Cross-Sectional Failure"

Nuclear Safety

Advisory Letter

Subject: Reactor Vessel Head Control Rod Drive Mechanism Penetration Thermal Sleeve Cross-Sectional Failure	Number: NSAL-20-1 Revision 1
Basic Component: Thermal Sleeve in CRDM Reactor Head Penetration	Date: September 23, 2021
Substantial Safety Hazard or Failure to Comply Pursuant to 10 CFR 21.21(a)	Yes <input type="checkbox"/> No <input checked="" type="checkbox"/> N/A <input type="checkbox"/>
Transfer of Information Pursuant to 10 CFR 21.21(b)	Yes <input type="checkbox"/>
Advisory Information Pursuant to 10 CFR 21.21(d)(2)	Yes <input type="checkbox"/>

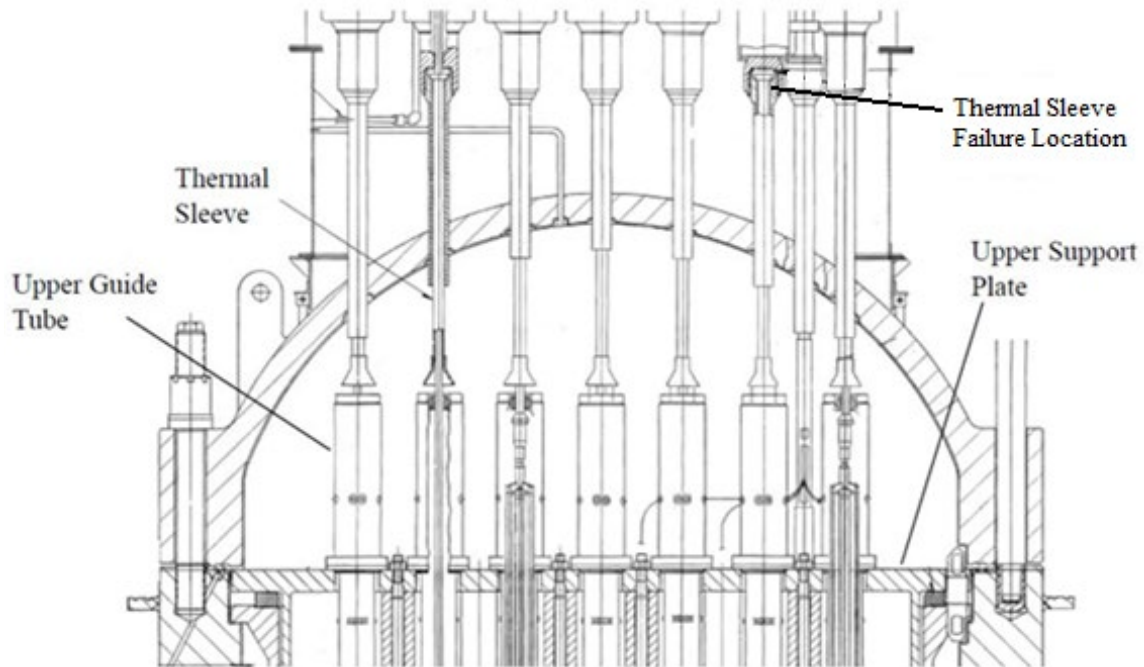
Figure 1 Thermal Sleeve Location in the RVCH

During a planned 2019 refueling outage at a Westinghouse NSSS plant, a thermal sleeve (Figure 1) was observed to be fractured and resting upon an upper internals upper guide tube (UGT). The OE showed that a mechanical failure of the thermal sleeve had occurred across its cross-section. The failure mechanism was different from the thermal sleeve flange wear discussed in NSAL-18-1 and TB-07-2, Revision 3 [3]. The fracture occurred beneath the “collar” (illustrated in Figure 2) which is present on a subset of thermal sleeves supplied by Westinghouse (The affected plant was operating with its original reactor vessel closure head [RVCH] and CRDM thermal sleeves.)

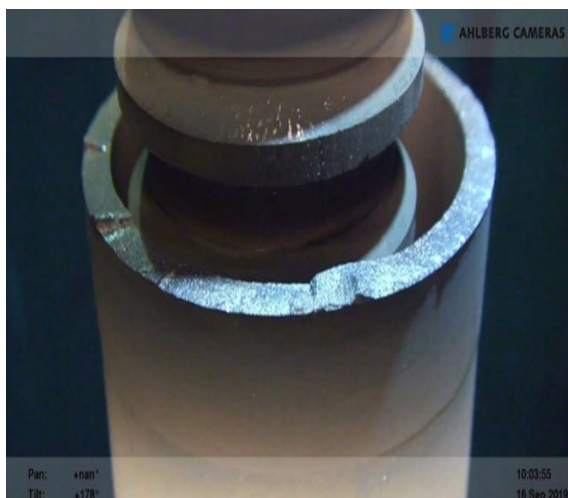
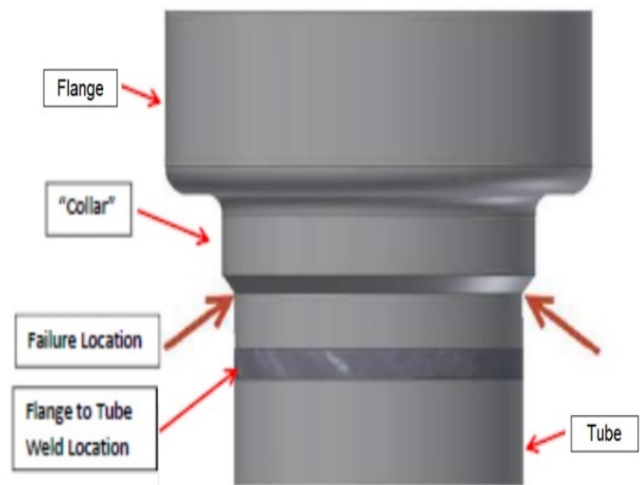
Figure 2 Thermal Sleeve Flange Failure Location

Operating experience (OE) in 2019 showed that Westinghouse nuclear steam supply system (NSSS) plants that operate in a T-cold configuration and have control rod drive mechanism (CRDM) penetration thermal sleeves with a collar below the flange (Figure 2), are susceptible to cracking and separation of the flange from the sleeve. This separated condition, when combined with the type of flange wear discussed in NSAL-18-1 [1], was conservatively assumed to be capable of impeding control rod movement and Rod Cluster Control Assembly (RCCA) insertability. In accordance with 10 CFR Part 21, Westinghouse identified this to be a potential defect and reported it to the U.S. NRC [2] on December 12, 2019.

In response to this OE, the affected utility performed a causal analysis with support from Westinghouse. Based on metallurgical examination of the separated sleeve, the analysis concluded that the most likely cause of failure was fatigue crack propagation. The analysis identified the transition between the collar and the tubular section on the outer diameter of the thermal sleeve to be a potential contributor, due to the stress concentration resulting from the tube wall thickness transition and potentially sharp transition radius in this location; however, this was not substantiated through the identification of a crack initiation site. These results were later corroborated through an industry-backed examination of the fractured part. This examination identified multiple initiation locations without a clear initiation mechanism.

Thermal sleeve designs without the collar have a large, controlled transition radius between the tubular section and the flange. This transition results in a much lower stress concentration, which is less susceptible to this failure mechanism. Therefore, plants operating with thermal sleeve designs without a collar below the flange are not included in Table 1.

The recommendations from Revision 0 of this NSAL were focused on minimizing the risk to nuclear safety. Based on new information documented in PWROG-21010-P, the NSAL recommendations have been re-focused. The recommendation is that affected plants address CRDM thermal sleeve separation at the flange collar as an asset management issue.

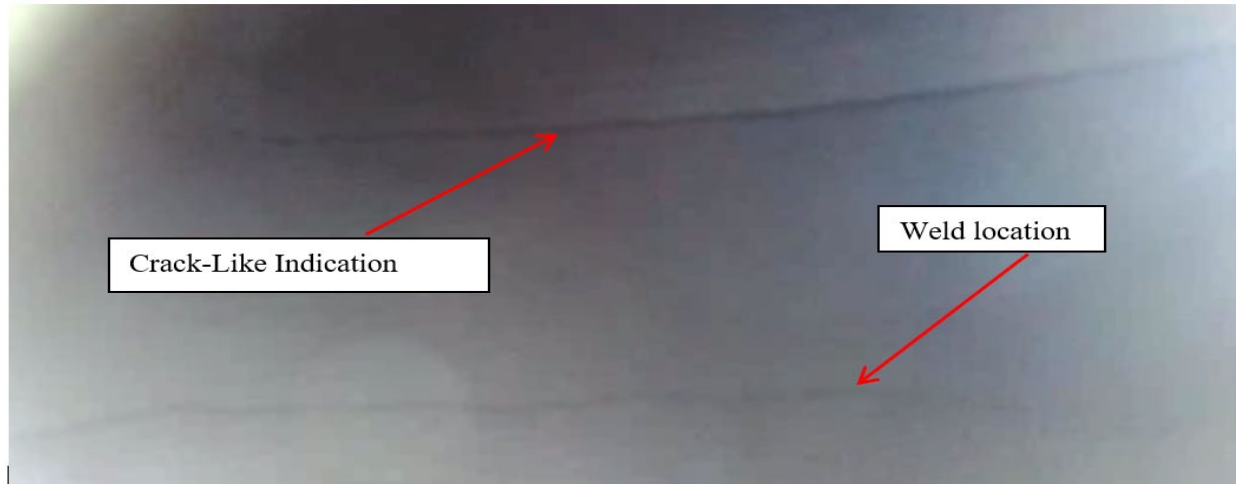
Figure 3 Crack-Like Indication Identified by Visual Inspection

The utility performed extent of condition inspections on the remaining thermal sleeves at the affected plant as well as on a second plant at the same site. Both plants have the same thermal sleeve design. The inspections were performed via visual examination of the inner surface of the thermal sleeve. A total of thirteen thermal sleeve locations (twelve at the first unit and one at the second) had visible crack-like indications, as shown in Figure 3. No additional locations had failed. The locations of the affected sleeves were distributed throughout the RVCH, with a higher concentration of cracked sleeves toward the center of the head. Crack-like indications of varying lengths were identified with no correlation to the amount of flange wear experienced. The affected utility did not identify any issues associated with drive rod movement during operation prior to identifying the failure.

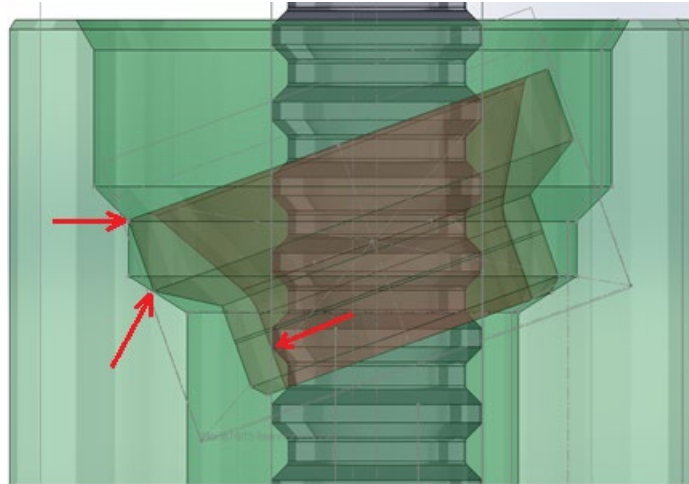
Figure 4 Potential Flange Wedging Scenario

In certain conditions in which the CRDM housing is worn (as discussed in NSAL-18-1) and the thermal sleeve flange is separated from the sleeve, the flange remnant can move from its normal position and become misoriented at the top of the CRDM housing. Evaluations of this misorientation were conducted in support of Revision 0 of this NSAL and included a simplifying assumption that the drive rod could radially deflect far enough within the thermal sleeve and penetration housing assembly to permit the separated flange remnant to orient itself such that wedging could occur, as depicted in Figure 4.

The simplifying assumption and other geometric constraints were evaluated in PWROG-21010-P to determine the feasibility of this potential wedging scenario. It was determined that applicable forces and geometric constraints would not permit the drive rod to deflect far enough in the radial direction to allow wedging to occur. Moreover, the flange wear lowering criterion (i.e., the 0.80 inch lowering criterion) discussed in Revision 0 of this NSAL is no longer applicable as wedging cannot occur associated with a thermal sleeve that has fractured and separated at the collar, regardless of the amount of flange wear.
