Report No. 10CFR21-0133

**10CFR21 REPORTING OF DEFECTS
AND NON-COMPLIANCE**

COMPONENT: Swing Check Valve, P/N ESI50359

SYSTEM: Emergency Diesel Generator

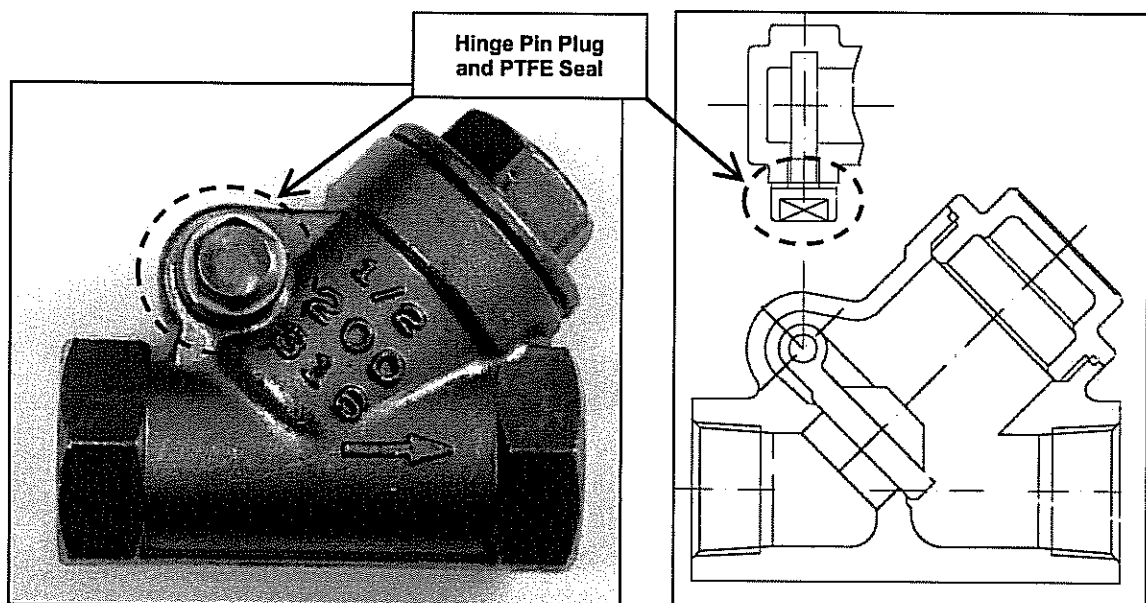
The hinge pin retainer plug used on check valve P/N ESI50359 may exhibit low breakaway torque and thus minimal resistance to loosening when subjected to engine operating vibrations. Consequently, if the plug were to completely dislodge, followed by the associated hinge pin, the pressure boundary of the lube oil system would be compromised and oil would discharge through the 3/16" diameter opening. ESI was notified by a nuclear customer of such an occurrence on a check valve that had been recently installed. Following notification, ESI inspected remaining check valves in inventory and confirmed an issue where the plug exhibited low breakaway torque that could potentially lead to unintended loosening.

Figures 1 & 2: View of Swing Check Valve P/N ESI50359

ESI recommends a rework of the check valve. Remove the hinge pin retainer plug and ensure plug threads and PTFE washer are free from damage or distortion. Apply Loctite 243 sparingly to clean plug threads then re-install the plug and PTFE washer, using caution to minimize seepage of thread locker. Using a 10mm socket, torque the plug to 5 (± 0.5) in-lbs and allow the Loctite to cure.
