Subject: 10CFR21 Reporting of Defects and Non-Compliance -  
Engine Systems, Inc. Report No. 10CFR21-0134, Rev. 0

EMD Cylinder Head with Fireface Thickness Below Specification  
Cylinder Head P/N 40121485

**Report No. 10CFR21-0134**

## 10CFR21 REPORTING OF DEFECTS AND NON-COMPLIANCE

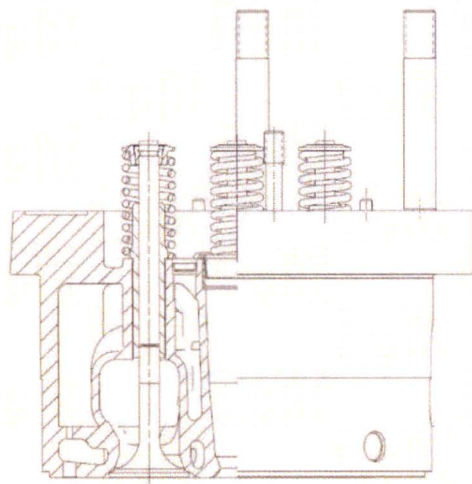
Fireface → **Figure 1: Cylinder Head (side view)**

*A fatigue crack was discovered in the fireface of an EMD cylinder head installed on an emergency diesel generator set. The crack initiated on the coolant side and propagated through the fireface wall to the combustion side resulting in a water leak. Fatigue failure was likely caused by a reduced fireface thickness which reduced overall rigidity of the fireface, allowing increased deformation and ultimately failure due to high tensile stress at the blend between the fireface and valve seat.*

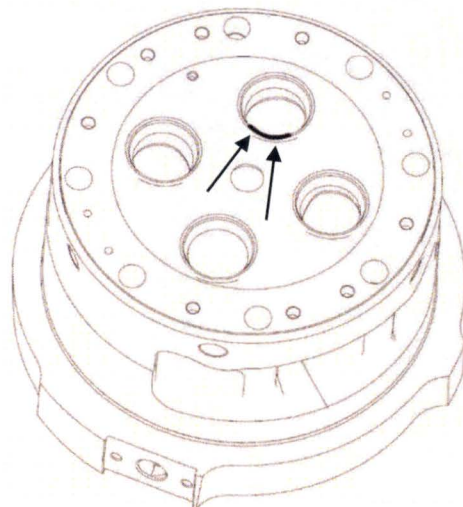
**Figure 2: Location of Crack (transition of fireface to valve seat)**

*ESI recommends an ultrasonic thickness inspection on the fireface to confirm thickness is within specified range. This requires removal of the cylinder head from the power pack assembly to access the fireface. If desired, ESI will assist with an on-site inspection and/or provide equipment to support the inspection. Alternatively, power pack assemblies may be returned to ESI for this activity.*

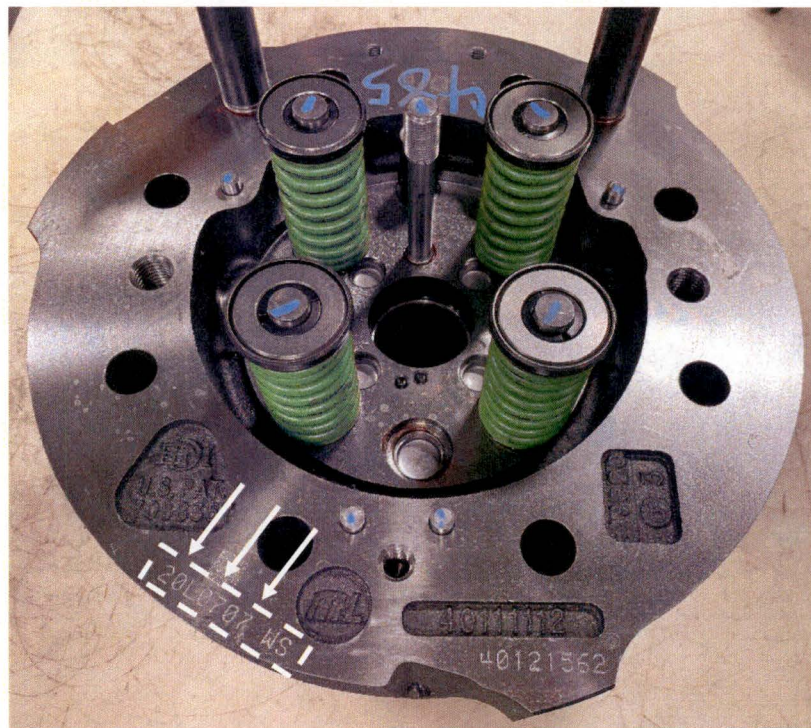
*To ease identification of affected cylinder heads, Photo 1 below shows location of serial number stamping on the head.*

**Photo 1: Location of Serial Number Identification  
(ex. S/N 20L0707)**
