Subject: 10CFR Part 21 Notification for Curtiss-Wright Supplied RCS-Dresser Actuator P/N: SURE-24-10-4

Evaluation Report No. CJ18111.FE
Revision 2

RCS/Dresser Actuator

TVA / Browns Ferry Nuclear Plant

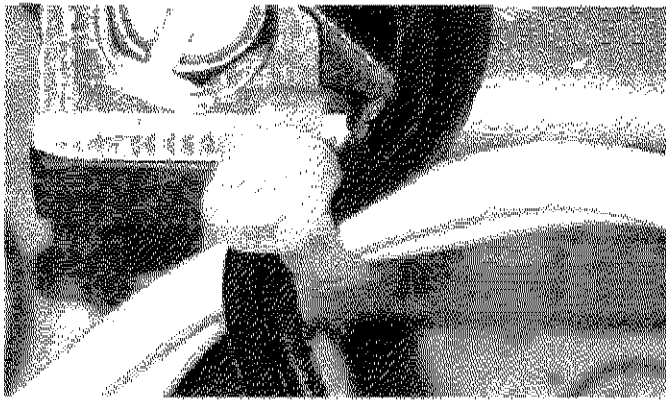
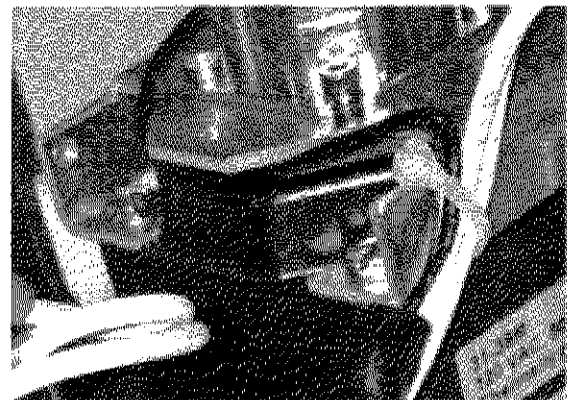
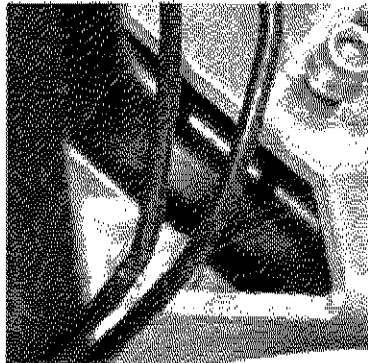
Photos of Tag # CJ1811101: Serial Number 02

Root cause of the failure is friction between wire insulation & the sharp metallic edge that cut through the insulation via vibration which in turn shorted the power leads to the frame. The blown fuse was a secondary failure to the insulation failure in the wire bundle affected.

Method used by the manufacturer to secure the wires leads to damage and operational failure.

Damaged wires from being improperly secured by the manufacturer

The leads must be pathed in such a way as to avoid cut/sheared edges without being able to touch or interfere with moving parts. If such a path is not possible, then the wires will require additional protection such as a fiberglass sleeve or wire mesh sleeve to protect the insulation from abrasion. In reviewing the EGS qualification Reports (see Section 1.0) if the wire path were to be in close proximity or touching a cut/sheared metallic edge there is the potential that vibration over time or a seismic event could cause fraying of the wire insulation, resulting in a short as previously noted. If the wire path is led away from these sharp surfaces there is little to no risk of wire fraying from in service vibration or a seismic event.

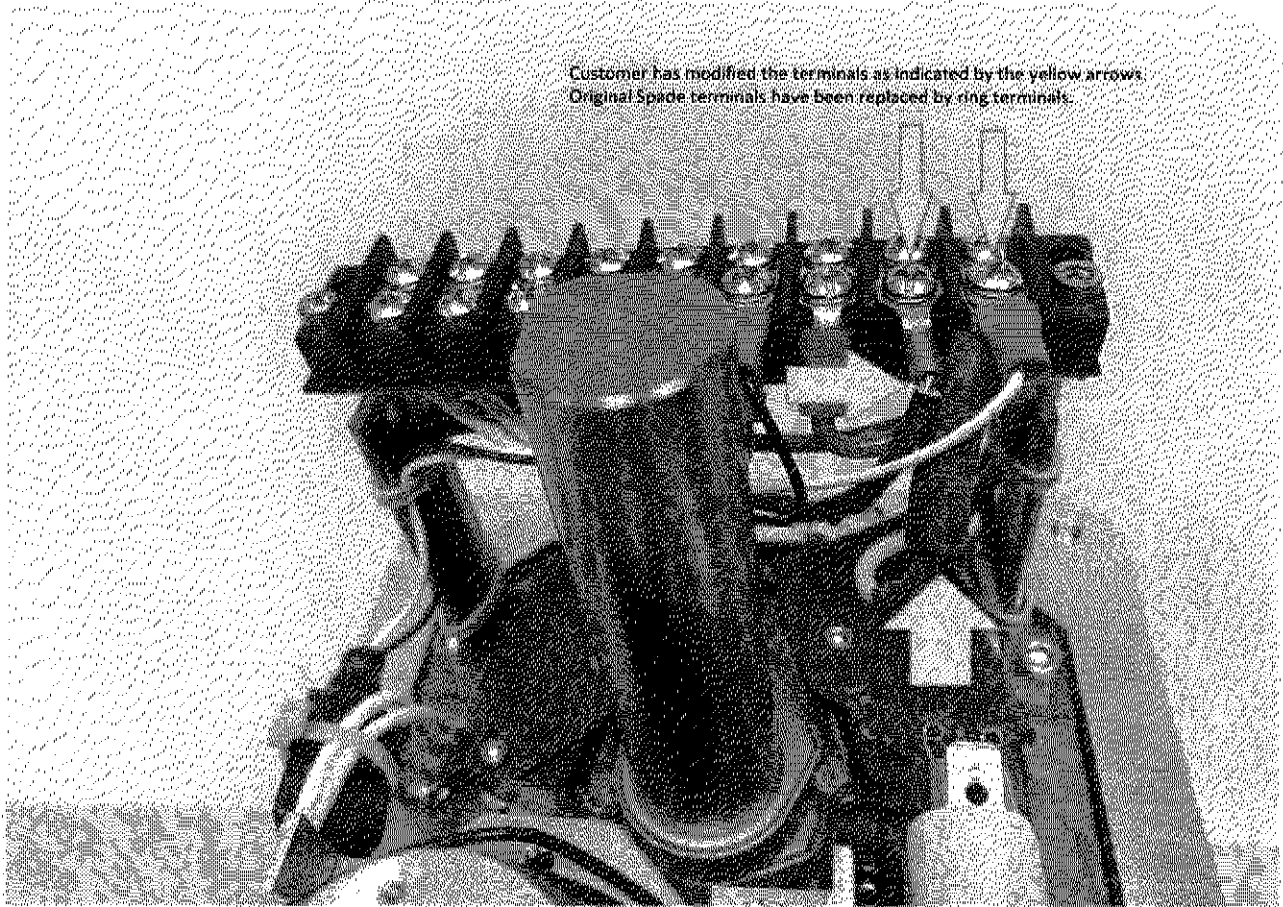
Tag # CJ1811101; Serial Number 02 shown

Customer has modified the terminals as indicated by the yellow arrows.
Original Spade terminals have been replaced by ring terminals.

Customer modification: spade to ring lugs

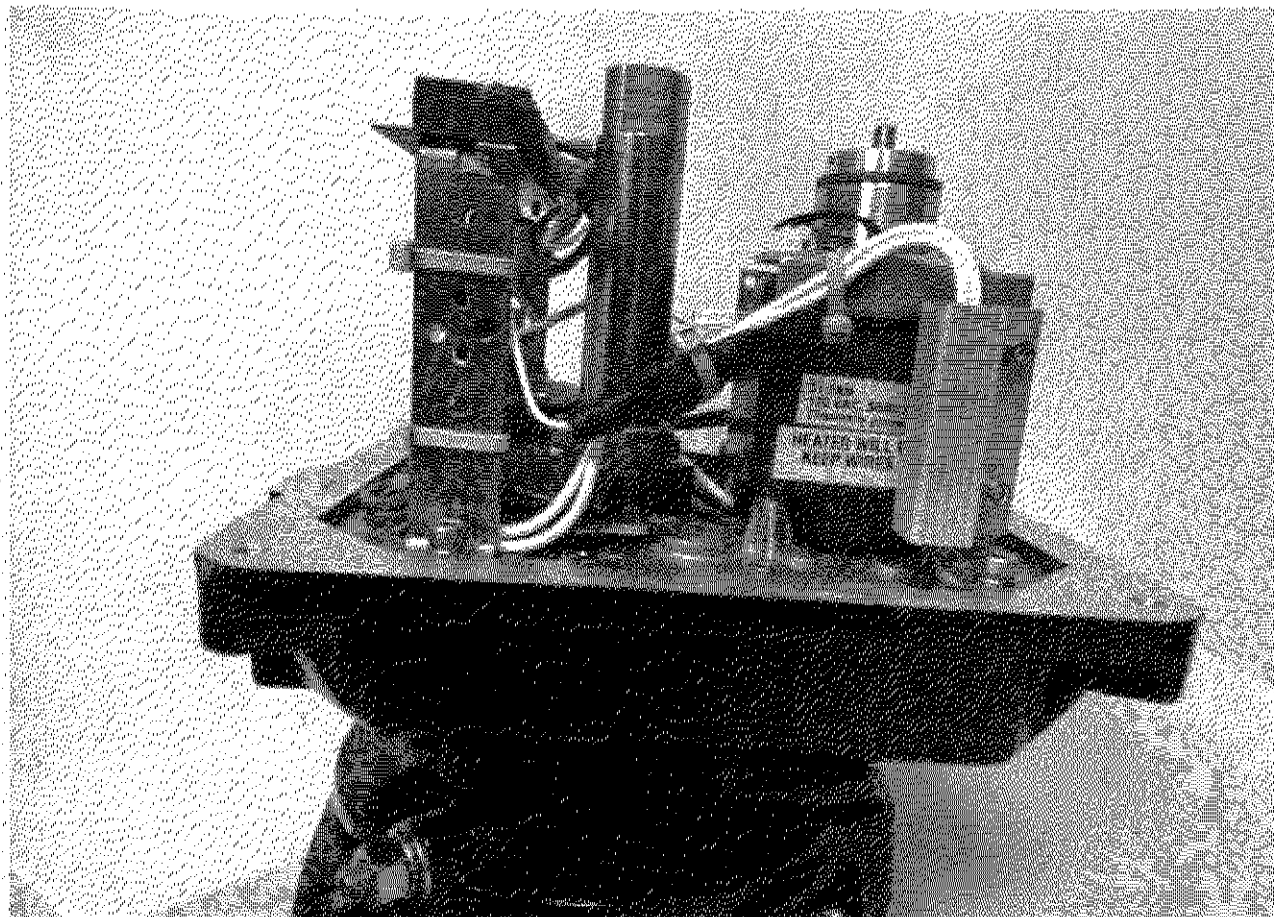
Tag # CJ1811101; Serial Number 02 shown

Similar view to as found condition
