U.S. Nuclear Regulatory Commission
Attn: Document Control Desk
Washington, DC 20555-0001Subject: 10 CFR Part 21 Report – 38878-8 Solenoid Valve at Duke, Catawba
Flowserve Evaluation #105

**Failure Analysis of 38878-8 Solenoid Valve
Duke – Catawba
Serial Number BT443**

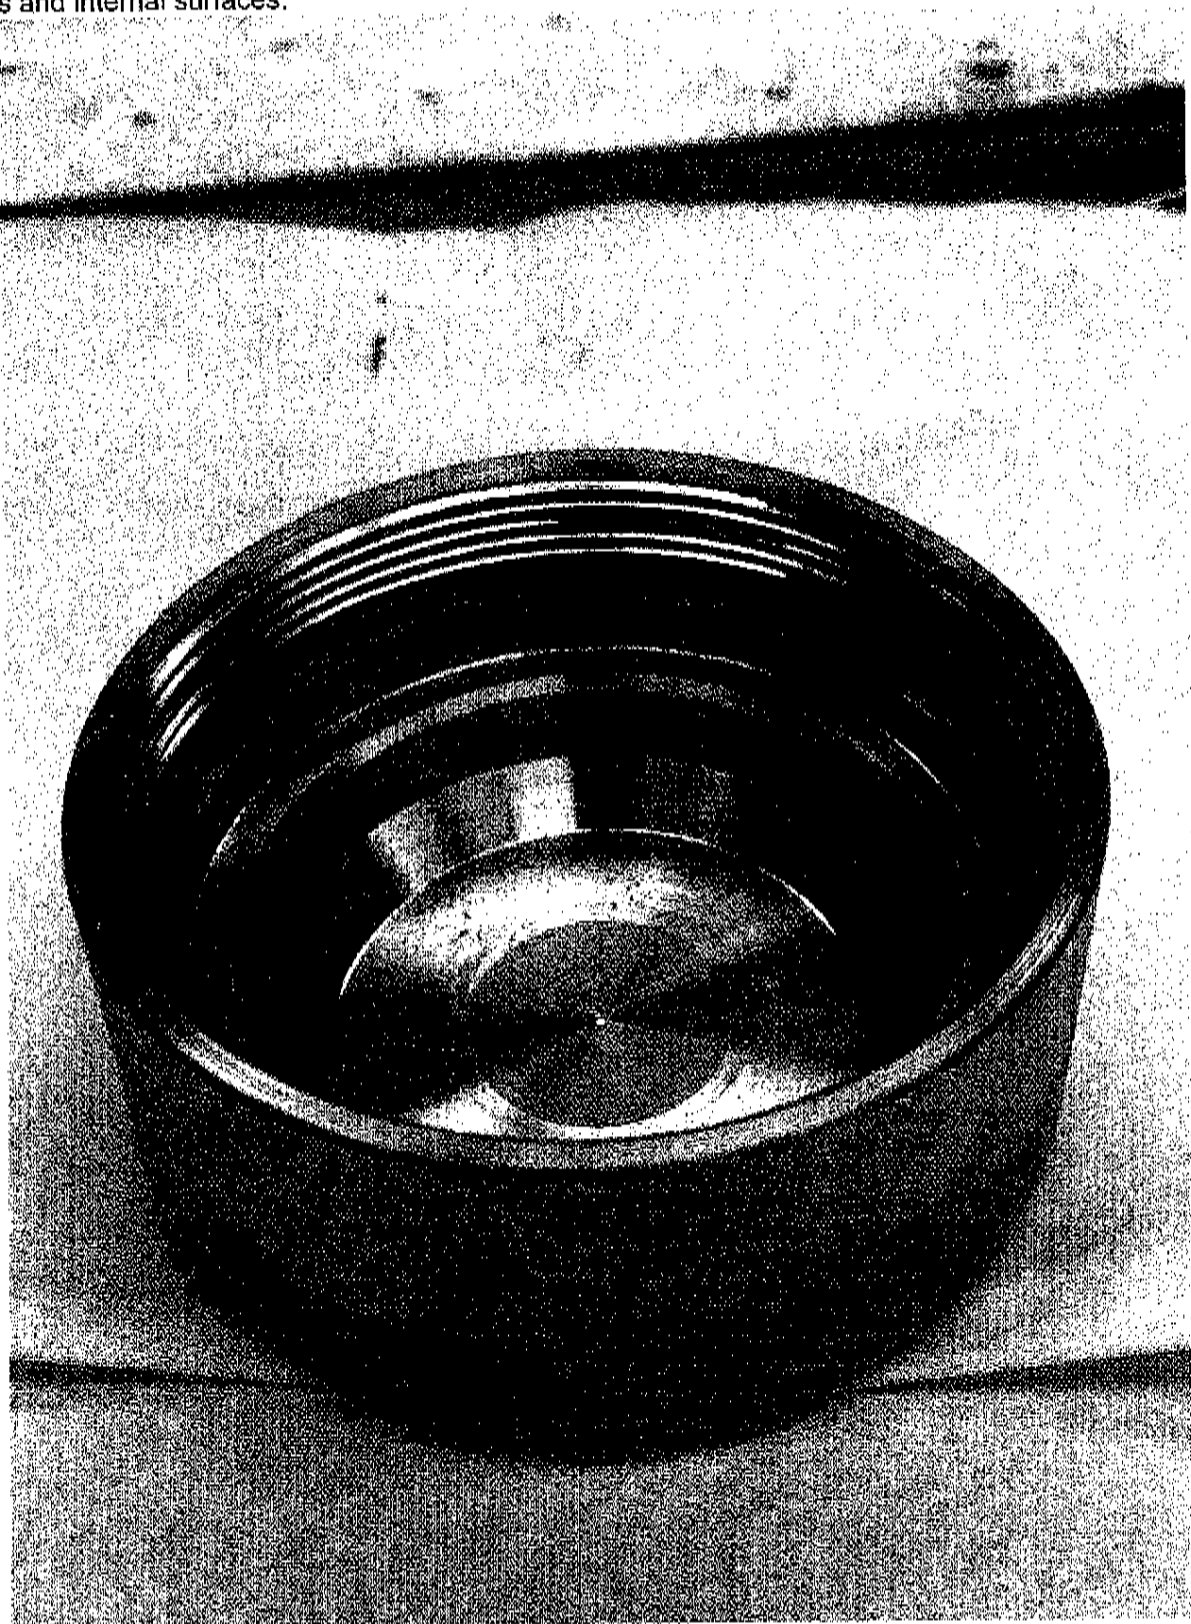
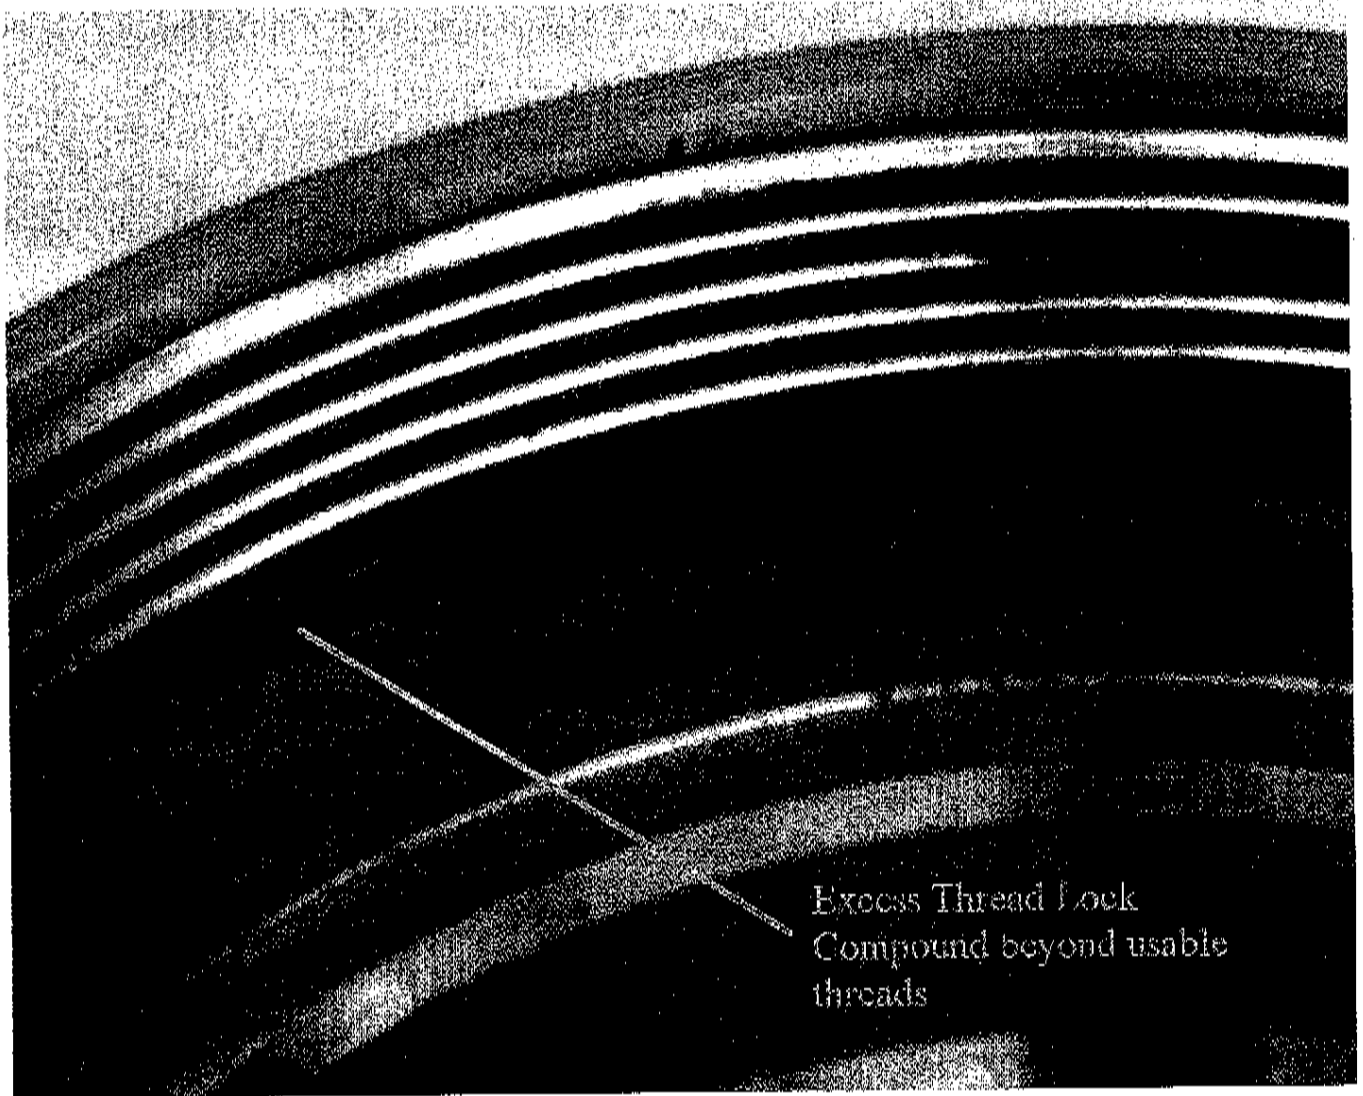
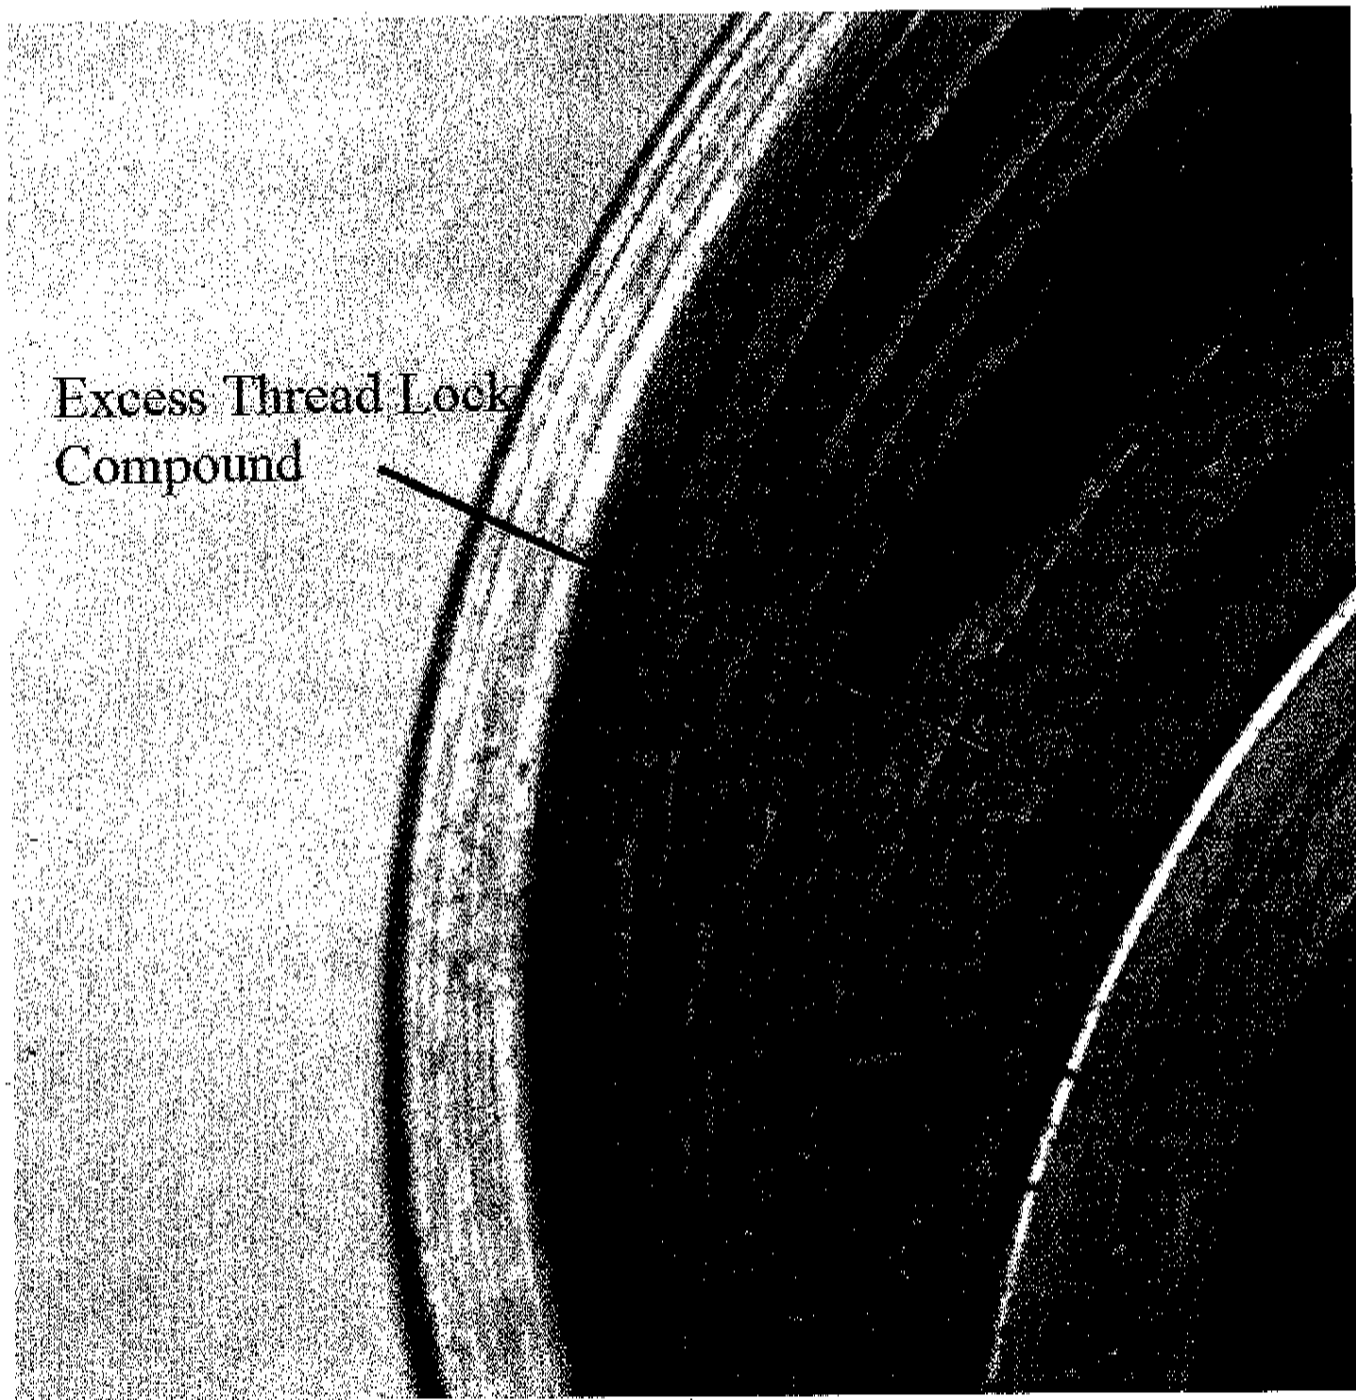
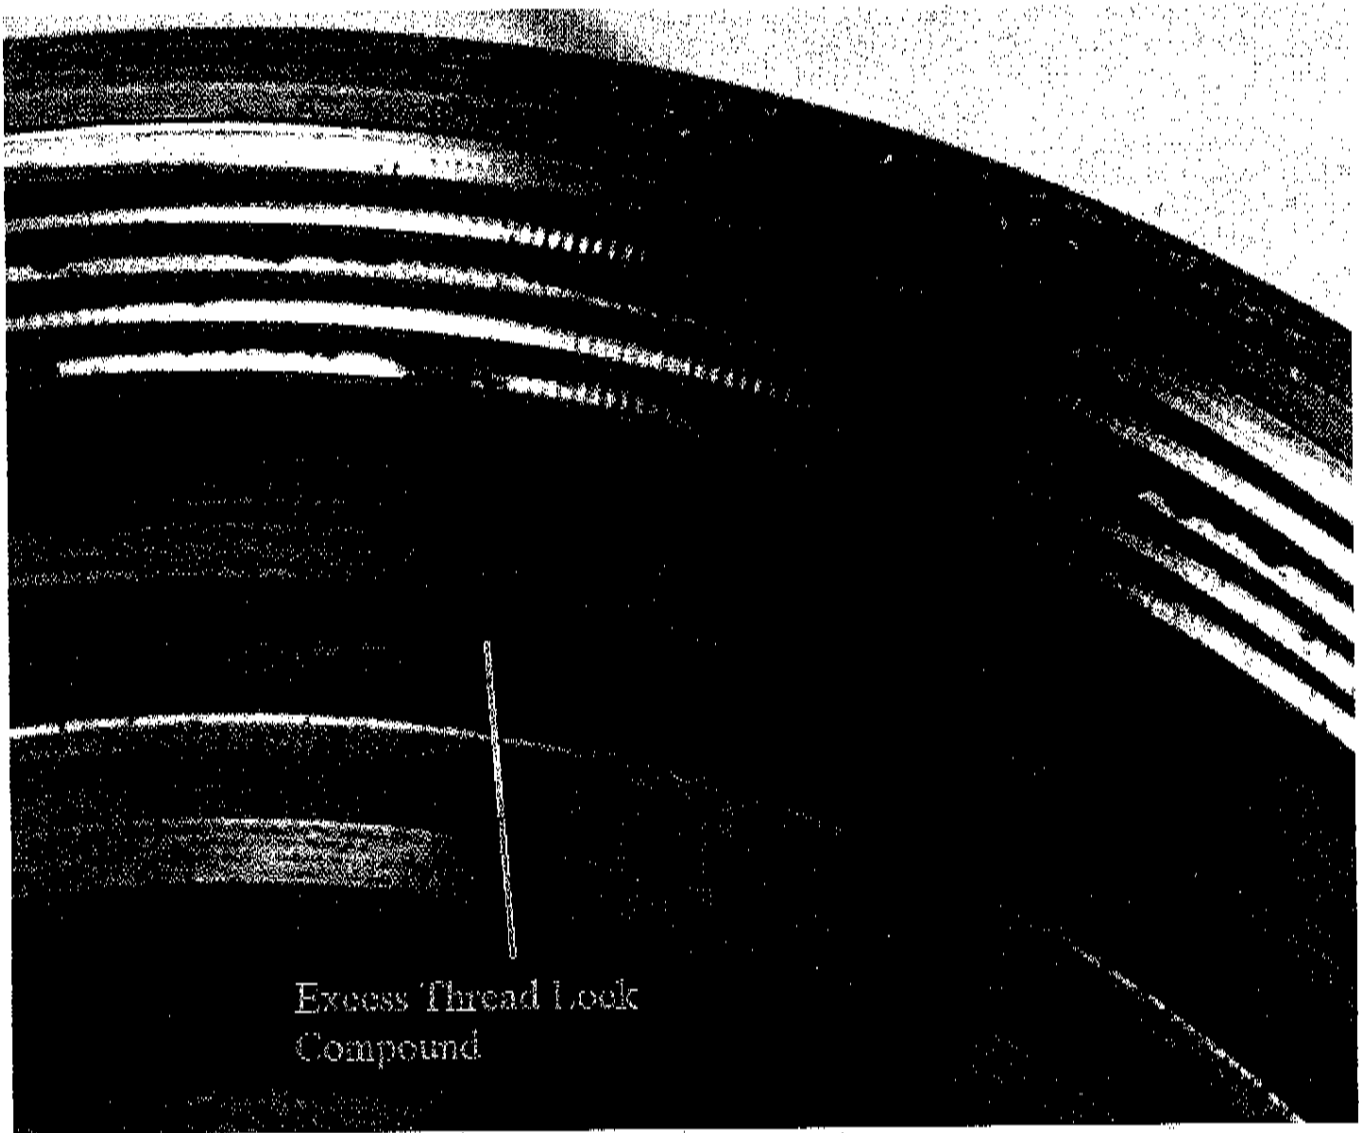
End Cap (6): Visual inspection showed no signs of damage. Excess thread lock compound observed on threads and internal surfaces.

Excess Thread Lock
Compound

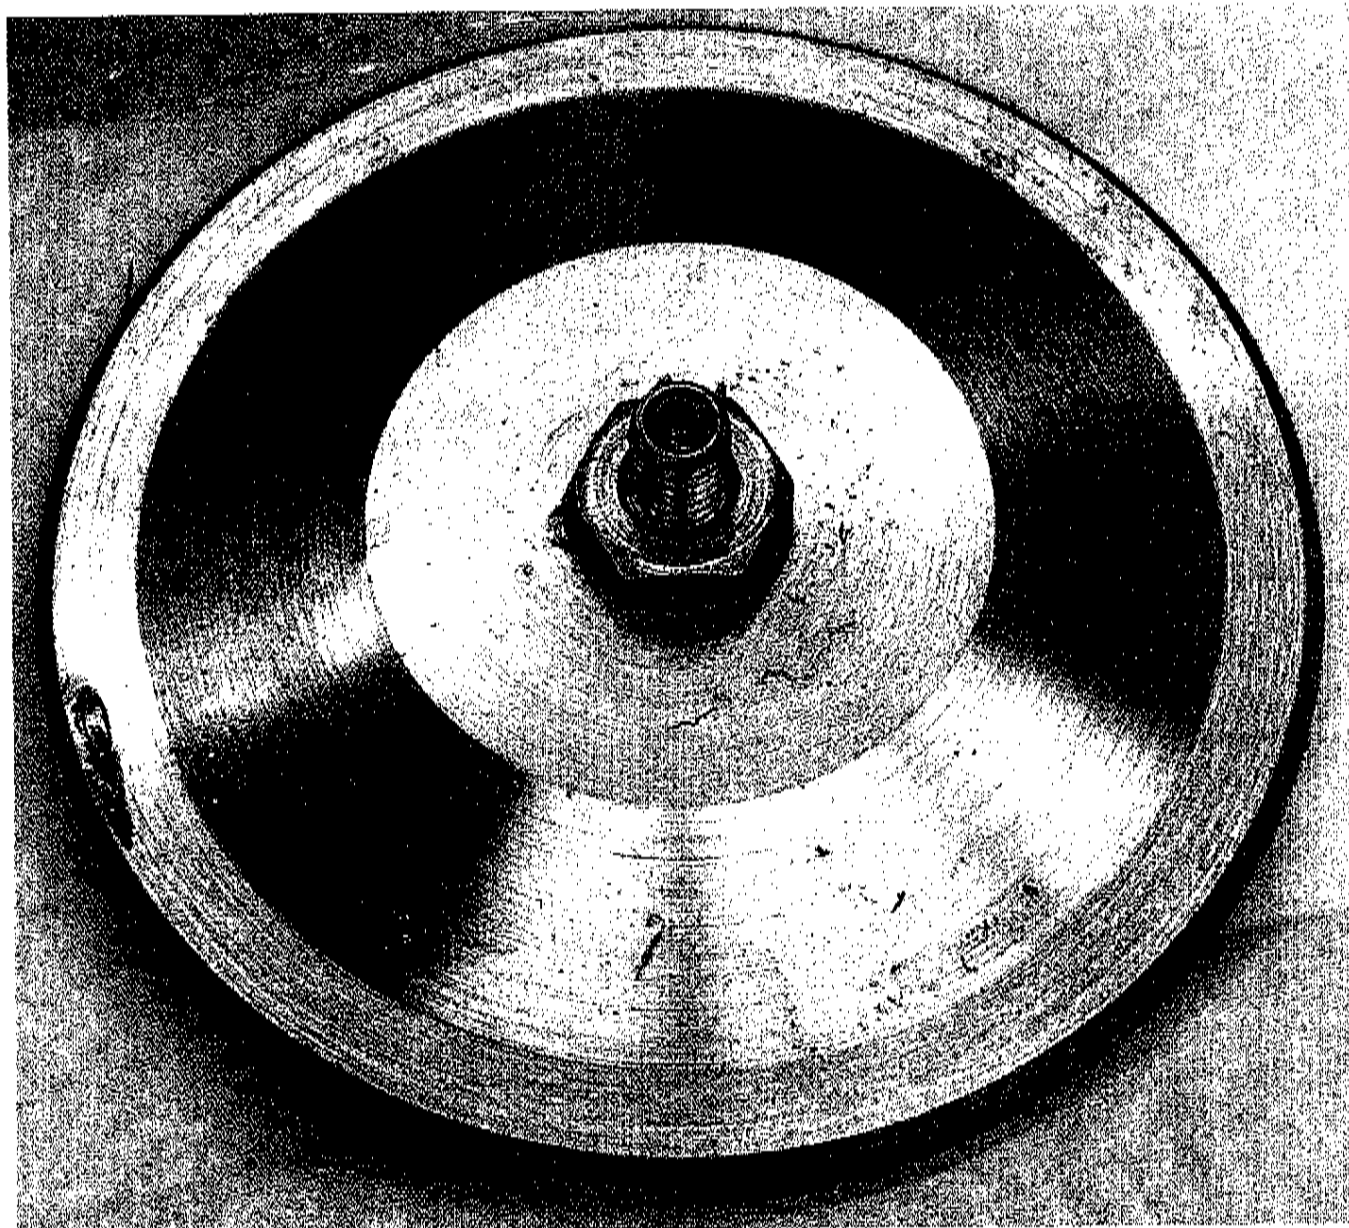
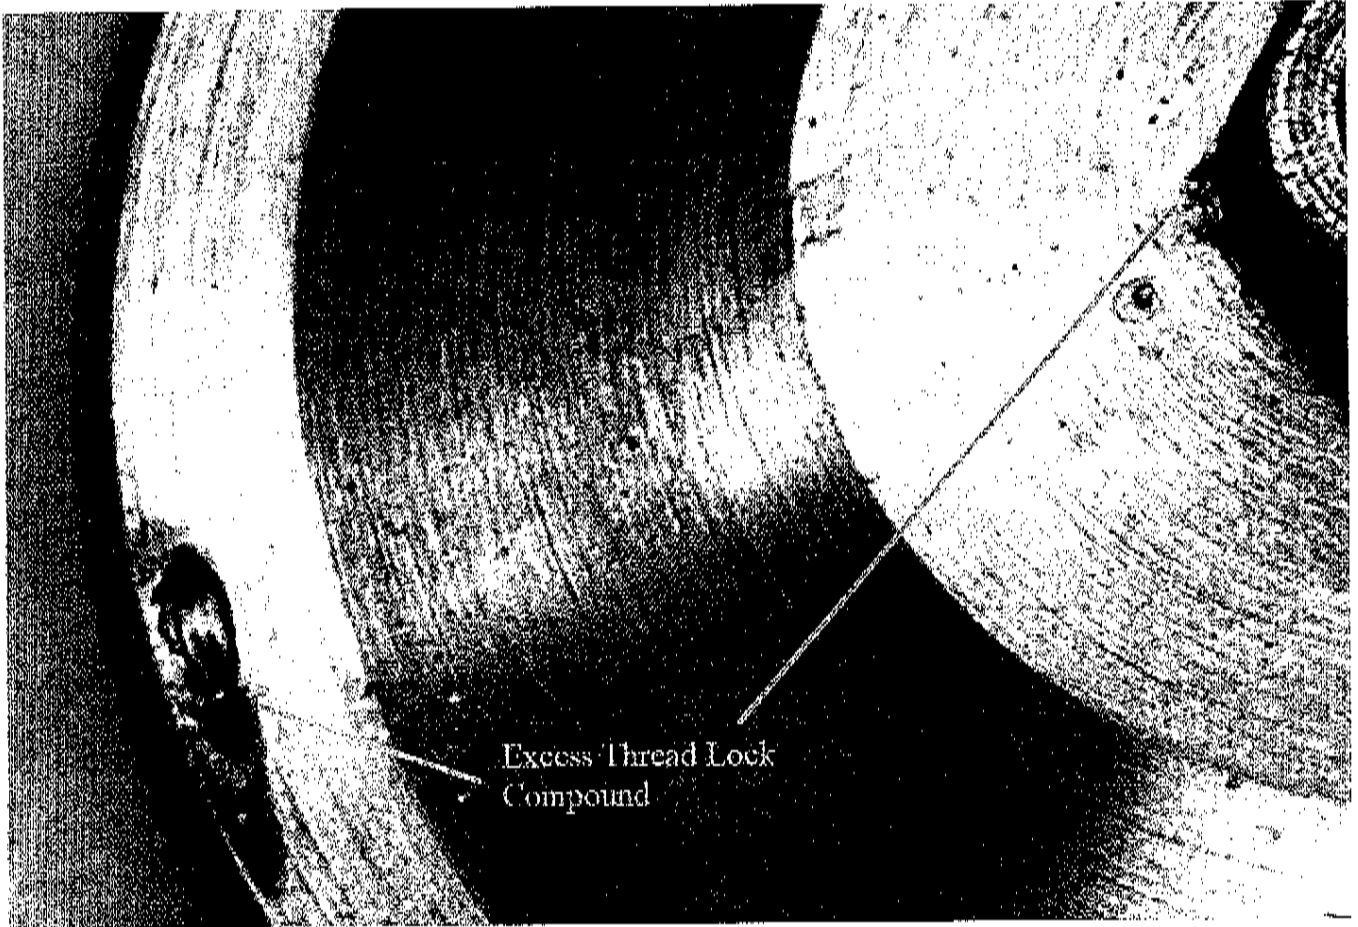
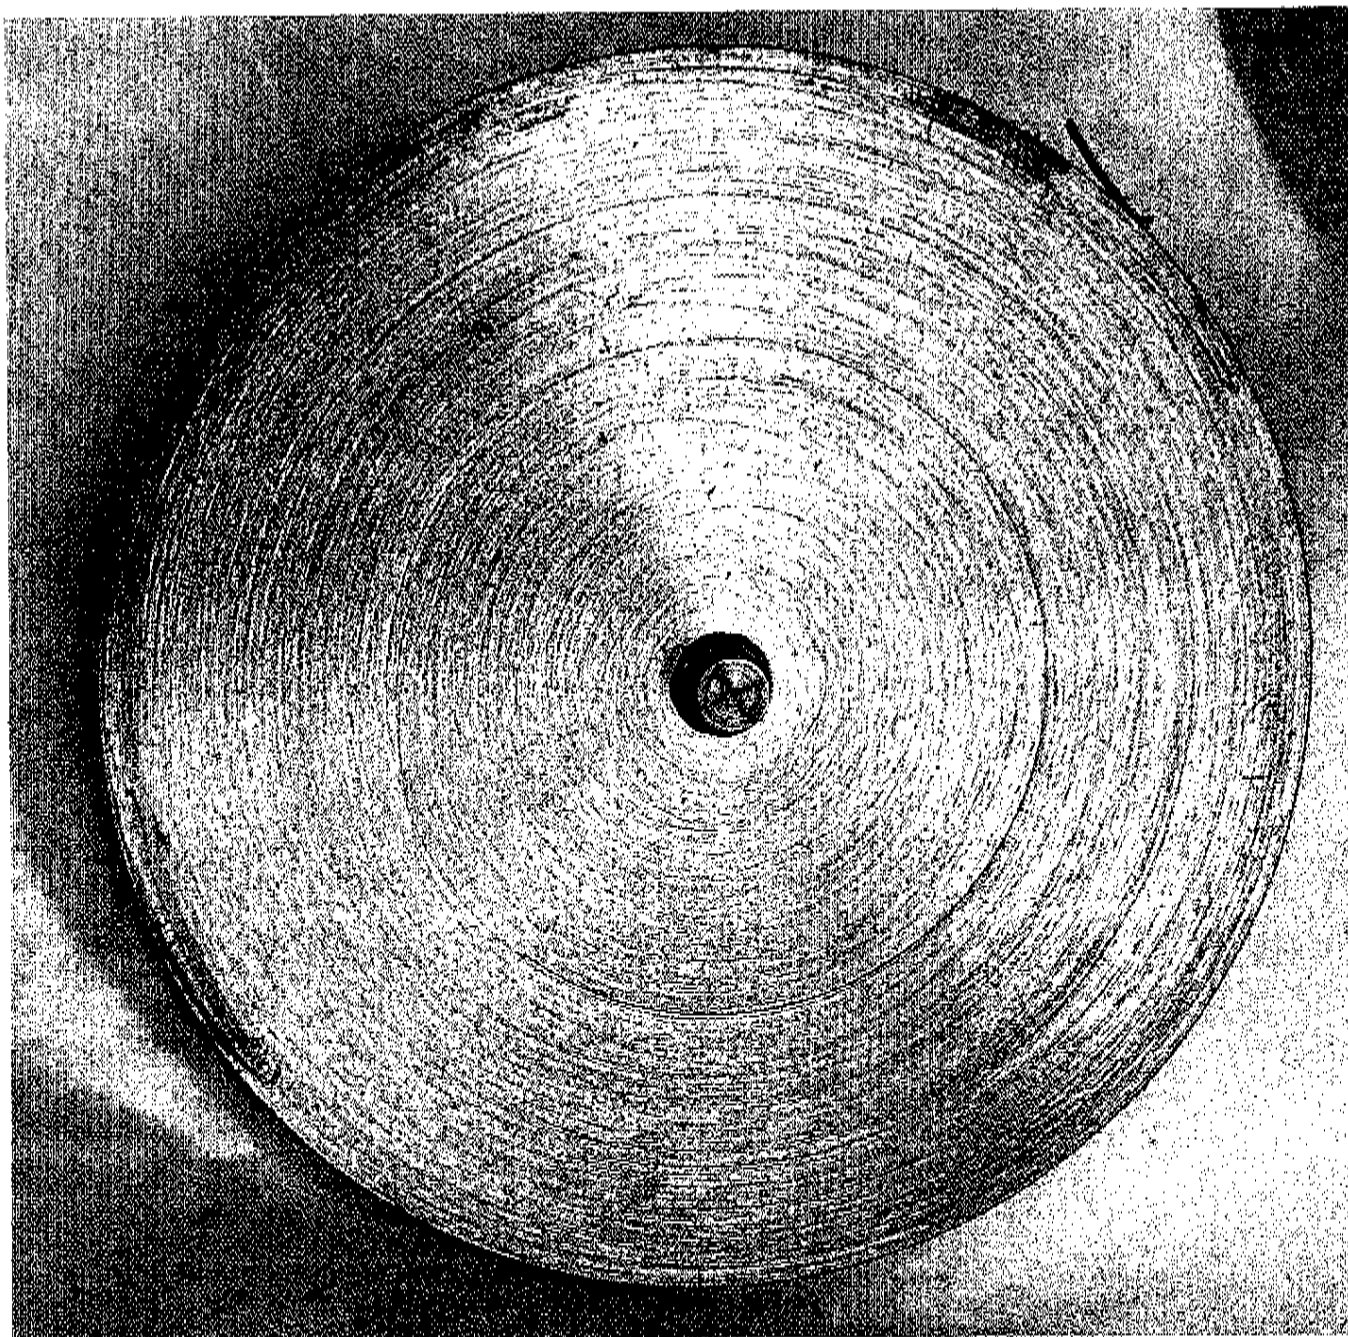
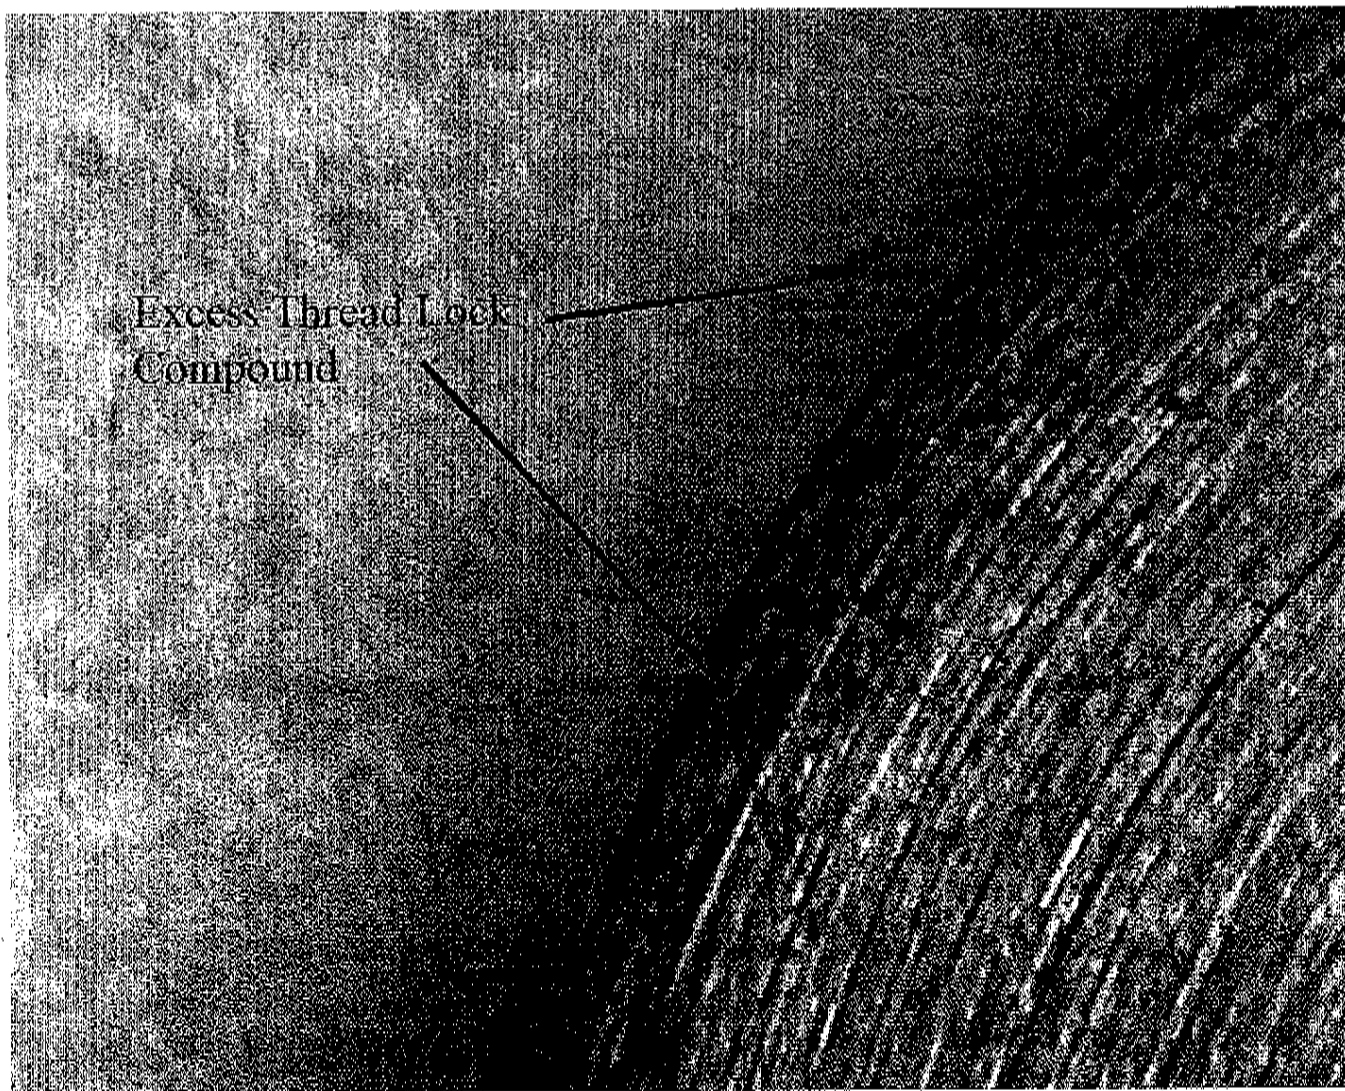
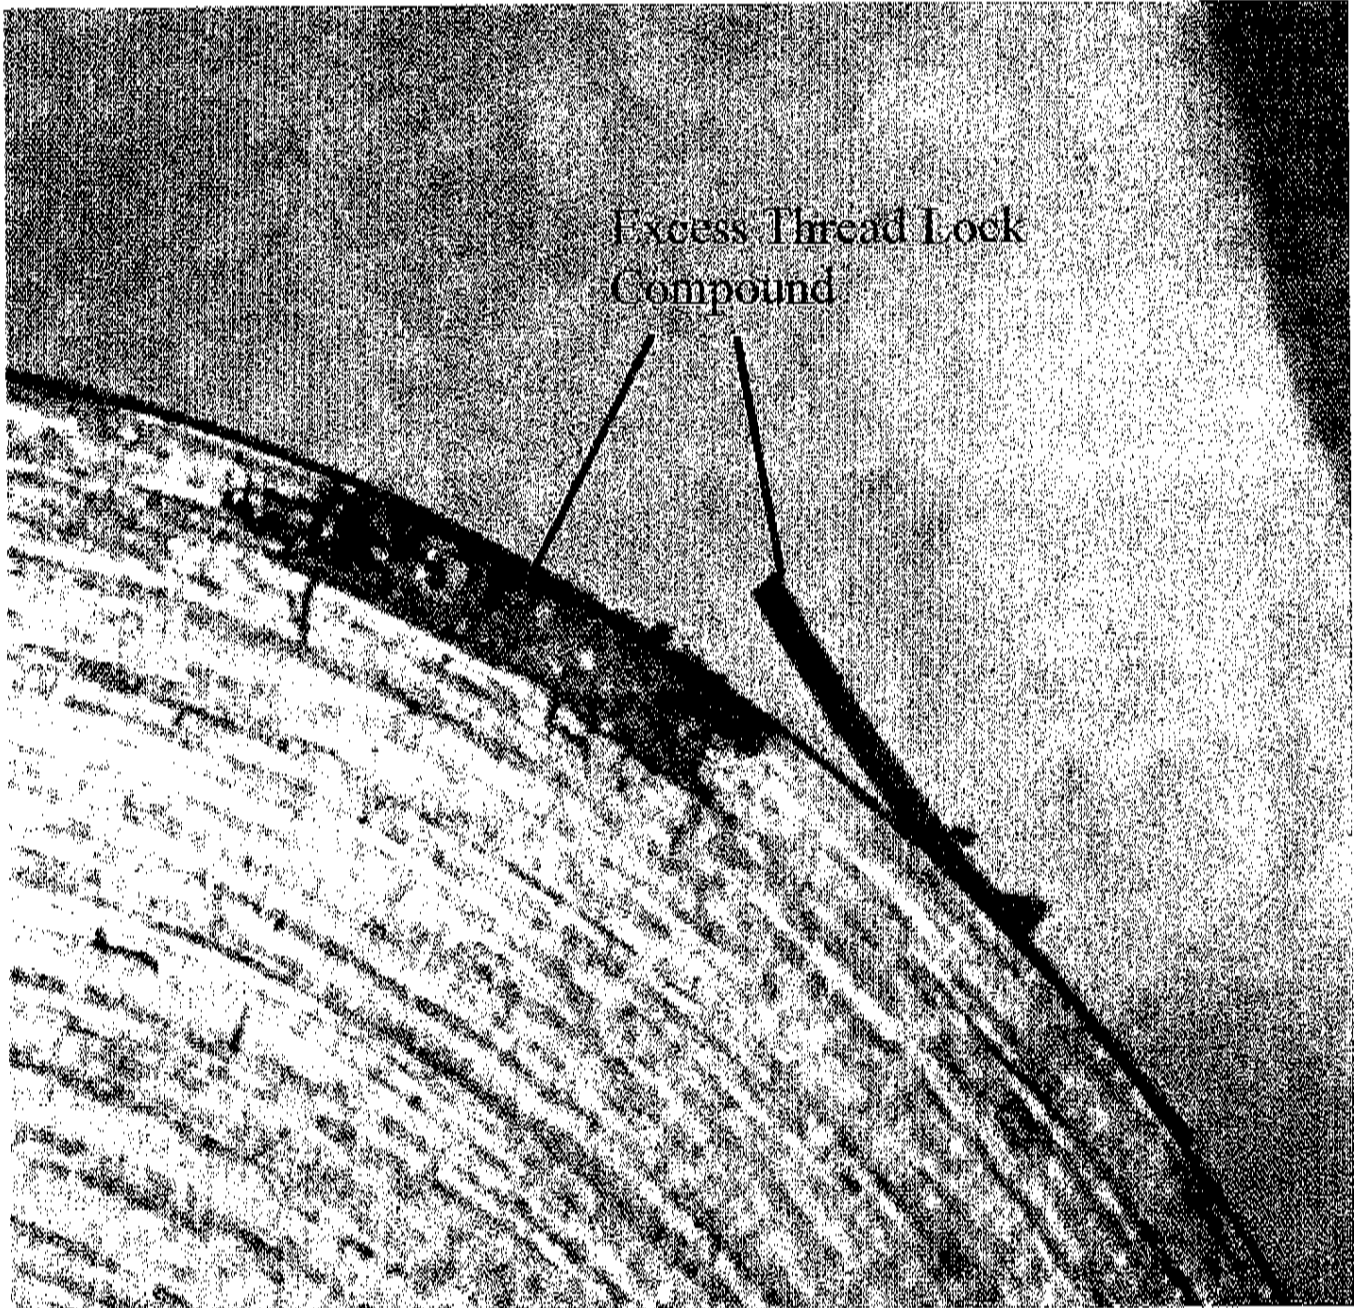
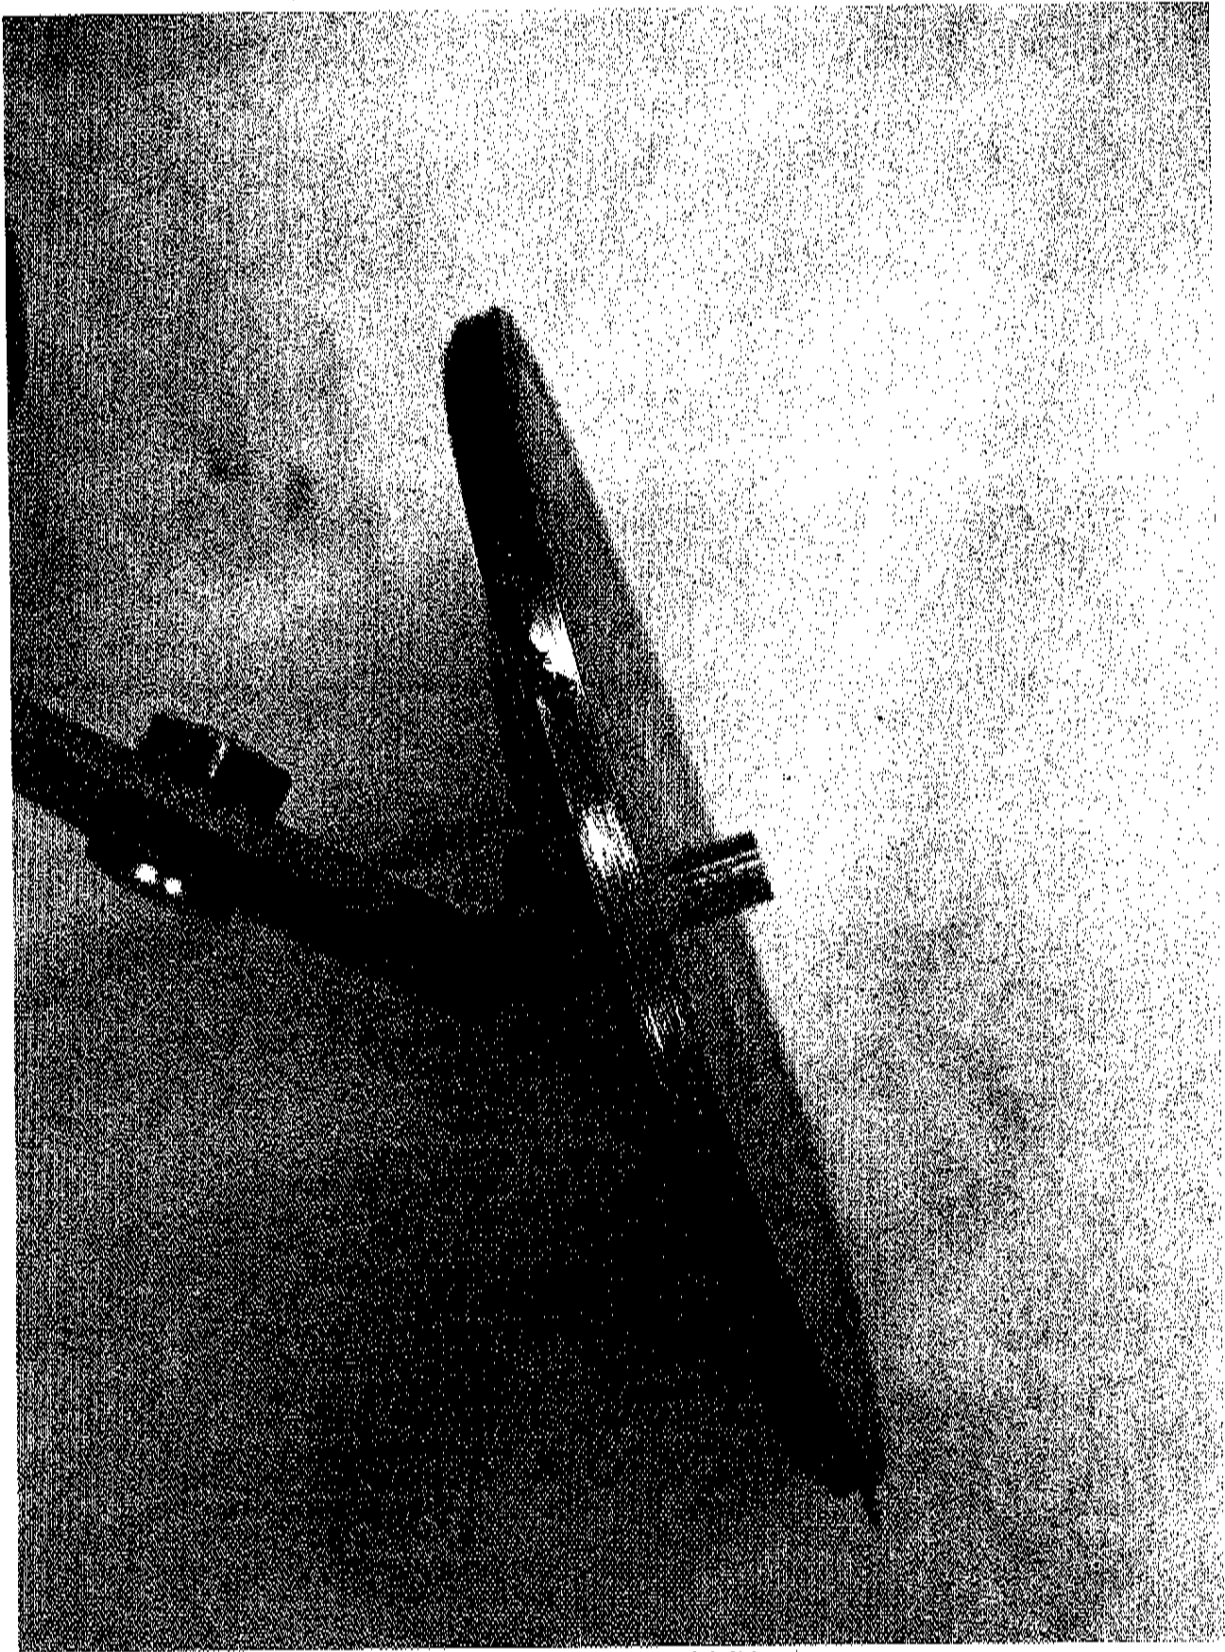
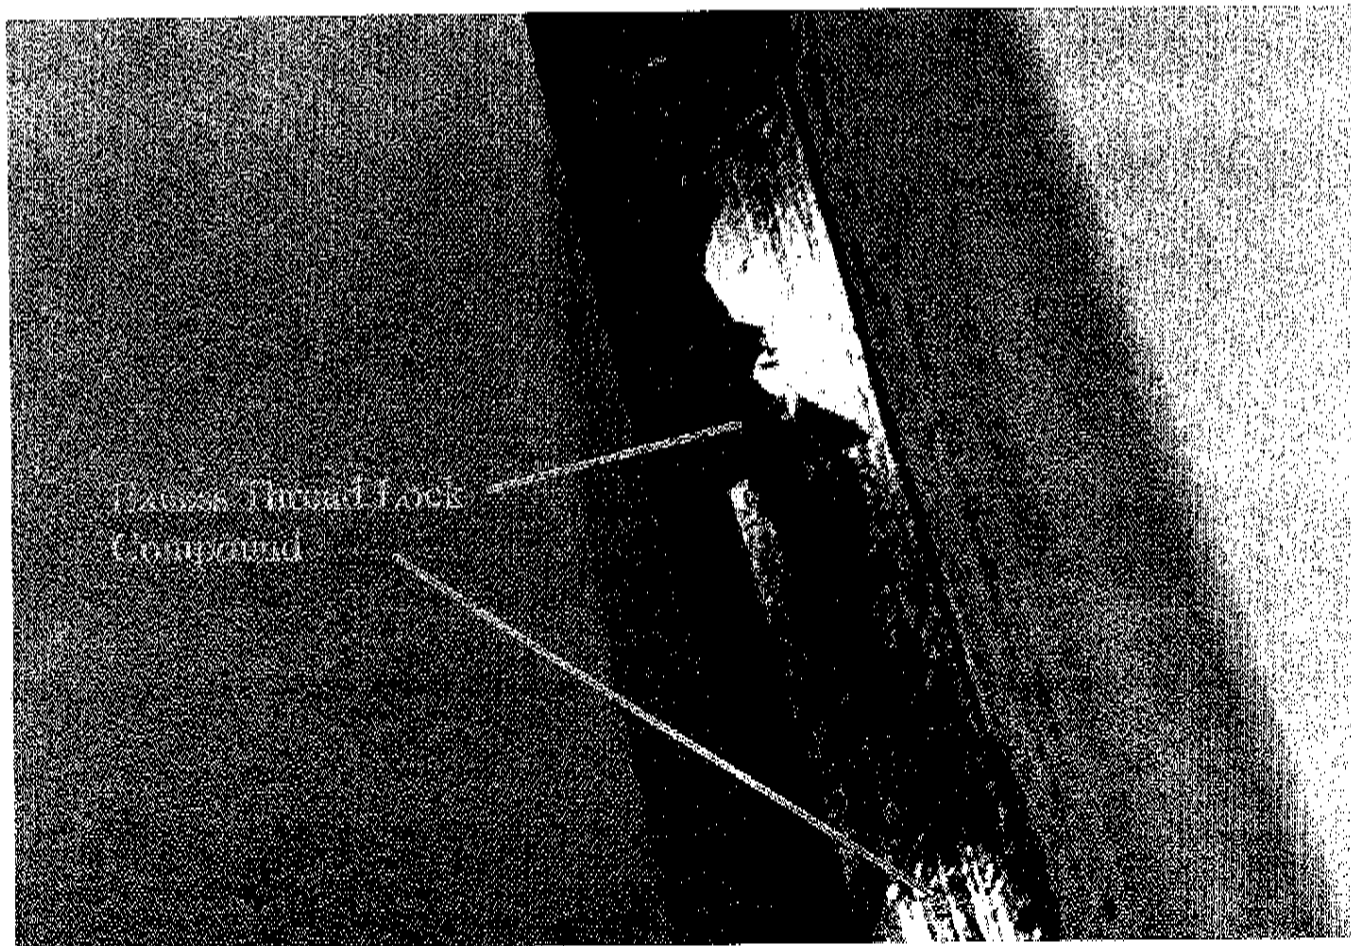
Coil Cap (5): Visual inspection showed no signs of damage. Excess thread lock compound observed on top, bottom near the outside diameter and side.

Excess Thread Lock
Compound

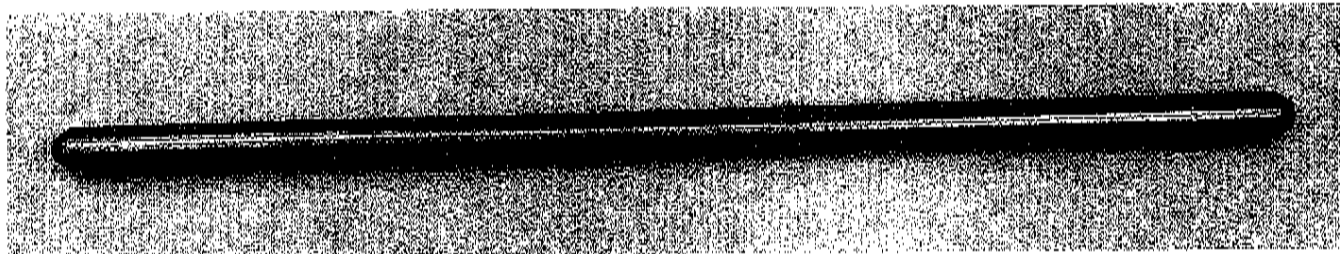
Figure 23: Spool Adjustment Rod

Rod, Spool Adjustment: Visual examination showed no signs of damage.

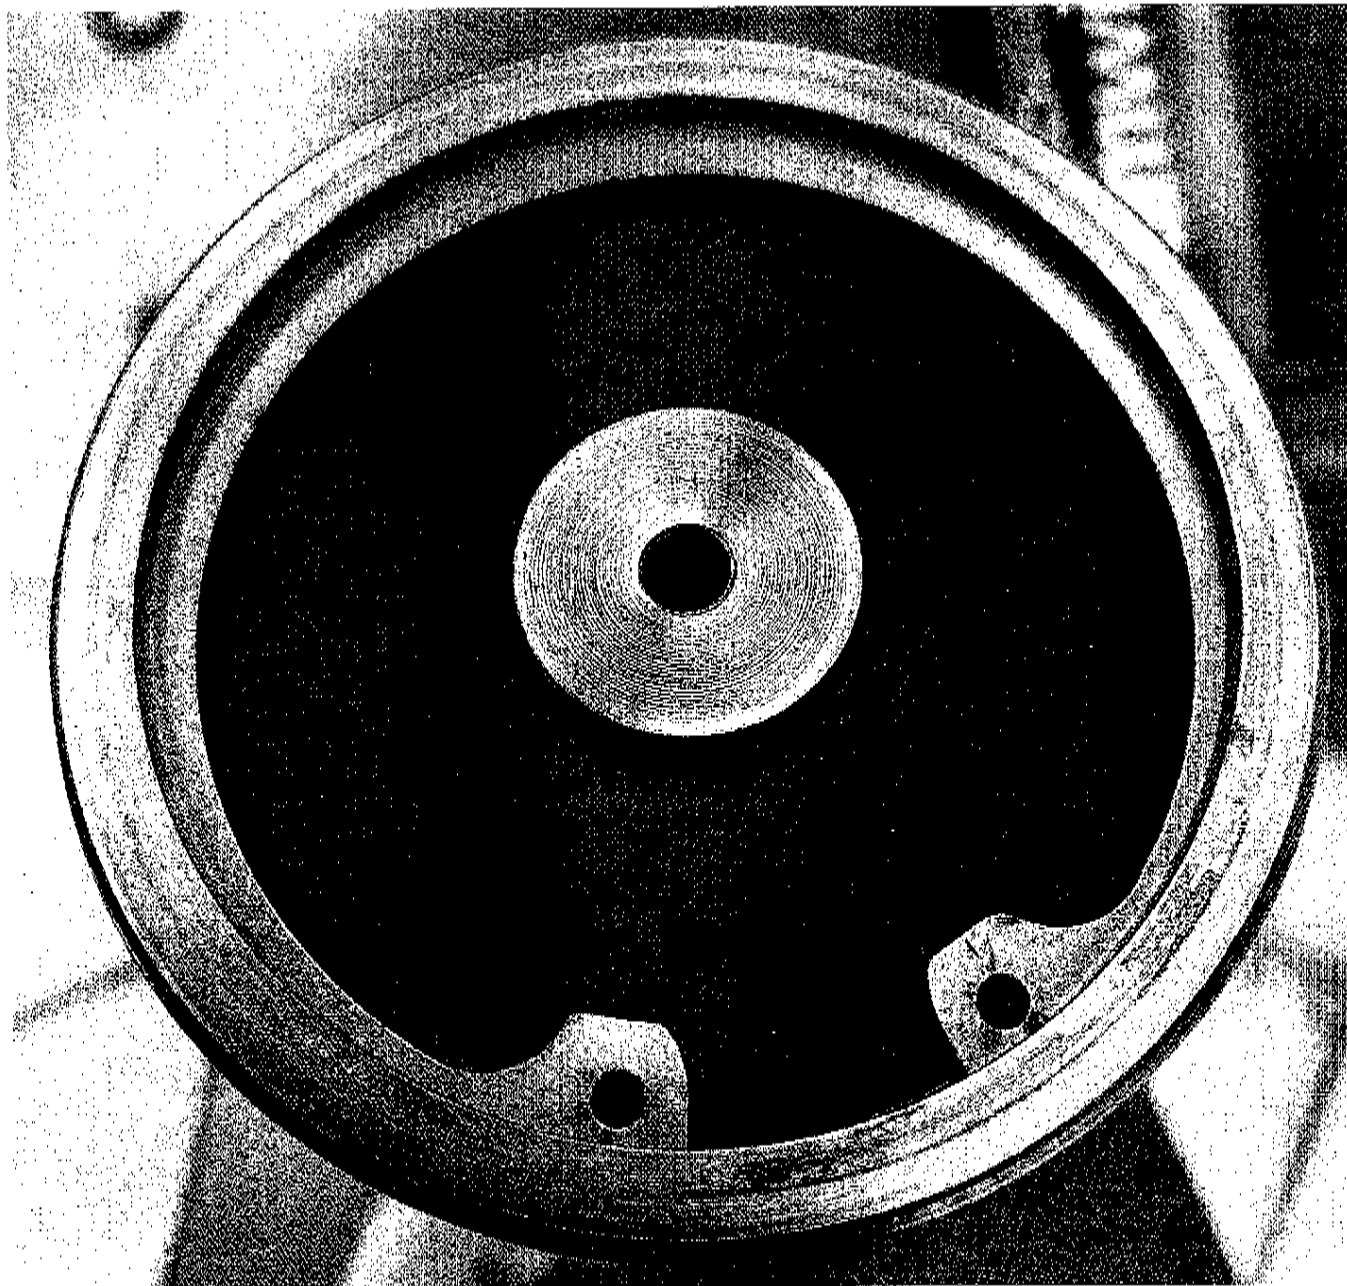
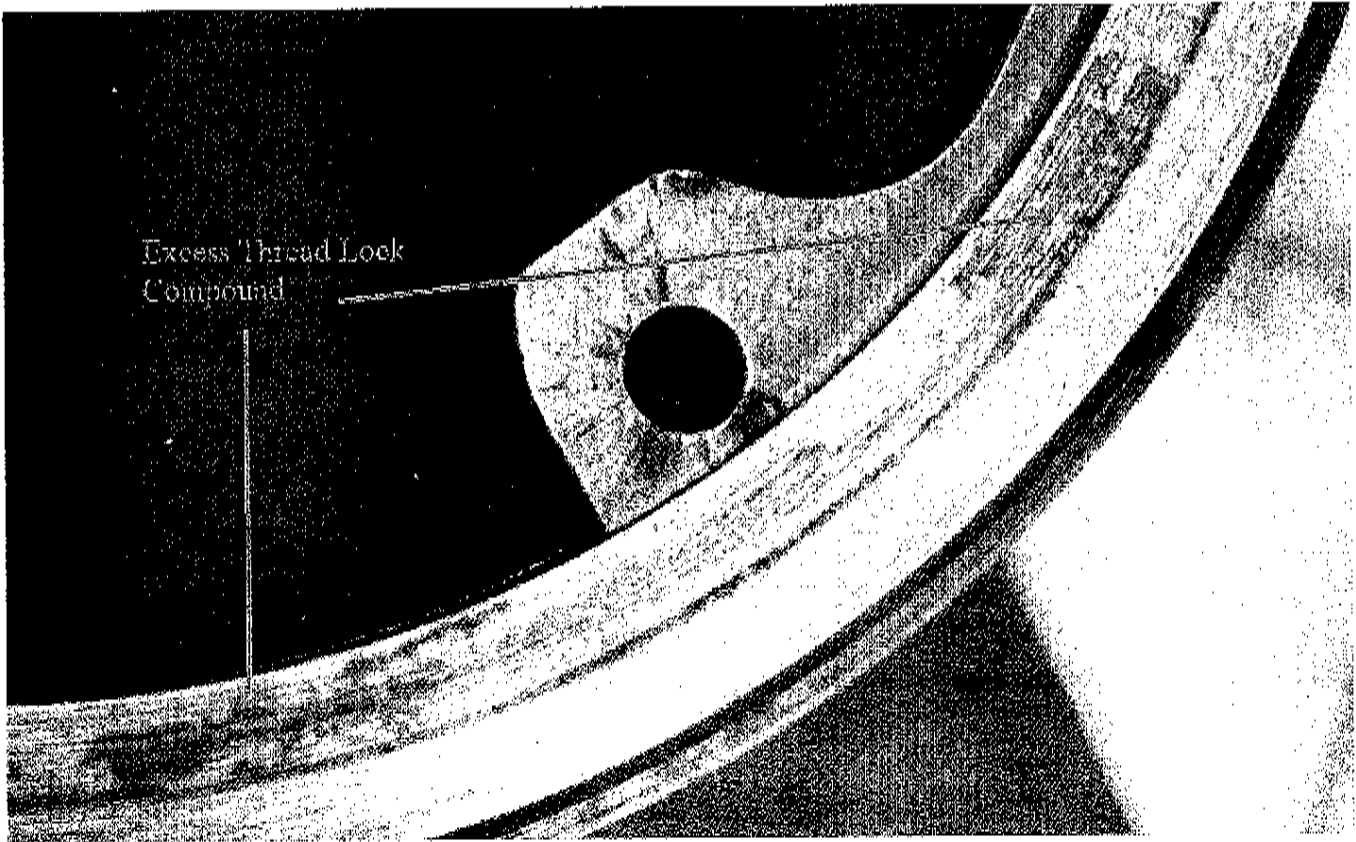
Coil Assembly (10): Visual examination showed no signs of damage. Excess thread lock compound observed on top surface in the area of the gap between the Coil Assembly (10) and the Coil Cap (5).

Excess Thread Lock
Compound

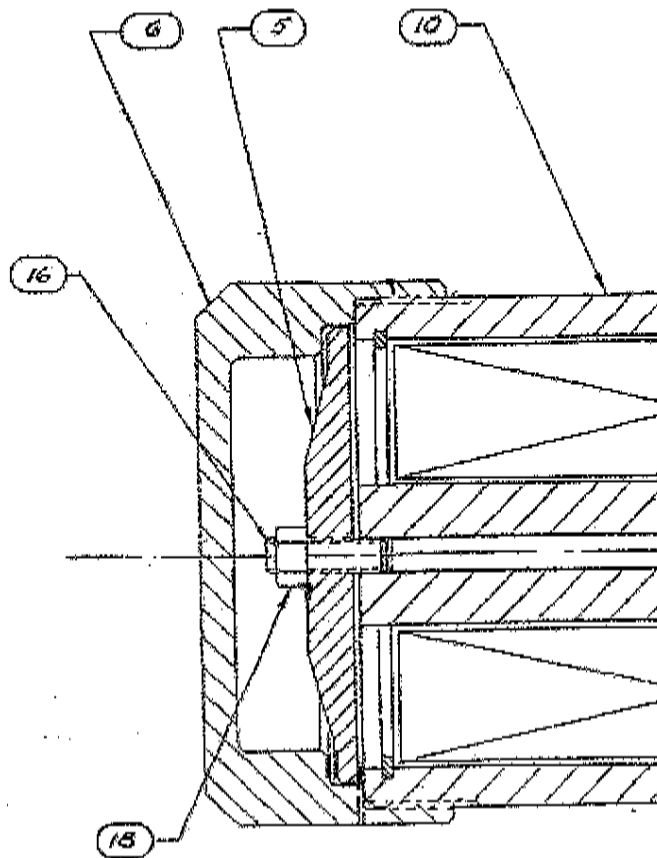
Figure 29: Areas Where Excess Thread Lock Compound was Observed

During Flowserve's investigation into the root cause of the solenoid valve failure, Flowserve was unable to replicate this failure. Based on examination of the solenoid valve components, excess thread lock compound had been applied to the Set Screw (16) and Nut (18) on the Coil Cap (5). The excess thread lock compound then ran down the Coil Cap (5) and wicked between the Coil Cap (5) outside diameter and the End Cap (6) inside diameter. Once this excess thread lock compound cured, the Coil Cap (5) was locked in the de-energized position, preventing the Coil Cap (5) from shifting. After the customer left the solenoid valve energized for 10 minutes, the Coil Cap (5) broke free from de-energized position and was able to shift freely. In the procedure for assembly and testing of this solenoid valve, the solenoid valve is not energized after application of the thread lock compound.

— Excess Thread Lock Compound Observed in These Areas

Nuclear Power Plant Customers with model 38878 solenoid valves that have not undergone acceptance testing should verify that these suspect solenoid valves will shift on demand when energized.

Provide training to assembly and test personnel on the importance of ensuring that excess thread lock compound has not been applied. The assembly and test procedure for the Model 38878 solenoid valves will be revised to add a final test after the thread lock compound has been applied and been allowed to cure to verify the solenoid valve shifts when energized.
