HITACHI

10 CFR Part 21 Communication

SC 23-01 Revision 1
007N7348

Subject: Failure of the CRD Collet Retainer Tube/Outer Tube Weld

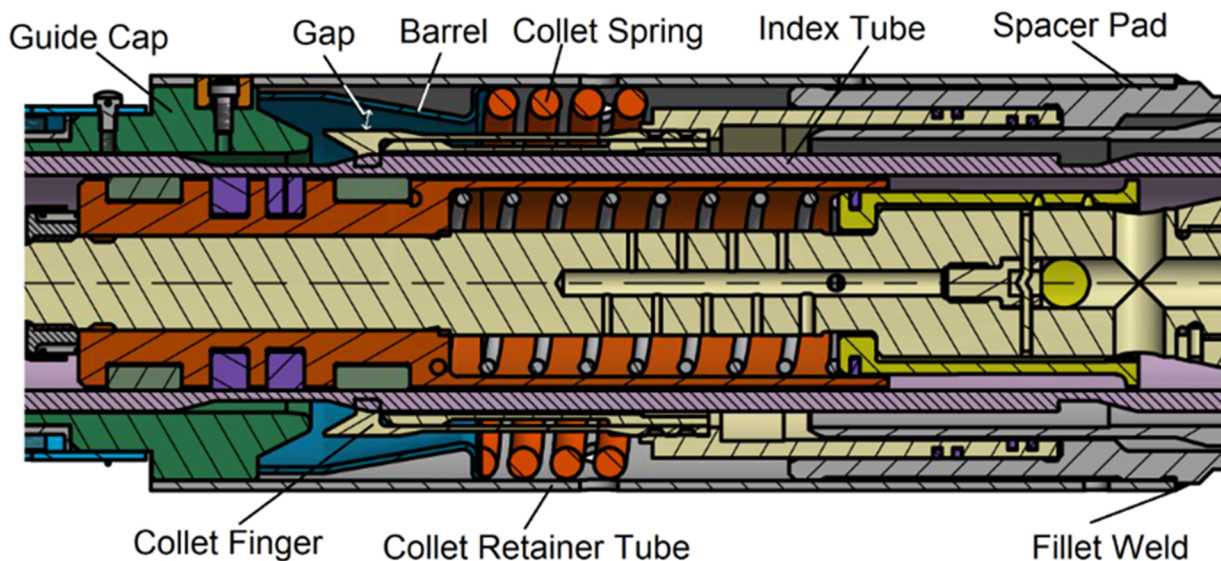
Figure 1
Upper Section of CRDM Assembly

During removal of a Control Rod Drive Mechanism (CRDM) from a domestic plant in February 2023, it was discovered that a 360° failure of the collet retainer tube fillet weld had occurred, and the retainer tube had displaced approximately 1.125" from its original position. This retainer tube is part of the CRD 919D258G003 Cylinder, Tube and Flange (CTF) assembly. The function of this assembly (see Figure 1) is to react to the applied hydraulic loads so that the collet fingers can be retracted from the index tube and allow the CRD to be moved for control rod positioning or scram.

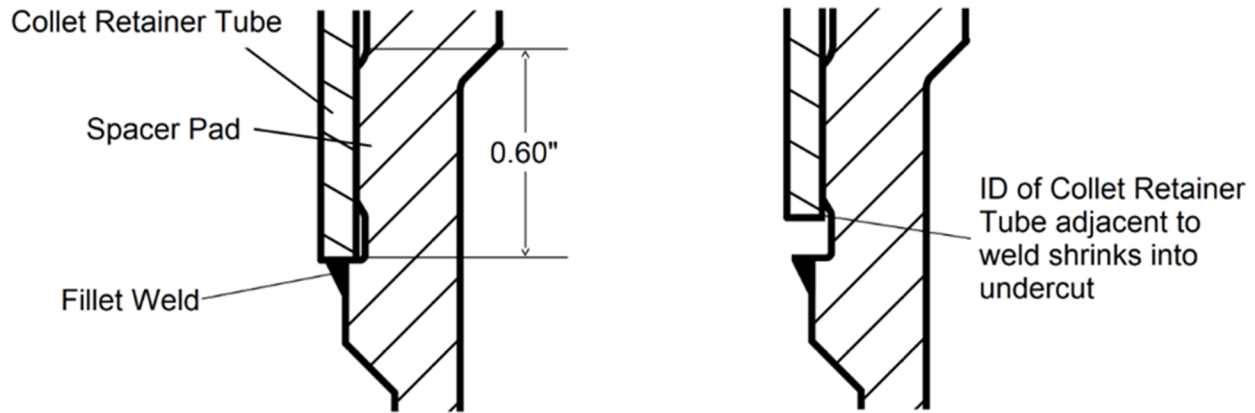
Figure 2
Retainer Tube to Spacer Detail

For the 2011 event, GEH determined that fillet weld geometry with incomplete fusion at the bottom of the retainer tube (Figure 2), can create creviced areas with high stress concentrations which were shown to be points of fatigue (crack) initiation. Fracture analysis of samples from the failed CTF assembly found evidence of fatigue crack initiation (in the creviced areas) and crack propagation. GEH concluded that thermal and mechanical cycling caused crack propagation.

For the February 2023 event, GEH performed similar inspections and fracture analysis on the separated CTF assembly. The inspections found that the fillet weld geometry was such that there was incomplete fusion across the bottom of the retainer tube, and at some locations the weld had fused with only $\approx 30\%$ of the bottom of the retainer tube. At these locations, the weld size did not meet the weld size requirement and did not achieve complete root fusion as required by the weld process specification. The fracture analysis similarly found evidence of fatigue crack initiation in the creviced areas which propagated through a weld ligament adjacent to the bottom of the retainer tube and not through the weld throat.

Therefore, when the retainer tube to spacer fillet weld does not meet the weld size requirement and does not achieve complete root fusion, crevices of sufficient size are created at the root of the weld, forming areas of stress concentration. Then, when exposed to cyclic loading conditions, fatigue (crack) initiation can occur at the high stress areas.

1. Limit use of elevated drive water differential pressure to when excessive collet piston seal leakage is preventing the collet mechanism from actuating during attempts to notch out from position 00. Specifically, elevated DP may be used to allow for unlatching after it has been confirmed that the control rod is inserting as expected, and the withdrawal stall flow has been confirmed to be high (significantly above trend) due to suspected collet piston seal leakage. It is recognized that other issues may prevent normal control rod insertion. Use of elevated drive water DP to assist with rod insertion is not limited by the above recommendation.

2. If a control rod fails to insert or withdraw with normal drive water DP (250 to 265 psid), recognize that these are potentially symptoms of a separated collet retainer tube on the CTF assembly.

3. Review SIL 139 and its supplements (References 3-9) and ensure recommendations provided in these SILs are adequately addressed in plant procedures.
4. When prioritizing CRDMs for rebuild, consider elapsed time since last inspection of each CTF assembly, and plant specific G002 and G003 PT examination failure rates. Those

CRDMs with CTF assemblies with the greatest in-service time should be given priority consistent with Reference 2.
