**Report No. 10CFR21-0137**

## 10CFR21 REPORTING OF DEFECTS AND NON-COMPLIANCE

**COMPONENT:** EMD Cylinder Liner with Bore Deficiency  
P/N 9318833 (component of power assembly P/N 40124897)  
S/N 20M0938

**SYSTEM:** Emergency Diesel Generator

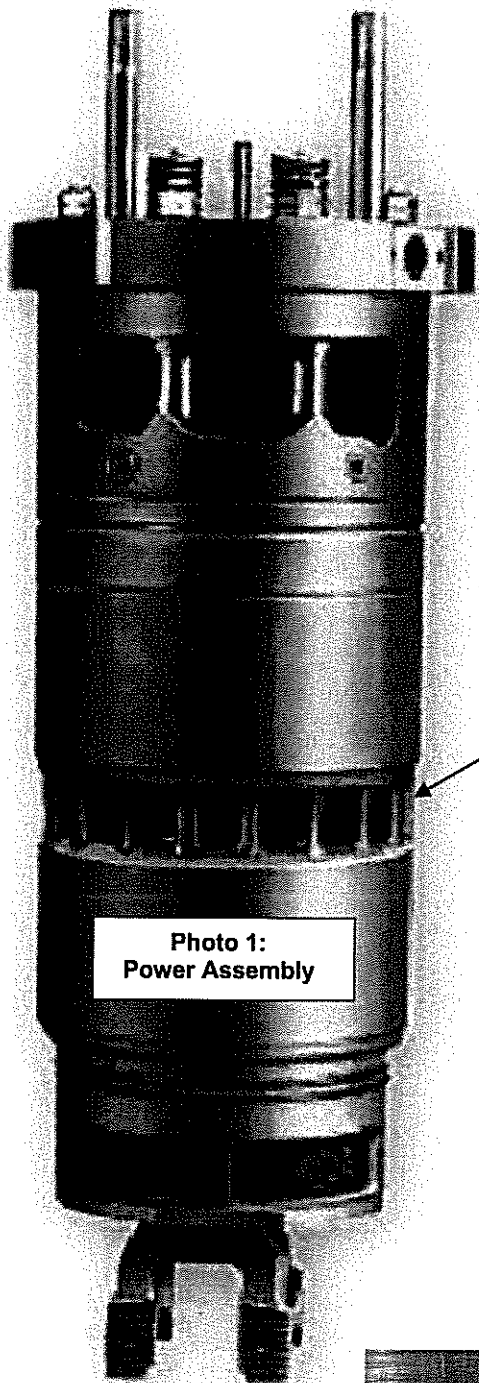
**Photo 1:  
Power Assembly**

*An edge or lip in the bore of an EMD cylinder liner prevented successful installation of the corresponding power assembly on an emergency diesel generator set. The lip is located axially at the bottom of the inlet ports and is present around the circumference of the bore. See photos of the power assembly, liner, and air inlet ports on page 3. The EMD model 645E4 is a 2-stroke engine with air inlet ports in the wall of the cylinder liner. As the piston travels below the inlet ports, air box pressure scavenges and replenishes air to the power assembly.*

*Installation of the power assembly requires lowering the piston through the liner in order to secure the connecting rod to the crankshaft. During this process the piston could not be lowered below the inlet ports due to the piston rings catching on the lip. The power assembly was not installed and therefore there was no safety hazard; however, if the defect had gone undetected there was the potential to damage engine components and possibly reduce load carrying capacity of the engine.*

*To prevent reoccurrence, ESI has revised the dedication package to include verification that bore machining is continuous along the entire length and no edges or lips are present. The revision was implemented on December 6, 2023.*

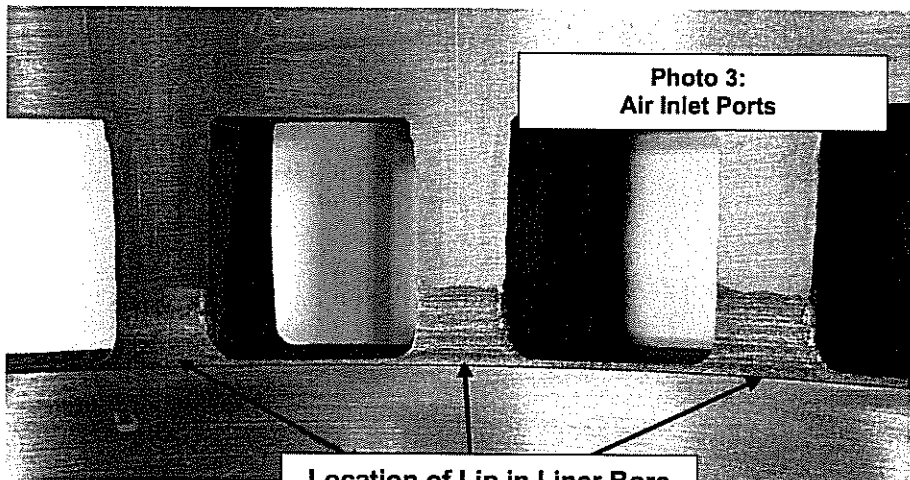
**Photo 3:  
Air Inlet Ports**

Location of Lip in Liner Bore  
at Bottom of Inlet Ports
