U. S. NUCLEAR REGULATORY COMMISSION

Report No: 50-331/99014(DRP)

Facility: Duane Arnold Energy Center

Duane Arnold Energy Center NRC Inspection Report 50-331/99014(DRP)

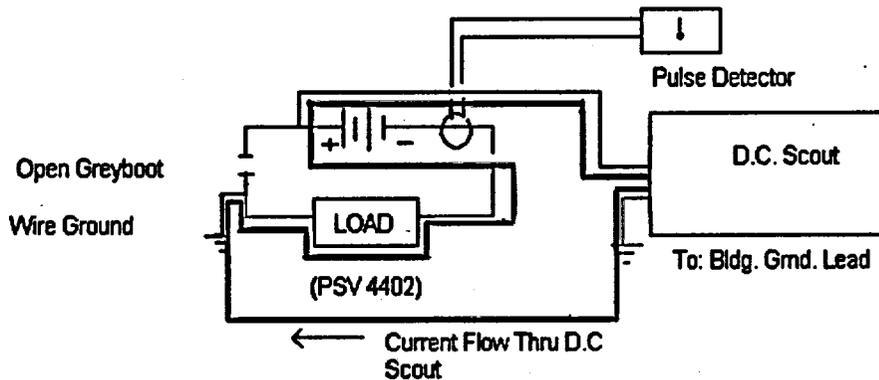
On November 27, 1999, during plant startup from RFO 16, main steam line relief valve PSV 4402 spuriously opened for approximately 30 seconds. On-shift operators became aware of the relief valve lifting when the high temperature tail-pipe alarm annunciated and torus water level increased. Reactor water level swelled to 200 inches and reactor

Electrical maintenance technicians were troubleshooting a ground on the 125 VDC Division I electrical system at the time of the relief valve lifting. The system's in-line ground detection system indicated a ground on the negative portion of the circuit. Electrical maintenance technicians were using a "non-intrusive" ground detection device (DC Scout) to locate the source of the ground. The ground detection device had narrowed down the ground to a DC power sub-panel. As directed by the vendor manual, electrical maintenance technicians had tied the DC Scout input lead into the positive side of the 125 VDC system. The DC Scout output lead was tied into the building ground. When amperage allowed through the DC Scout was increased to 50 milliamperes, the pilot solenoid valve for relief valve PSV 4402 actuated. The reason the pilot valve actuated was because there was also an open environmentally qualified wire splice, known as a greyboot connection, at the pilot valve in addition to the ground. The greyboot connection was open on the positive side of the pilot solenoid. This masked the fact that the ground was also on the positive side of the pilot valve circuitry. This resulted in the electrical maintenance technicians erroneously connecting the DC Scout ground detection device to the positive bus.

The simplified diagram above shows the 125 volt system with the actual system faults and the DC Scout ground detection device as it was installed. The heavy line represents the current and flow-path which caused actuation of the pilot solenoid valve. The inspector's review of the vendor manual found that the electrical maintenance technicians connected the DC Scout in what would be considered the proper manner to troubleshoot the ground as indicated by the 125 VDC system's ground detection system.

A review of work orders completed during Refueling Outage 16, found that the sealite (insulation jacket around the wiring) had been pulled from a junction box that supplied power to relief valve PSV 4402. The sealite was re-installed back into the junction box and re-tightened; however, the wiring internal to the junction box and the conduit box for the solenoid was not inspected for potential damage caused when the wiring was pulled out of the junction box. The junction box and the conduit box are approximately three feet apart. A work order to examine the wiring in the conduit box, following failure of relief valve PSV 4402 to open during the surveillance test, found that the insulation around a lead had been stretched and exposed the wiring. Also, an examination of the greyboot connection on the same wire found that the connection had been pulled apart. The necessary repairs were made to the wiring and greyboot connection. The post-maintenance testing was performed satisfactorily.
