**CAROLINA POWER & LIGHT  
COMPANY  
(Shearon Harris Nuclear Power Plant)**

**EXHIBITS SUPPORTING THE  
SUMMARY OF FACTS, DATA, AND ARGUMENTS  
ON WHICH APPLICANT PROPOSES TO RELY  
AT THE SUBPART K ORAL ARGUMENT**

**AFFIDAVIT OF GEORGE J. LICINA**

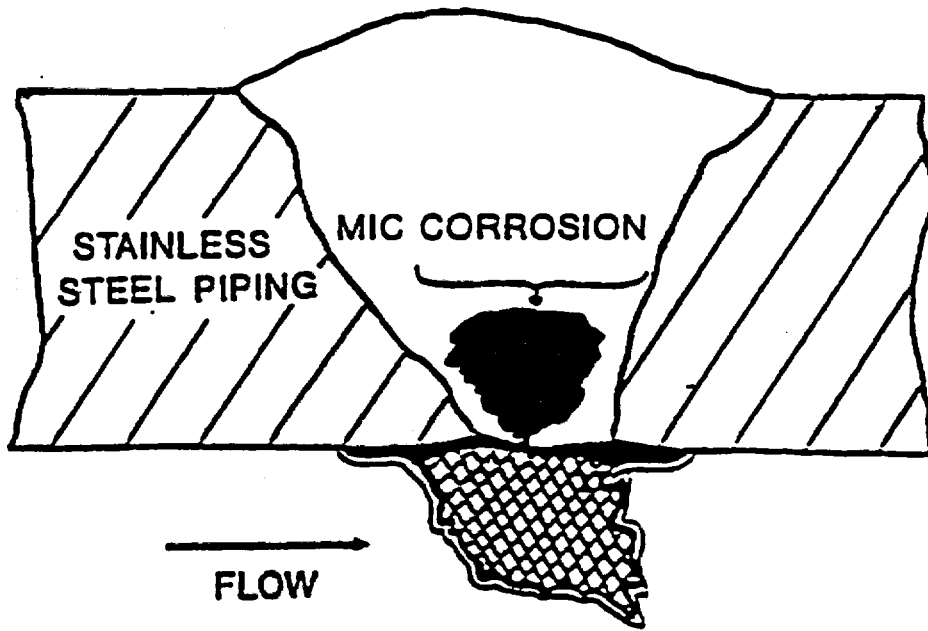
Figure 5-1. Closed Pit, Typical of MIC in Stainless Steel Piping Welds (from [7])
