SUBJECT: PUBLIC MEETING CONDUCTED ON JANUARY 13, 2000

Comanche Peak Refueling Outage

Plant Incident Report 1999-2650

*Unplanned descent of Unit 1
Reactor Coolant Pump Motor 1-03*

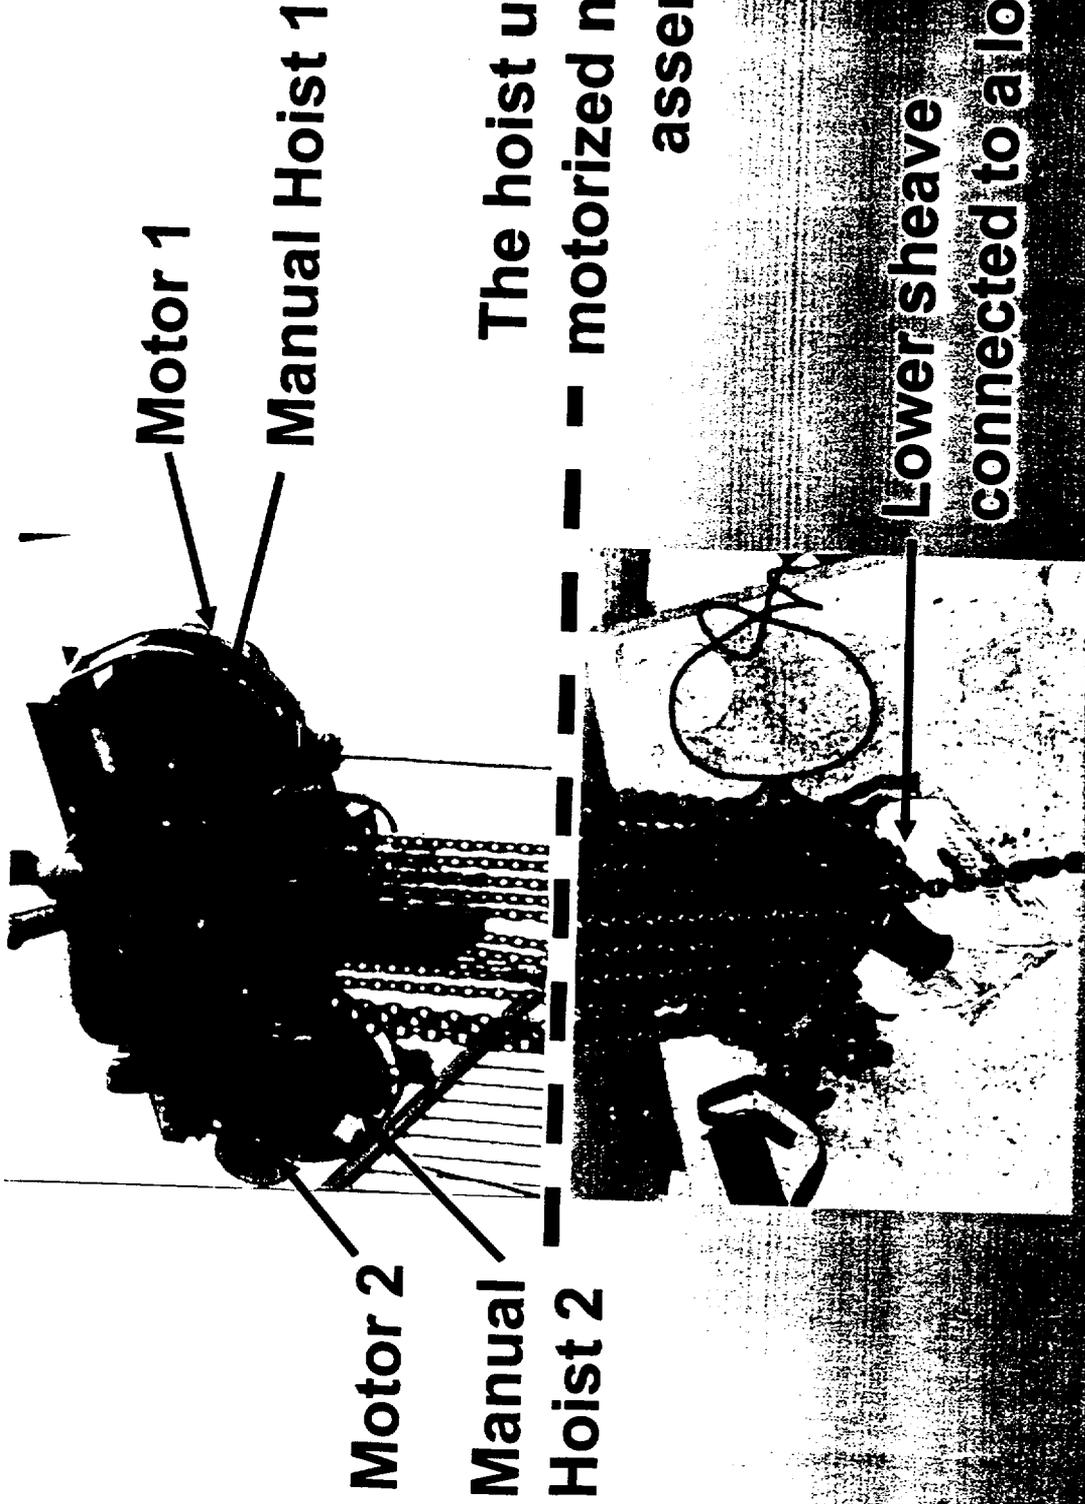
Hoist Unit CP2-MEMHCH-42

The hoist unit is a dual motorized manual hoist assembly.

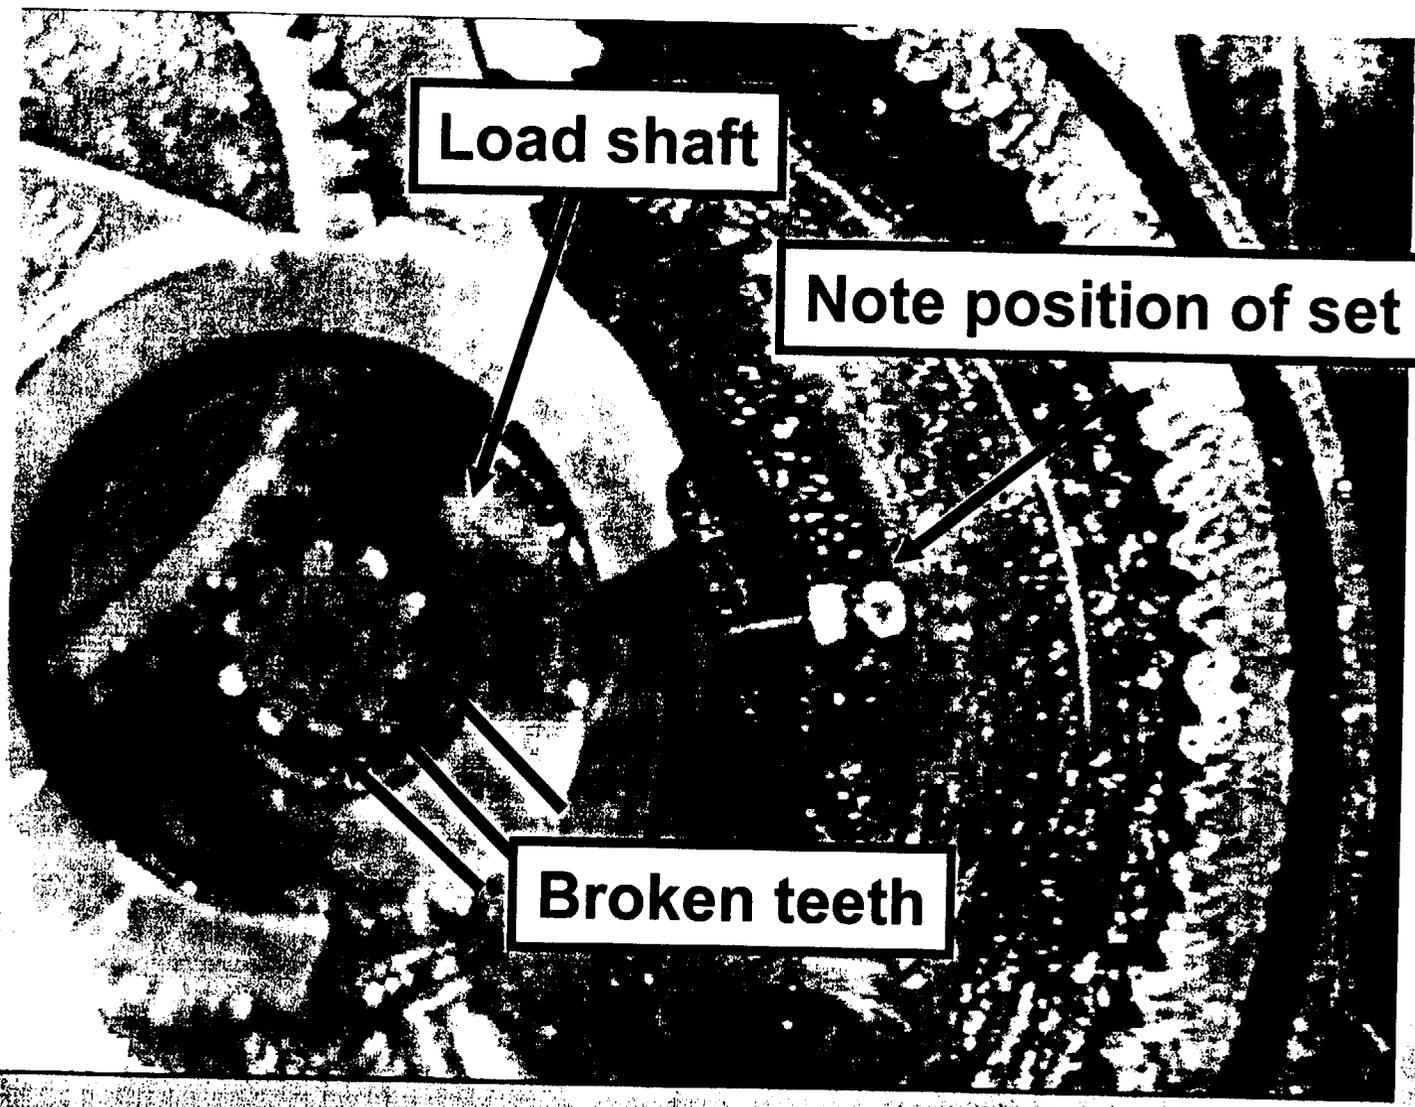
Damaged Gear Assembly

Note broken & missing parts

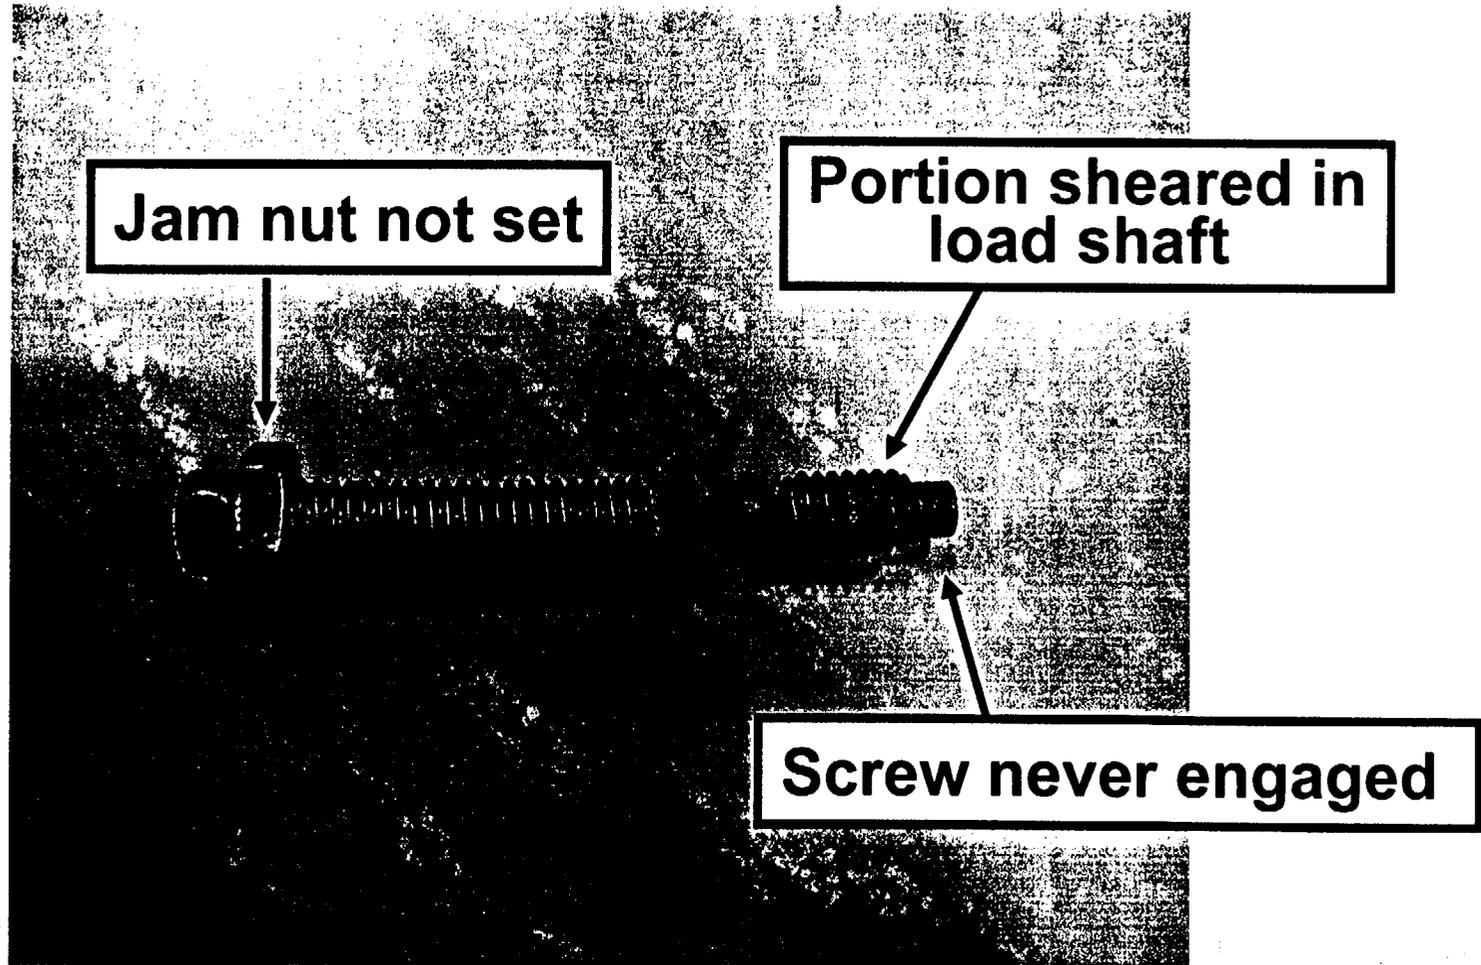
Set Screw

Load shaft

Note position of set screw

Broken teeth

- **During re-assembly, the load shaft was not fully shouldered into the ball bearing on the hand wheel side of the frame unit.**
- **The set screw hole in the load shaft and the groove in the spindle shaft were misaligned.**
- **The set screw was not properly installed.**

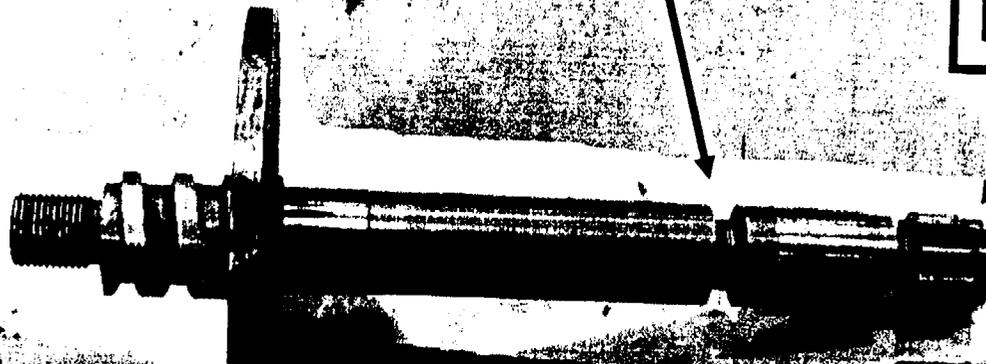
Spindle Unit from Failed Hoist

Set screw goes in here

Note damage

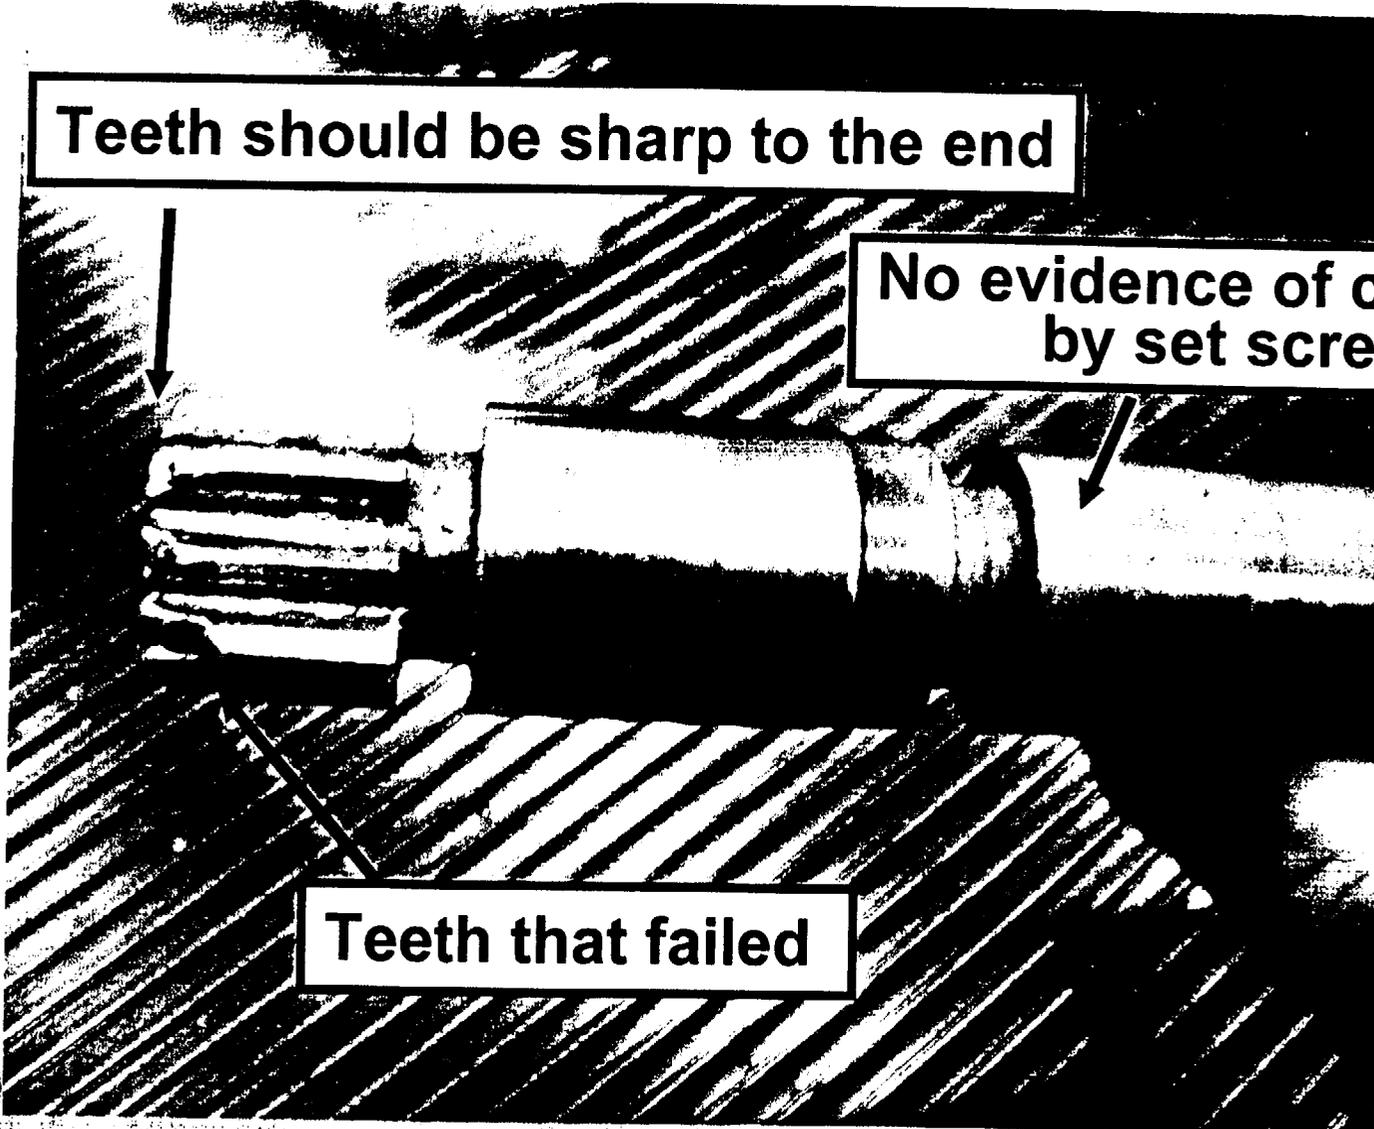
Damage to Spindle Teeth

Teeth should be sharp to the end

No evidence of contact
by set screw

Teeth that failed

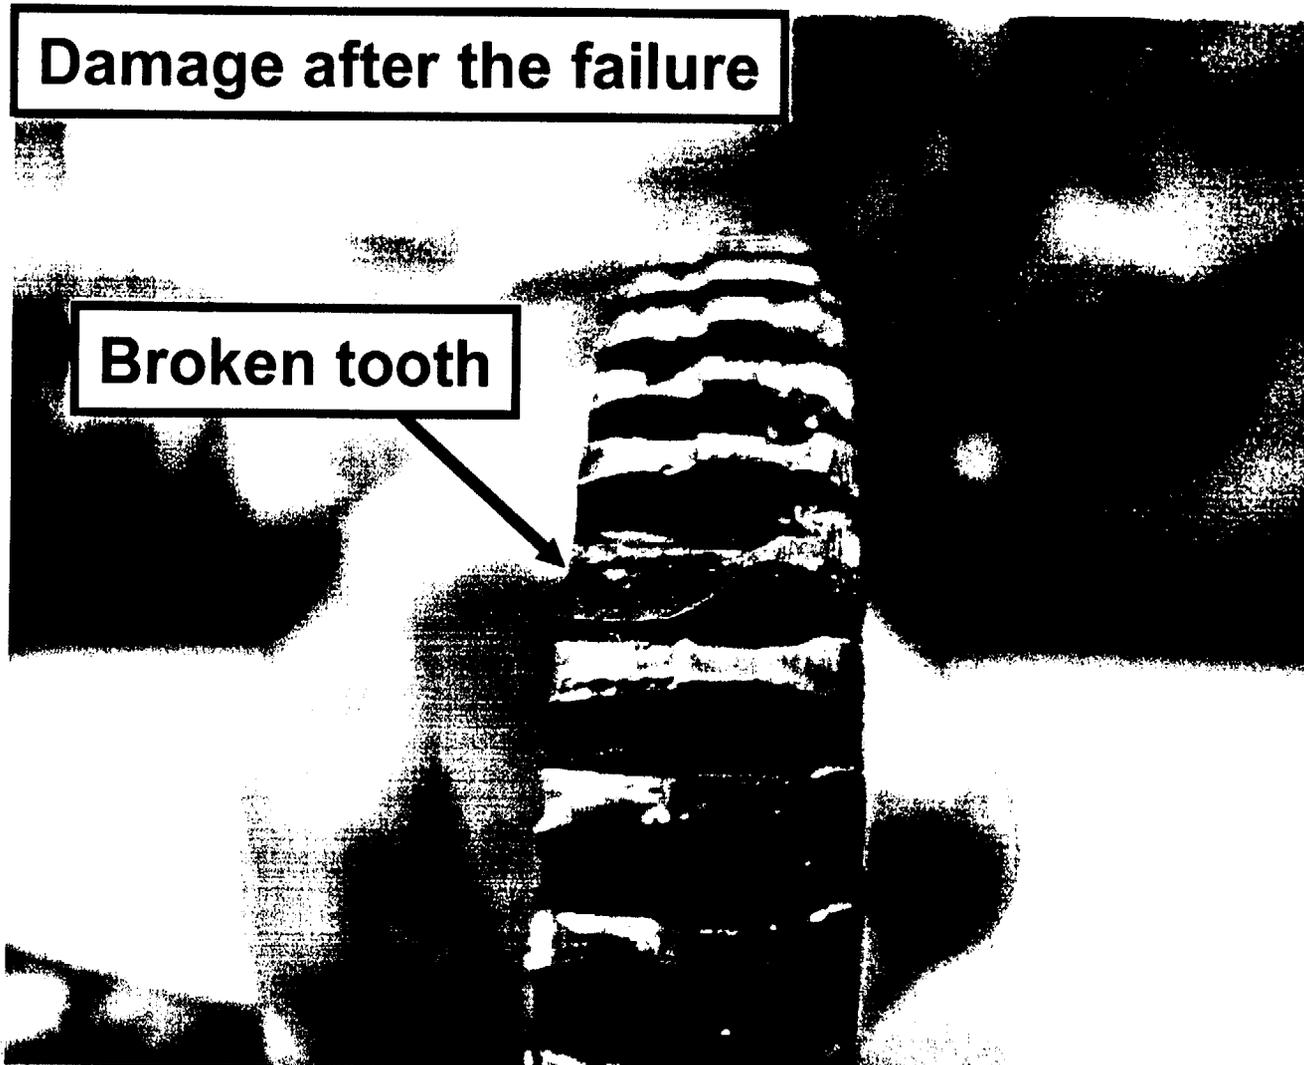
Side View- Failed Gear

Broken tooth

- **Scrap these two hoists.**
- **Identify & inspect ACCO Wright hoists.**
- **Revise Preventive Maintenance Work Orders to require additional inspections.**
- **Revise operating procedures for hoists.**
- **Develop a maintenance procedure for working on hoists.**
- **Evaluate ACCO Wright motorized manual hoists.**

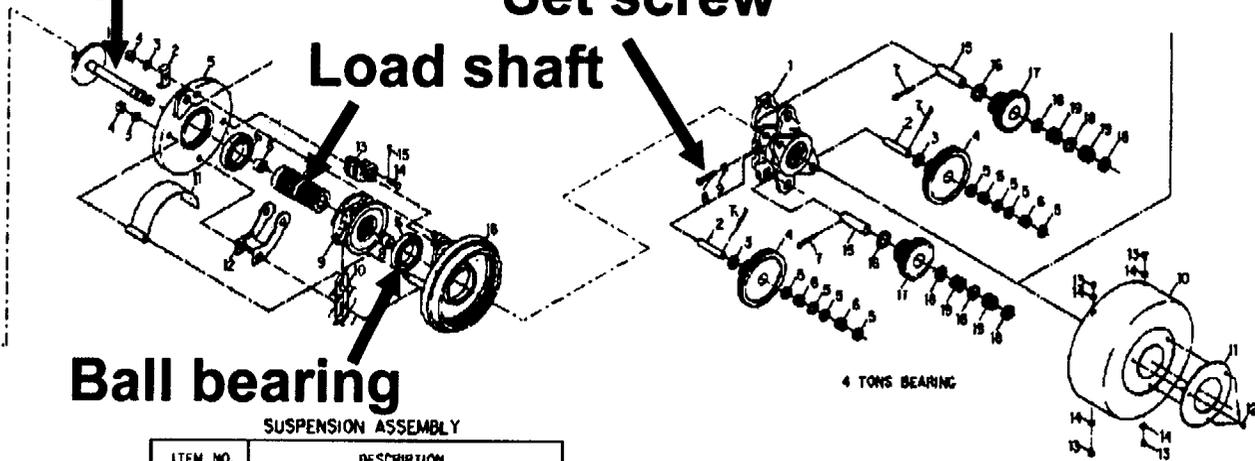
Ball bearing
4 TONS BEARING
SUSPENSION ASSEMBLY

Spindle unit
Set screw
Load shaft
