**U.S. NUCLEAR REGULATORY COMMISSION
REGION IV**

Report No.: 50-445/99-18
50-446/99-18

Facility: Comanche Peak Steam Electric Station, Units 1 and 2

Comanche Peak Steam Electric Station, Units 1 and 2
NRC Inspection Report No. 50-445/99-18; 50-446/99-18

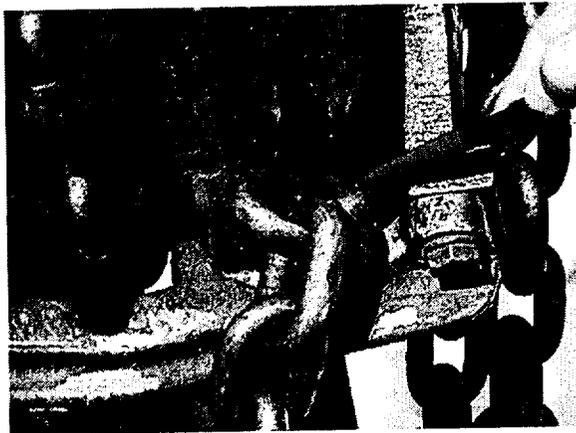
The condition of the chain hoist was unknown following the event. The licensee clearly observed that a chain link was wedged in the lower chain block between the outermost sheave and a brass guide bar across the sheaves (see photo below). It was speculated that this was all that was preventing the motor from descending further. Each of the hoist's drive trains was equipped with an electric and mechanical brake. The brakes had failed to prevent the initial drop, so it was unknown whether any of them were engaged and holding the load.

The inspectors observed the licensee's decision making process during several strategy meetings to plan the recovery of the motor. Despite the sense of urgency, the licensee methodically evaluated several possible strategies, including rigging temporary kevlar slings to the motor as well as shoring the motor from underneath. The licensee ultimately chose to stabilize the chain by shackling opposite passes of chain together as close to the chain blocks as possible so that, in the event the one link of chain became dislodged, the remaining chain would not be able to free wheel through the chain blocks. Once this had been completed, the licensee was able to lower the motor to its base using the polar crane's main hook. This was accomplished without further incident.
