**U.S. NUCLEAR REGULATORY COMMISSION  
REGION IV**

**Report No.:** 50-445/99-18  
50-446/99-18

**Facility:** Comanche Peak Steam Electric Station, Units 1 and 2

**Dates:** November 14, 1999, through December 25, 1999

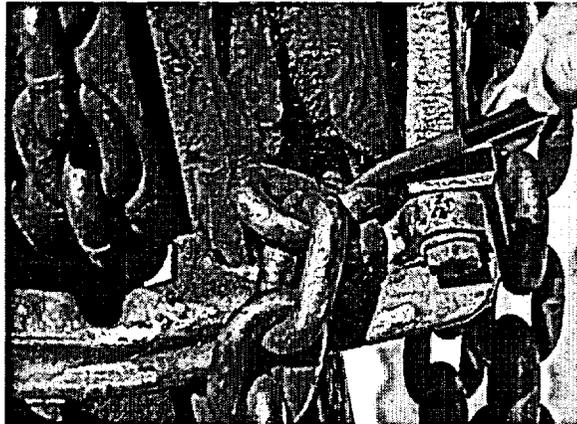
The condition of the chain hoist was unknown following the event. The licensee clearly observed that a chain link was wedged in the lower chain block between the outermost sheave and a brass guide bar across the sheaves (see photo below). It was speculated that this was all that was preventing the motor from descending further. Each of the hoist's drive trains was equipped with an electric and mechanical brake. The brakes had failed to prevent the initial drop, so it was unknown whether any of them were engaged and holding the load.

The inspectors observed the licensee's decision making process during several strategy meetings to plan the recovery of the motor. Despite the sense of urgency, the licensee methodically evaluated several possible strategies, including rigging temporary kevlar slings to the motor as well as shoring the motor from underneath. The licensee ultimately chose to stabilize the chain by shackling opposite passes of chain together as close to the chain blocks as possible so that, in the event the one link of chain became dislodged, the remaining chain would not be able to free wheel through the chain blocks. Once this had been completed, the licensee was able to lower the motor to its base using the polar crane's main hook. This was accomplished without further incident.

The RCP motor did not free fall during this event, since its decent was slowed by friction generated in the chain hoist. However, none of the brakes on the failed drive train were engaged and the brakes on the intact drive train were destroyed during the event, since they were insufficient to hold the load. The only thing that arrested the fall was the link of chain that lodged in the lower chain block. The postevent examination of the hoist revealed severe damage to the brass retaining bar and its threaded fasteners which

indicated that, had the chain lodged in the center of the chain block rather than the edge, the retaining bar may have failed, allowing the motor to continue to fall.
