Subject: **Docket Nos. 50-361 and 50-362**
30-Day Report
Licensee Event Report No. 2000-001
San Onofre Nuclear Generating Station, Units 2 and 3

TITLE (4)
Inadequate Design-SWC Pump Control Circuits Do Not Meet Fire Protection Design Basis

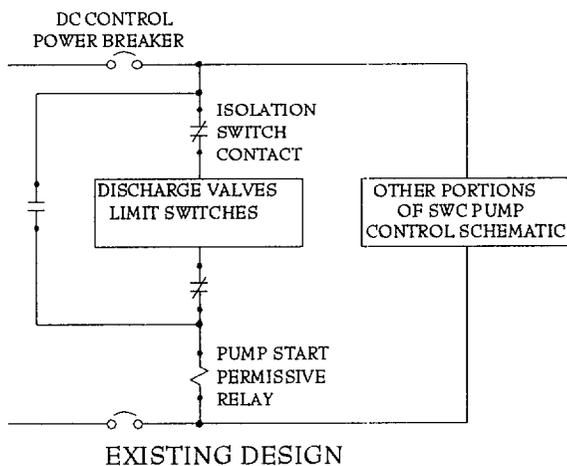
FIGURE 1

On January 25, 2000, SCE engineering determined the circa-1987 fire protection design change for the SWC Pump control circuits did not, in fact, provide an isolation fuse {FU} as intended (See Figure 1). As a result, a fire occurring at the location of the CCW heat exchanger discharge valves could cause a ground fault to the power cable of the SWC pump discharge valve solenoid {FSV}. In addition, the fire could cause an electrical fault at the pump interlock circuit that, combined with the discharge valve cable fault, could potentially trip the DC control power breaker {726} to the pump. This in turn would de-energize the pump start circuit and the pump would not be able to start from the second point of control without an additional operator action to first restore the DC control power to the Units 2 and 3 Train B SWC pumps' breakers. Consequently, SCE is reporting this condition as outside the design basis of the plant in accordance with 10 CFR 50.73 (a)(2)(ii)(B).

The design change discussed above was prepared by a contract engineering firm and SCE considers this design error to be attributable to an individual personnel error (non-utility, non-licensed). Due to the passage of time, SCE did not determine the exact cause of the personnel error.

- SCE immediately ensured that an hourly fire watch was posted in the SWC pipe tunnel and in each Unit's SWC pump room.
- SCE will modify the affected circuits to eliminate the potential vulnerability discussed above. This will be implemented in accordance with the SONGS' corrective action program.
- As noted above, SCE considers this to be an isolated error by a contract-engineering firm. Additionally, the 1988 re-organization changes that consolidated the design functions and responsibilities within one department and developed comprehensive design basis documentation has appropriately enhanced the quality of engineering design at San Onofre.

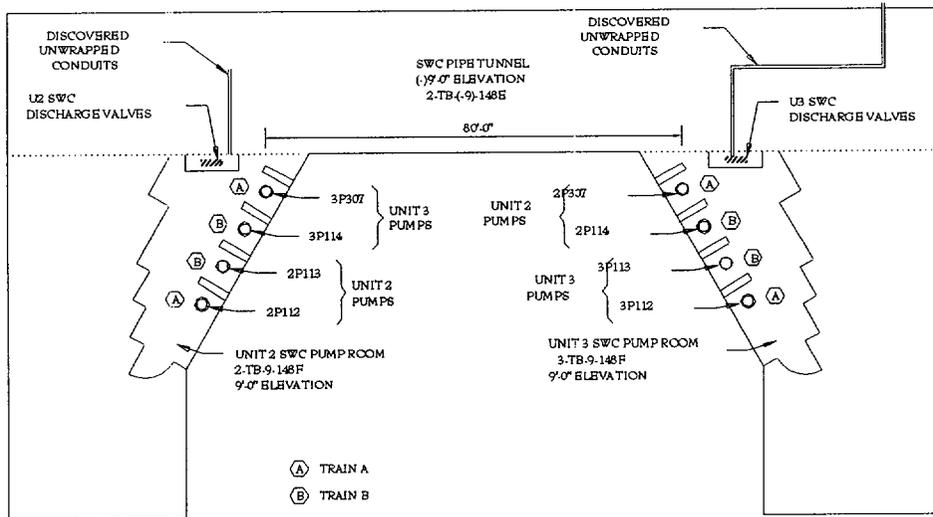
FIGURE 2

Unit 2 SWC Pump Room * (Fire Zone 2-TB-9-148F)	Unit 3 SWC Pump Room * (Fire Zone 3-TB-9-148F)
Train A	2P 112 3P 307	2P 307 3P 112
Train B	2P 113 3P 114	2P 114 3P 113

This distributed arrangement allows either pump room to provide salt water cooling for either unit. The SWC pump rooms (fire zone 2-TB-9-148F and 3-TB-9-148F) also contain control and power cables {CBL} for the SWC pumps, SWC system valves, and Heating Ventilation and Air Conditioning fans. Each SWC pump room communicates to a piping tunnel (fire zone 2-TB-9-148E), located one level below, through an 8'X8' opening. Redundant cables are routed through the tunnel with Train B cables wrapped with a 1-hour rated barrier.

If a postulated fire were to occur in the Unit 3 SWC pump room, it could:

- Cause a fault on the power cables for both Unit 3 Train A SWC pumps 3P 307 and 3P 112,
- Cause Unit 3 Train B SWC pump 3P 113 to be unavailable,
- Cause a fault on the control cable for Unit 3 Train B SWC pump 3P114, and
- Cause the DC control power to the breaker for the Unit 3 Train B SWC pumps (both) to trip.
