## Operational Assessment of ANO-2 Steam Generator Tubing for the Remainder of Cycle 14

February 3, 2000

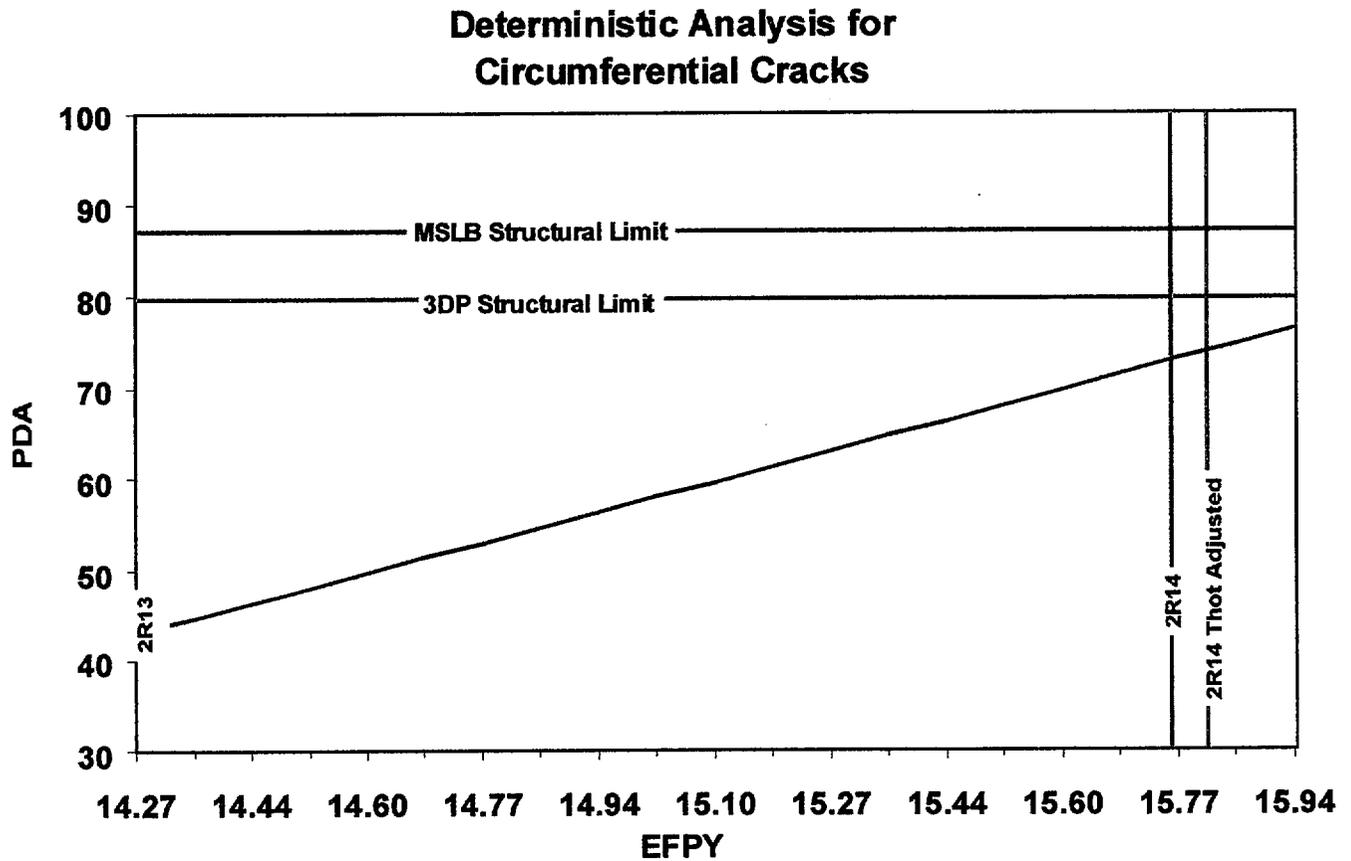
During 2P99, a limited inspection (503 tubes), was performed to mitigate potential leakage. The size and number of indications were well within the number projected in the previous operational assessment. No credit for this inspection was taken in the deterministic evaluation. Nine indications were identified and repaired. The beginning of cycle flaw size at a POD of 0.95 was used. This was equivalent to 43 percent degraded area (PDA)<sup>4</sup>. The growth rate used was the 0.95 value from the growth rate distribution based on a site specific sizing evaluation from 2R13. This value was equal to 20 PDA/EFPY<sup>5</sup>. Based on these inputs, operation for the full cycle is justified with added margin. This analysis was offset 3.7%<sup>6</sup> for increasing T-hot and is depicted in Figure 4.1 below:

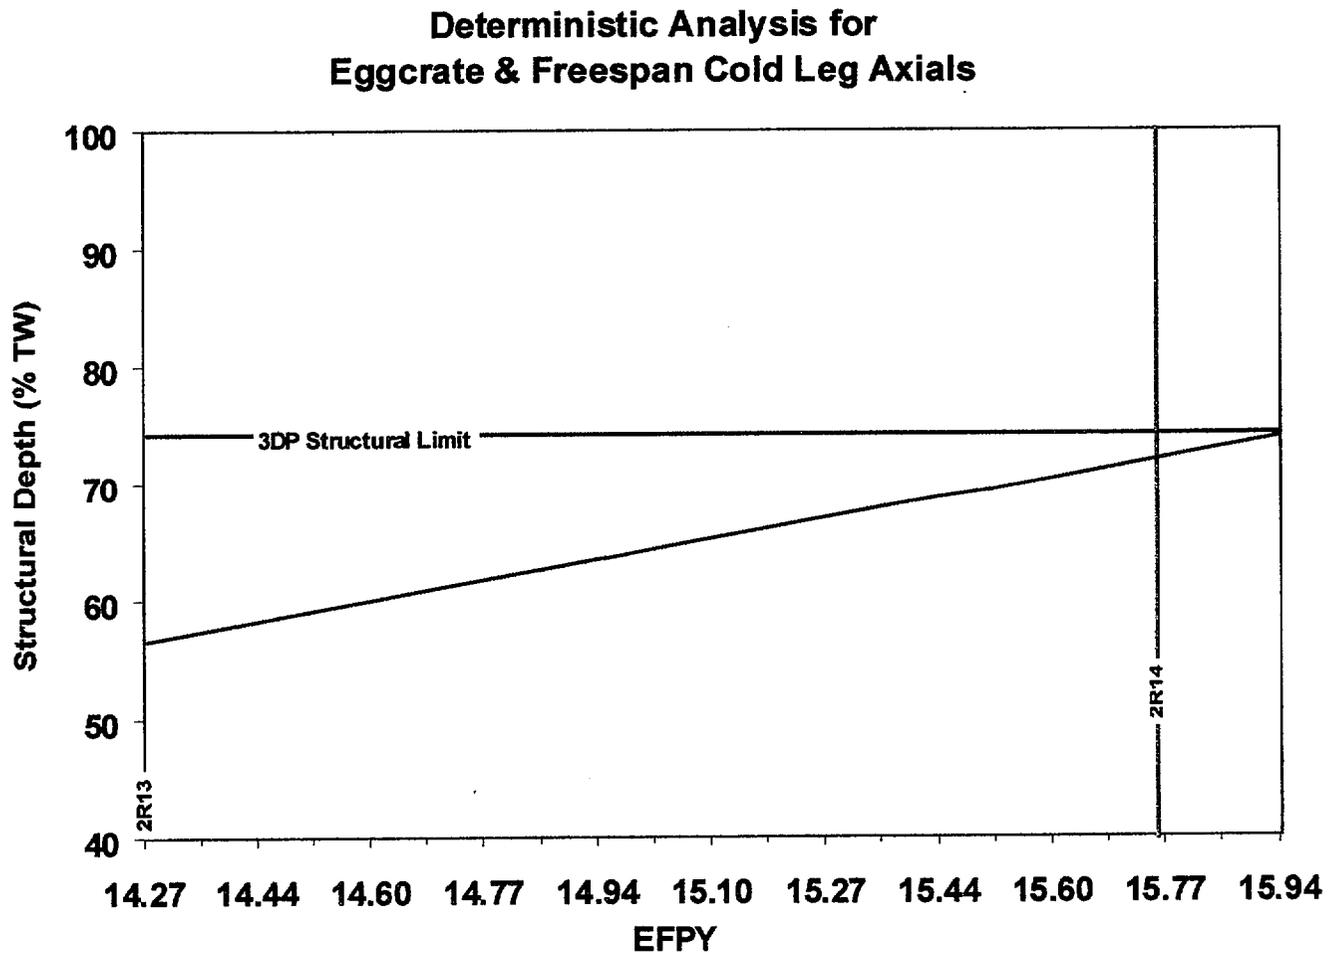
Figure 4.2

During 2P99, this area of the generator was not inspected. The operational assessment performed following 2R13 concluded operation for the full cycle was justified due to the limited number of indications and the size of the flaws, as well as the lower temperature this tubing experiences during full power operation. Based on these facts, it was not feasible to perform a growth rate study for this type of flaw. For the deterministic evaluation, the 0.95 growth rate of the hot leg eggcrates was used offset by a reduction in temperature of 15° F, which accounts for the location of the flaws high in the tube bundle. An approximate 50° F drop occurs across the bundle. The growth rate value is 10.35% per EFPY. The 0.95 POD value for this type of flaw is 56.6% structural depth with a length of 0.58 inch. These values result in a deterministic evaluation that meets the 3ΔP criterion at the next scheduled outage. This is depicted below in Figure 4.2.

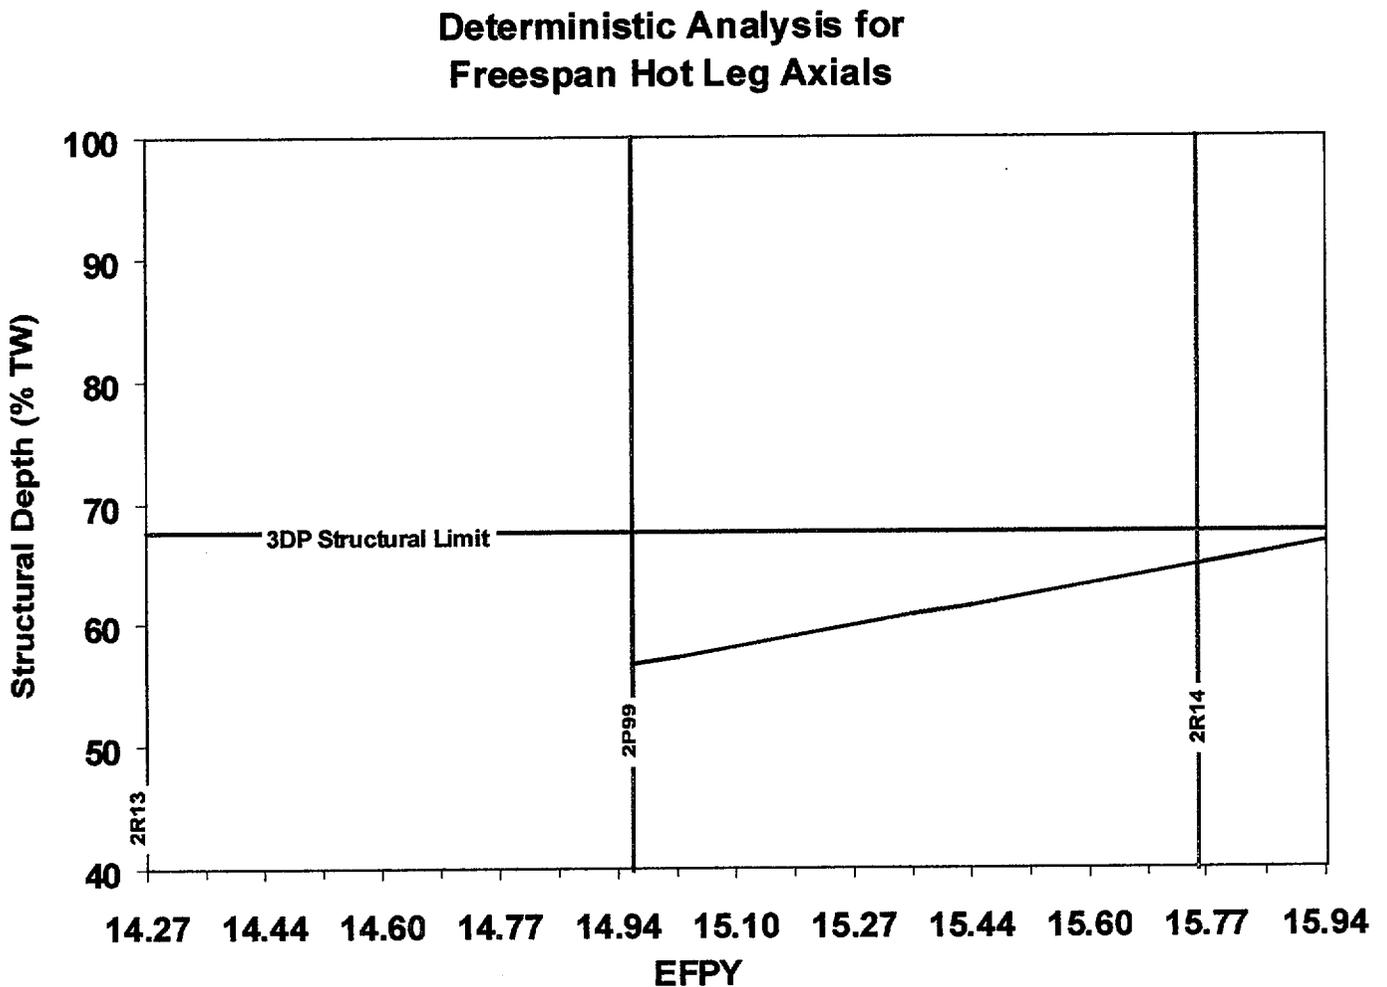
The hot leg free span area of the generator was included in the bobbin examination conducted during the 2P99 inspection. Five indications were identified and repaired. The sizes of the flaws were bound by the previous operational assessment. Once again, the 0.95 POD value was taken from the site specific performance demonstration (SSPD) performed following 2R13. This value was equal to 56.6% structural depth with a length of 1.48 inches. The 0.95 value on growth was offset by 15° F since the majority of the free span indications are found in the upper portion of the tube bundle. This value is equivalent to 10.35% per EFPY. This data is depicted in Figure 4.3 below:

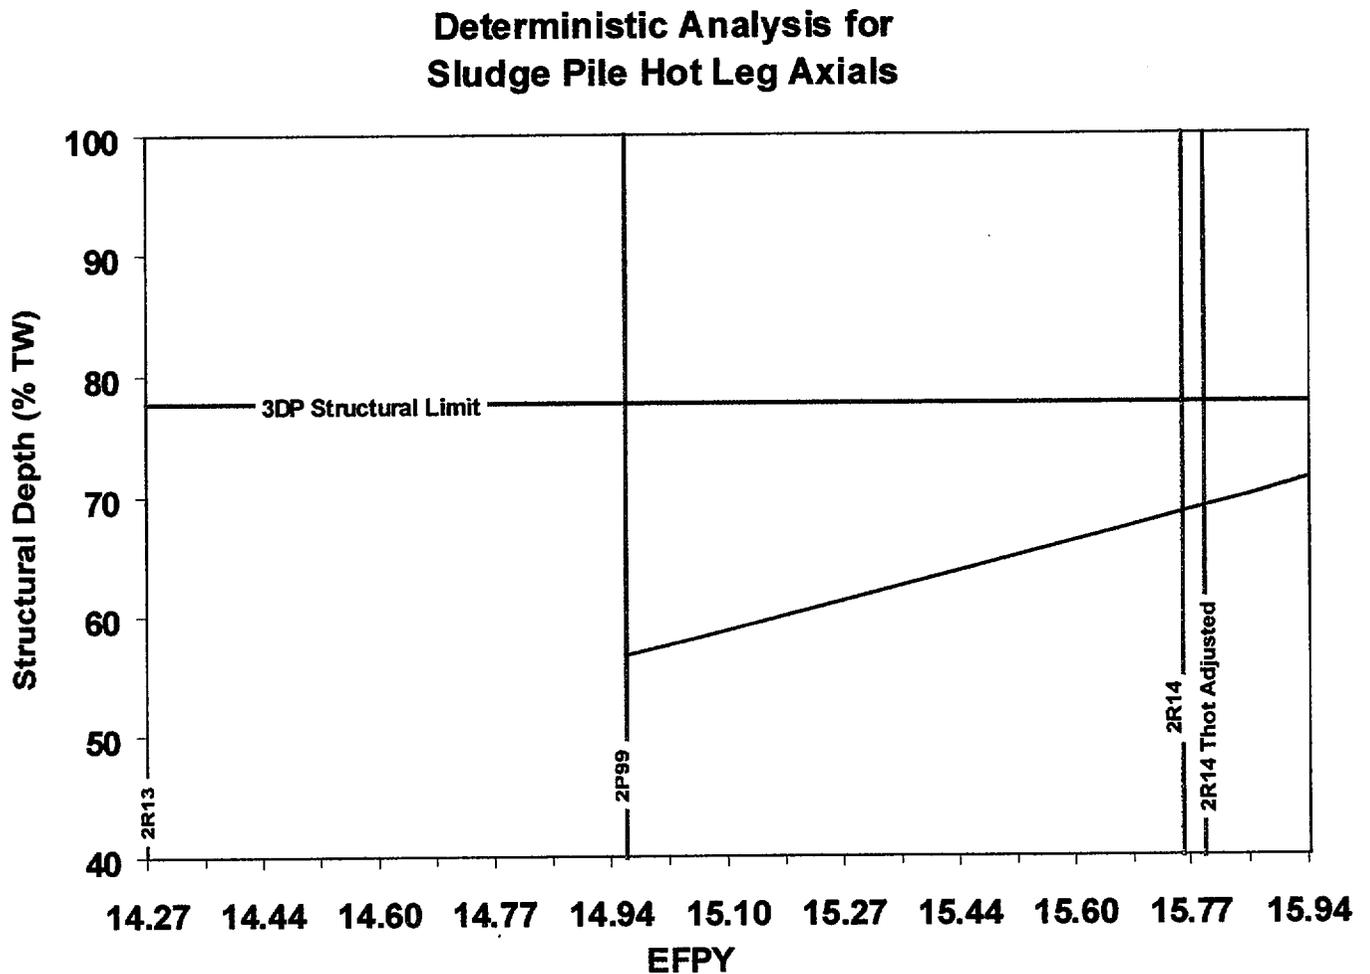
Figure 4.4

In previous outages, it was proven that consistent detection of axial cracking in the sludge pile was achieved with MRPC. Since the 2P99 inspection was performed in 100% of the tubes in the sludge pile area, credit was taken for the inspection. The 0.95 POD value for the sludge pile axials was a 56.6% structural depth with a 0.44 inch length. The 0.95 growth rate value was used due to the proximity of the flaws to the hot leg tube sheet. This growth rate was equivalent to 15.0% per EFPY. Additionally, a correction for increasing T-hot was used (3.7%). This analysis is depicted below in Figure 4.4:

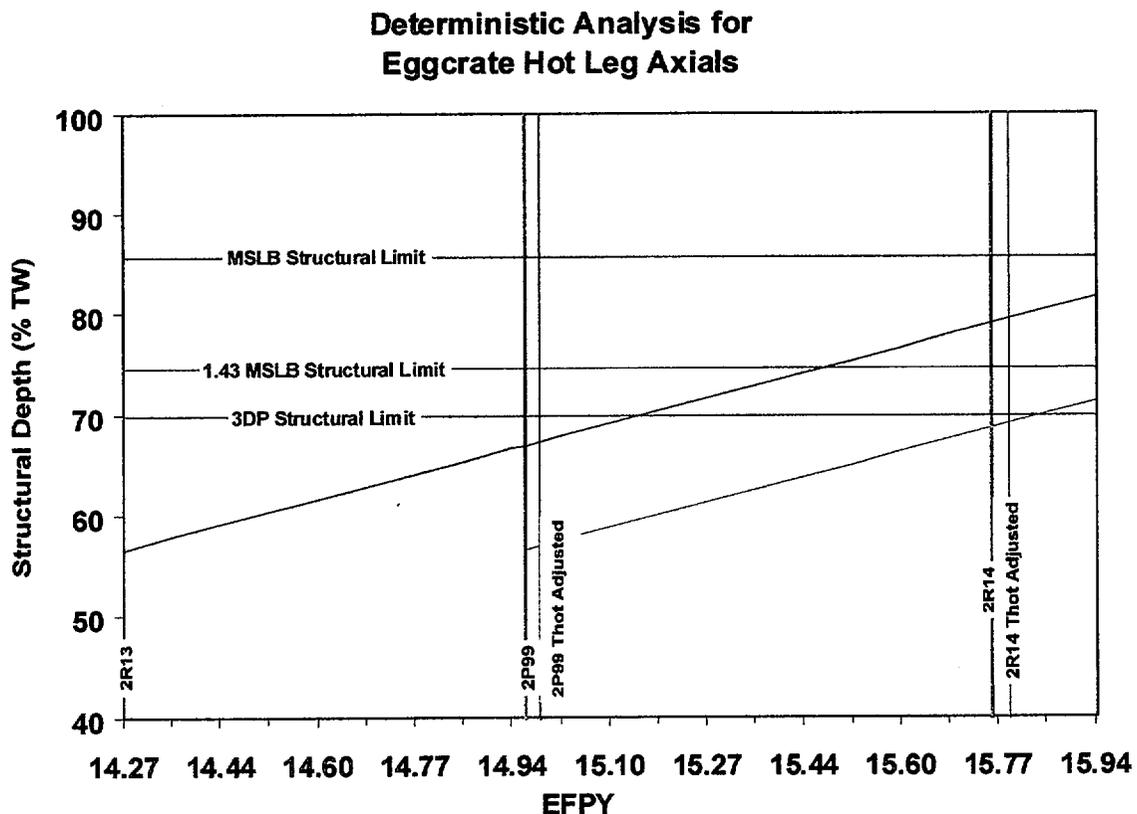
The initial deterministic evaluation for the eggcrate axial indications on the hot leg was performed during 2P99 to justify startup as part of the condition monitoring program. This initial evaluation justified approximately 7 months of operation and was submitted to the Staff December 21, 1999 (2CAN129911)<sup>1</sup>, based on using the peak in-situ pressure achieved on the worse case flaw identified (R72L72). After analysis to determine the maximum achieved pressure and completion of the growth rate study, this evaluation was repeated using the data in accordance with the EPRI Steam Generator Integrity Assessment Guidelines<sup>2</sup>. A 0.95 growth rate value of 15.0% per EFPY was used. The growth rate data was developed using information from the last three outages. To calculate the beginning of cycle flaw, the 0.95 value from the POD curve was used. The POD curve was developed from the SSPD performed following 2R13. The SSPD was previously described in the operational assessment submitted following 2R13 (2CAN069911). The 0.95 value for beginning of cycle structural depth was determined to be 56.6% with a length of 0.98 inch.

Based on the attached evaluation, tube R72L72 had a 278 psi of margin above the 3ΔP criterion. The inputs to the model were benchmarked against the previous outage (2R13) to evaluate if the values were appropriate. This data is depicted in Figure 4.5 below. The point at which 3ΔP would have been exceeded for the first half of the cycle was approximately 0.12 EFPY beyond 2P99. Using the same input values for the remainder of the cycle, the 3ΔP criterion would not be reached until after the designated EOC. This evaluation also accounts for the increase in operating temperature.

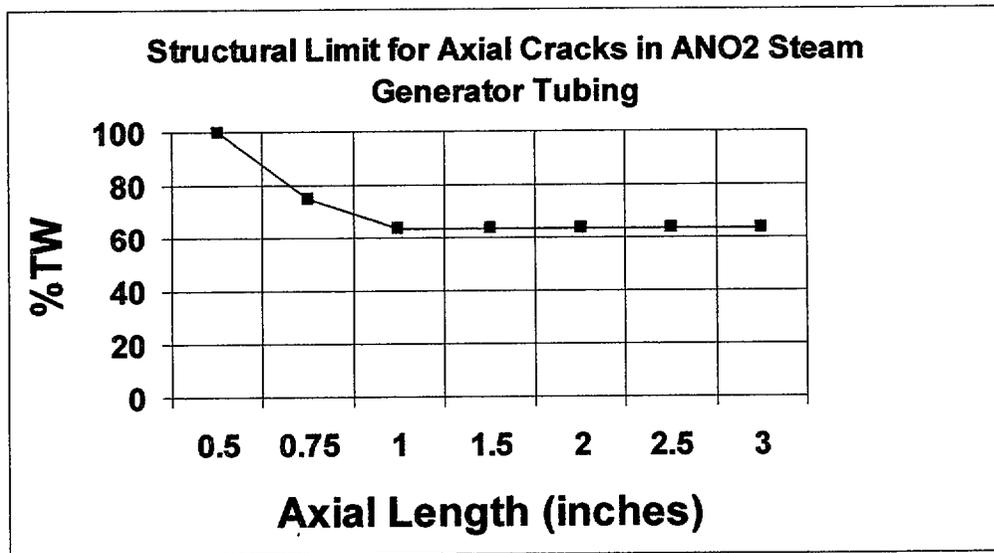
It is not possible to review data from previous inspections to quantify the growth rate, since 2R13 was the first time these intersections were tested with a rotating coil. However, due to the limited length of the indications, a deterministic approach was utilized. A structural limit curve is shown in Figure 4.6 that was derived from a study sponsored by the Combustion Engineering Owners Group<sup>7</sup> to determine the structural length vs. depth. The structural limit curve was based on a conservative burst correlation and used for screening data.

As shown in the figure, the structural limit in the range of lengths observed during 2R13 is 100% through-wall (TW). The largest of the two flaws (R50L114) was 0.33 inch in length and had a maximum depth of 75% TW. Since 2R13 was the first time that this mechanism was examined, it is possible that a flaw could have been left in service if it was at the detection level of the test. Using the plus point coil, the minimum detectable depth would be approximately 20% based on the EPRI qualification. To be conservative, a 40% TW value was used. Applying a maximum growth rate based

on the eggcrate axial data, 40% TW would be added for a total of 80% TW. Based on the length and calculated depth, the largest postulated flaw would pose no threat from a structural or leakage standpoint. Based on the above results, it is acceptable to operate full cycle due to potential axial cracks in a dented eggcrate.
