Commonwealth Edison Company  
Byron Generating Station  
4450 North German Church Road  
Byron, IL 61010-9794  
Tel 815-234-5441

Byron Station, Unit 2  
Facility Operating License No. NPF-66  
NRC Docket No. STN 50-455

Subject: Licensee Event Report (LER) 2000-001-00

TITLE (4) Automatic Reactor Trip System Actuation Due to Off-Site Power Line Fault and Failed Air Circuit Breaker Load Rejection Contact

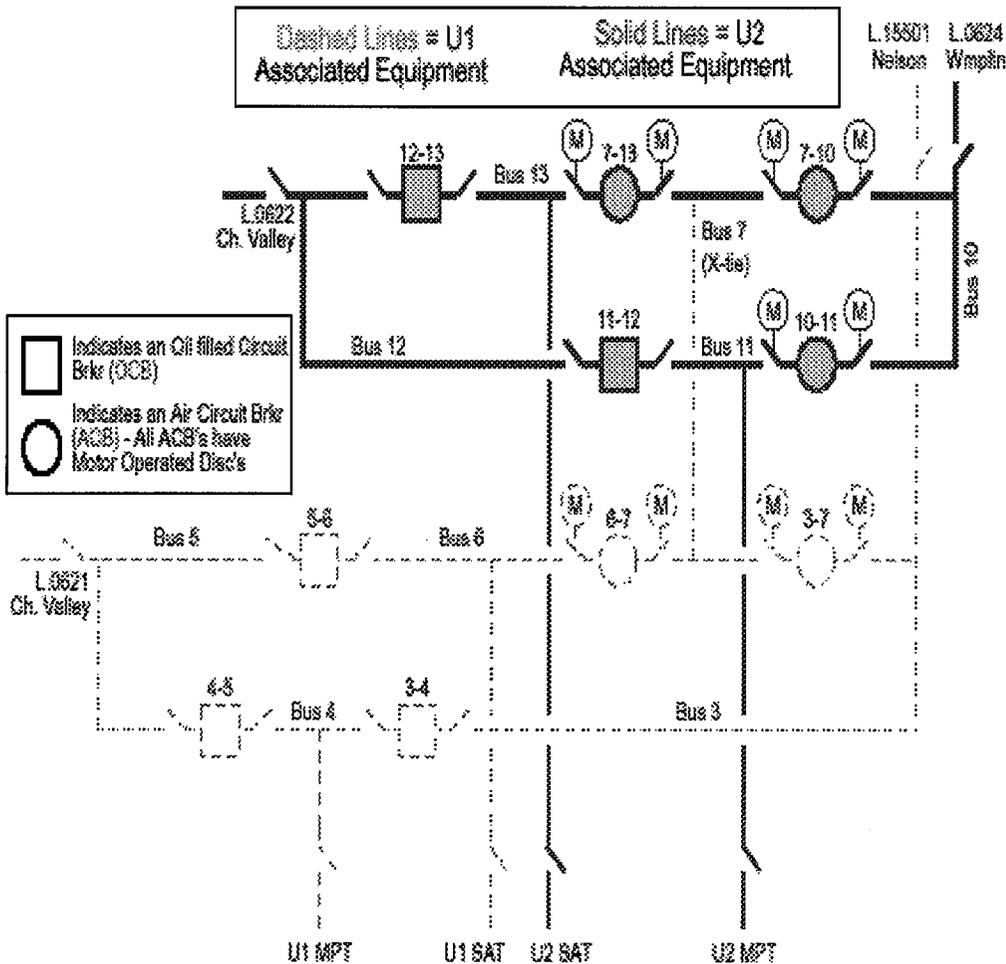
FIGURE 1 - LINE DIAGRAM OF BYRON STATION'S SWITCHYARD

The two Units at Byron Station have a common 345 Kv switchyard that is configured into two ring busses to afford reliability and redundancy of offsite power supplies. Figure 1 depicts a line diagram of Byron Station's switchyard. Two 345 Kv offsite transmission lines are connected to each unit's ring bus. The Unit 1 lines are numbered 0621 and 15501 and the Unit 2 lines are numbered 0622 and 0624. Line 0621 and 0622 are routed on the same transmission towers from the Cherry Valley substation into the Byron Station switchyard. Each line is provided with fault isolation capability from the ring bus through use of switchyard circuit breakers.

At 0059 hours on January 13, 2000, a static line on line 0621 broke and fell across the B phase of line 0622 thereby causing an electrical fault. Unit 2 received a line 0622 direct transfer trip alarm due to a phase B fault on line 0622. The direct transfer trip signal opened Oil Circuit Breakers (OCBs) 11-12 and 12-13 to isolate the line fault in the Byron Station switchyard. Due to the redundant offsite power supply (i.e., line 0624) the event should have terminated at this time without further interruption to unit operations. However, Unit 2 also received an unexpected Main Generator [TB] (MG) load rejection trip signal. The load rejection circuit provided a signal to actuate MG lockout relay 86G2A, which opened Air Circuit Breaker (ACB) 10-11 and automatically tripped the Unit 2 turbine [TA]. A turbine trip automatically generates a reactor trip above 30% power.

Conditions c. and d. are satisfied during the normal full power unit operation electrical lineup. Condition a. was satisfied when OCB 11-12 opened due to the line 0622 fault. The remaining permissive to complete the logic was the position of the ACB 10-11 load rejection auxiliary contacts. The Unit 2 Sequence of Event Recorder (SER) indicated ACB 10-11 was closed at the time of the load rejection alarm which indicated one of the ACB 10-11 auxiliary contacts must have been closed at that time to complete the logic. It was verified during subsequent troubleshooting that the ACB 10-11 phase A load rejection 'b' contact was found closed when the breaker was closed. The 'b' contact should have been open with the breaker closed to prevent the load rejection trip signal.
